Aviation Safety Digest

Contents

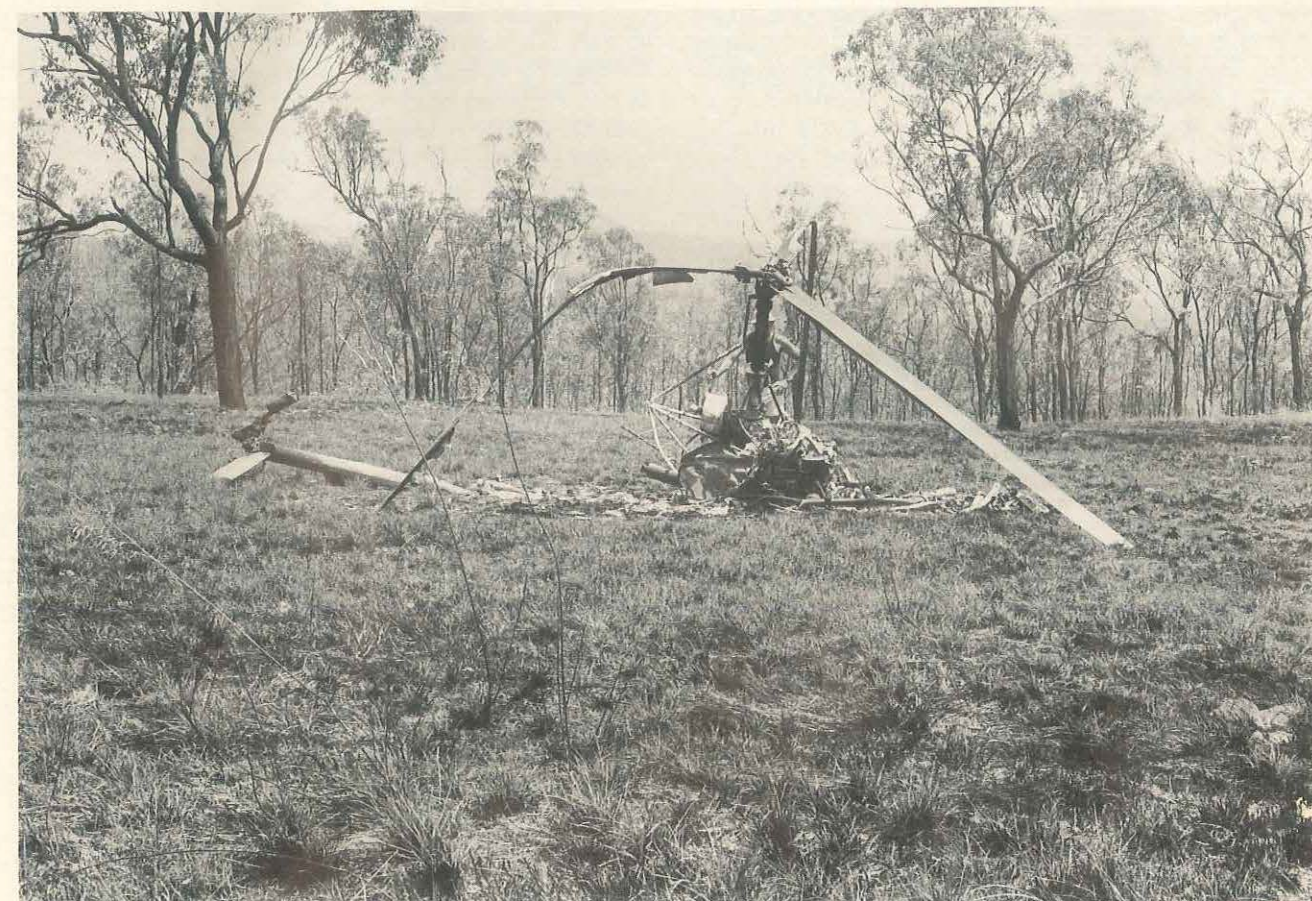
In the most recent accident the pilot landed his Hughes 269C in long grass to drop a passenger. He was aware of the fire danger and intended to take off again as soon as his passenger was clear of the aircraft. The passenger started to disembark 10 to 15 seconds after touchdown but was prevented from doing so by a wall of fire immediately outside the aircraft. He hastily withdrew into the cockpit. By then the pilot could feel the fire singeing his own legs as it spread, so he vacated the aircraft with his passenger in hot pursuit. Both men then retreated to a safe distance and watched the fire consume the aircraft.

In an earlier accident the pilot of a Hughes 269 landed in an open grassed area to allow his passenger to disembark to check the water level in a creek some 500 metres to the east of the landing site. The passenger, who was the manager of the property, intended to fire the area east of the creek if there was sufficient water to form a firebreak. The pilot intended to keep the engine running during his passenger's absence. Shortly after the passenger had departed, the pilot heard the engine run down and noticed that the grass to

the left and rear of the aircraft was alight, with flames reaching the top of the fuselage. He hastily vacated the aircraft through the right door and retired to a safe distance to watch the aircraft burn out.

Prior to the accident this pilot did not consider it possible for the Hughes 269 to start a fire. He normally flew Bell 47 helicopters and was conscious of the possibility with that aircraft, but considered that the higher ground clearance of the Hughes eliminated the problem. However, history has shown that his belief was ill-founded. Six aircraft destroyed in grass fires since 1967 have been Hughes 269s.

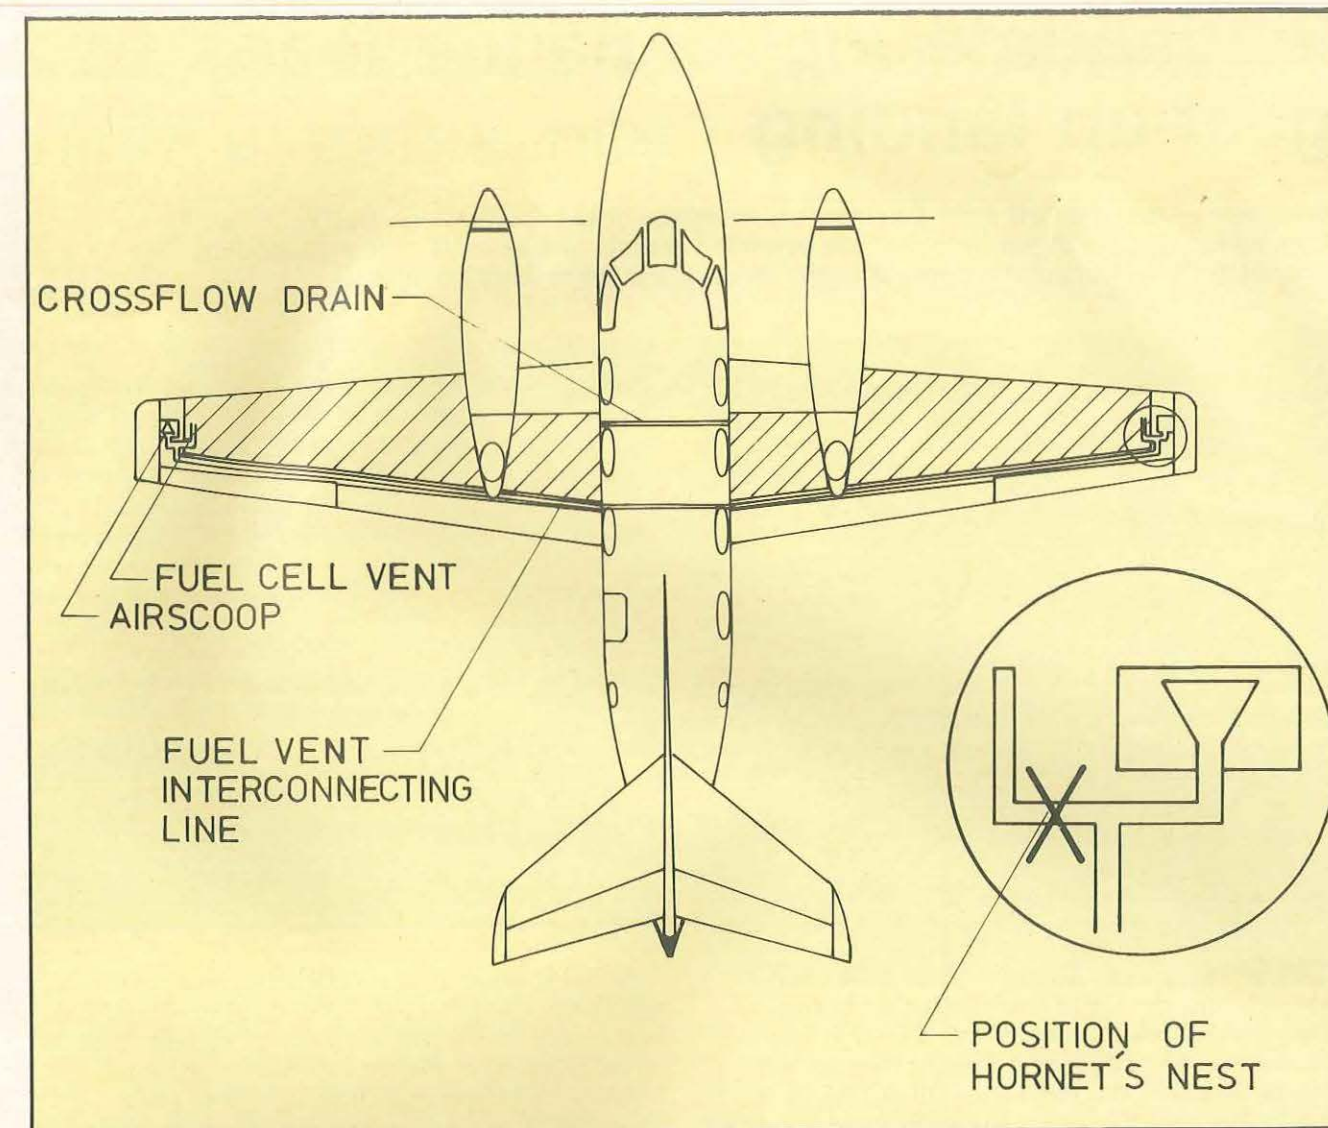
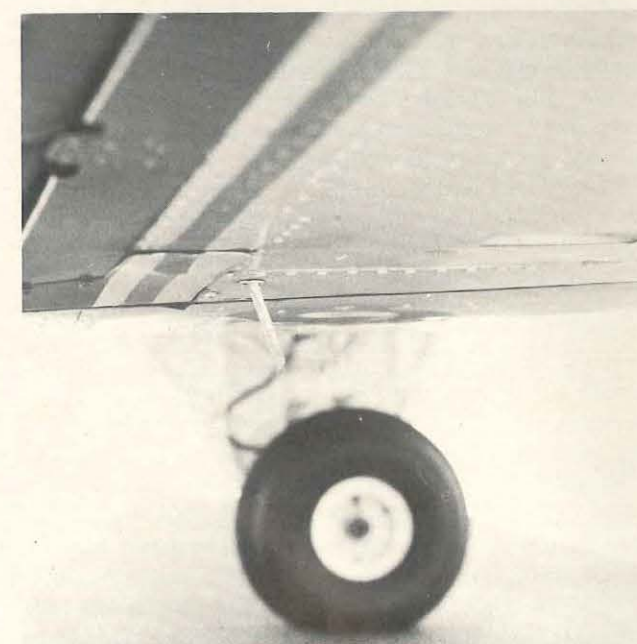
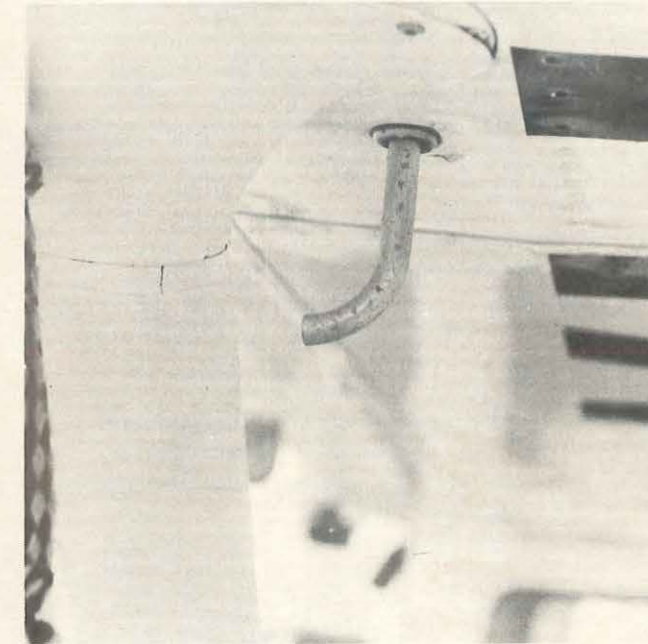
Typical light aircraft fuel vents

Tank vents have three main functions: to prevent a lowering of pressure in the tank by allowing air to enter as fuel is consumed; to prevent a build-up of pressure in the tank with increases in temperature, and to provide a small positive pressure over the fuel to ensure a positive flow to the engine in flight. Failure of the vents to do their job can result in fuel starvation, fuel tank collapse (which becomes really exciting if the tank is of 'wet wing' construction) or, in the case of excessive tank pressurisation, tank rupture and wing damage.

Most pilot's handbooks contain only sparse detail of what the pre-flight inspection of tank vents should include. In general, the pre-flight inspection should include a check for obstructions and a look at the condition and configuration of the vent. In the absence of any information on the correct configuration a comparison with other vents may be useful in detecting abnormalities. But as a general comment any configuration that might create a negative pressure in the vent system in flight should be treated with suspicion and be checked by a qualified person.

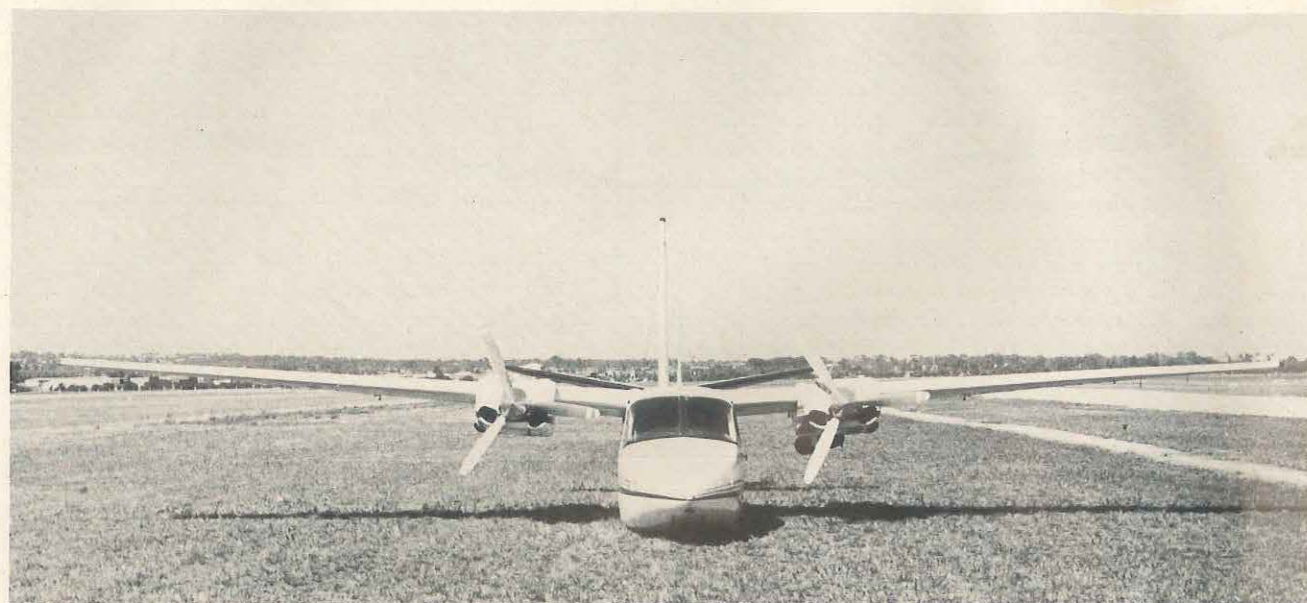
Unable to extend the left main landing gear on arrival at his destination, the pilot of an Aero Commander 500S elected to retract the extended wheels and execute a gear-up landing. The aircraft suffered only minor damage in the landing and there were no injuries.

The landing gear had retracted normally after take-off, and the flight was conducted in smooth conditions without incident. On arrival at his destination the pilot selected gear down on the downwind leg of the circuit and obtained down and locked indications for the right main and nose gear, but the left main extended only about 300 millimetres and then stopped. The pilot tried several times to free the jammed gear but was unsuccessful. Hydraulic pressure was normal throughout. Realising that a gear-up landing was becoming a distinct possibility he elected to divert to a major airport where better emergency services and maintenance facilities were available.

The pilot succeeded in retracting the left main gear by the application of negative 'g', but on arrival at the diversion airport his attempts to extend it were again unsuccessful. The left main gear again extended only partially and jammed. Repetition of the emergency extension procedures and the application of both positive and negative 'g' failed to change its position. On ATC and Company advice the pilot then diverted to a nearby general aviation airport where emergency services had been alerted.

Initial investigation revealed that two bushes which accommodate the landing gear torque link had failed, interfering with the 90 degree rotation of the inner strut during extension and retraction. However, the failure of these bushings alone should not have prevented gear extension. Further investigation revealed that the upper and lower needle bearings in which the inner strut rotates had partially seized. They showed evidence of moisture ingress, severe corrosion and lack of grease. This had prevented strut rotation and, in turn, gear extension beyond the partially extended position shown in the photograph.

In 1978 an Airworthiness Advisory Circular (No. 104) was issued to draw operators' attention to the importance of regular lubrication of landing gear systems. Furthermore, the manufacturer recommends a 3000 hour overhaul period for landing gear components in this aircraft. The relevant components had, in this case, been in service for over 11 000 hours and there was no evidence in the aircraft log book to indicate that any such overhaul had been carried out.

While recommendations of this type are not of a mandatory nature they are certainly not made lightly. Rather, they are made on the basis of service experience over a wide range of operating conditions. Individual operators may see fit to vary such recommended servicing periods in the light of their own experience, but they should recognise the possible implications of unduly large extensions ●

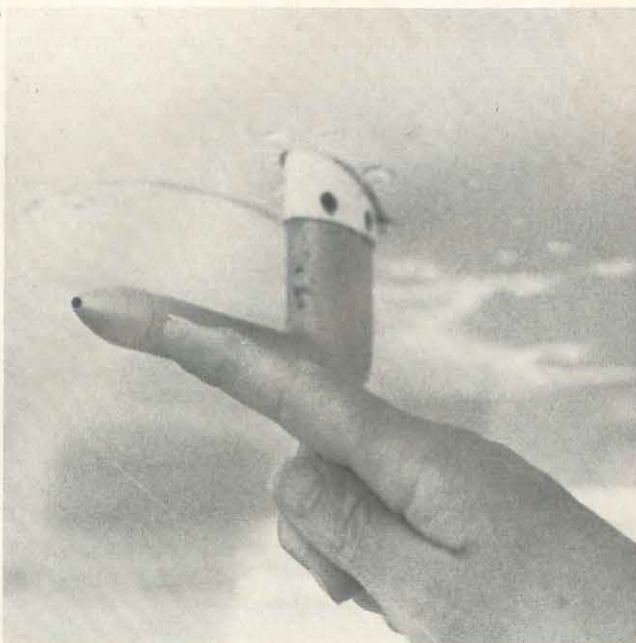
15

15. Remove covers from pitot heads and check for obstructions. Similarly, check fuel vents and static vents. If checking pitot heat wet your finger first. With no cooling airflow the pitot head can get very hot.

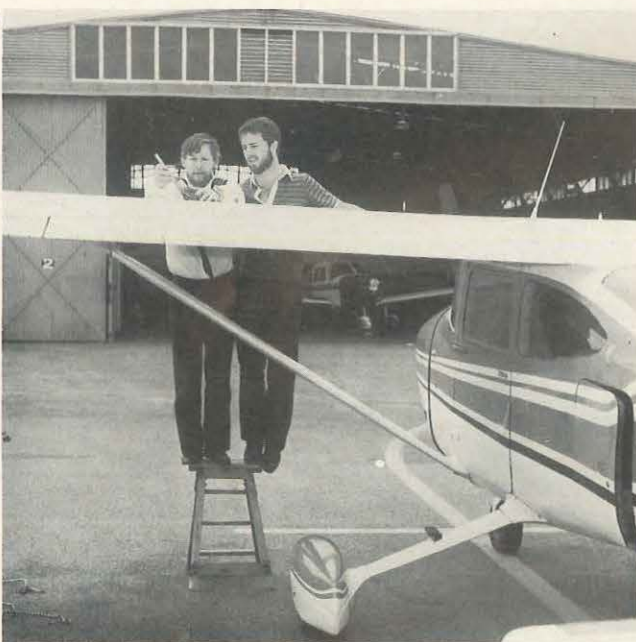
16

16. Fuel quantity — a vital check! But remember: visual estimate is unreliable unless tanks are full or filled to a defined level (tabs etc); dipstick may be inaccurate unless the aircraft is level; time card calculations are not always reliable; and gauges may lack sensitivity and be inaccurate. Therefore cross check, and then if in doubt fill up anyway or add enough fuel for the flight. Ensure caps are correctly fitted.

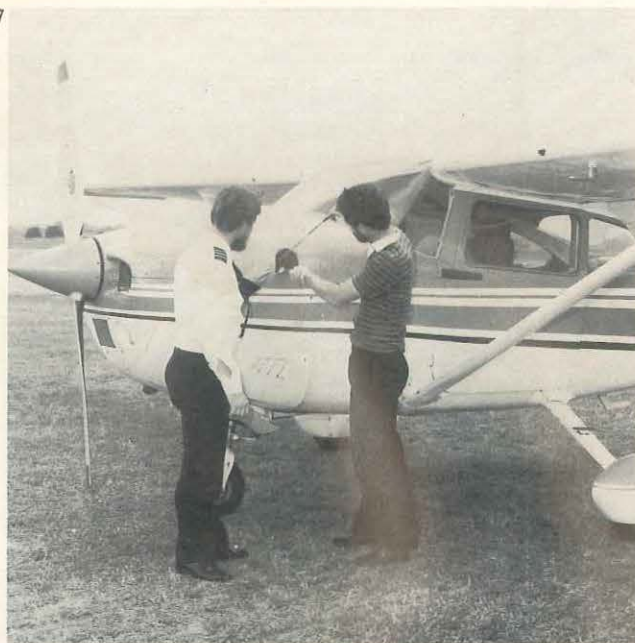
17

17. Another vital check! Without oil your engine wouldn't last a minute. Check also condition of the oil, tiny flakes of metal and water contamination. Ensure filler cap is correctly secured and the access panel is closed and fastened.

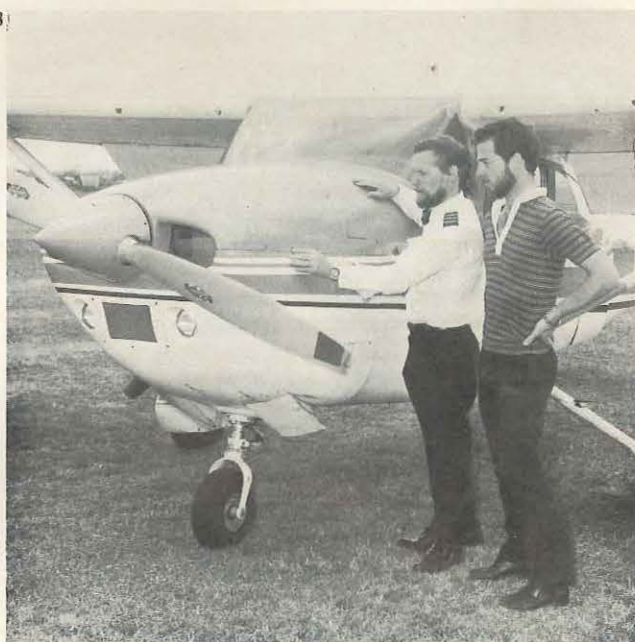
18

18. Check correct closing, fit and security of cowls after checking engine bay for: bird nests, cleaning rags or other foreign matter; cracked exhaust systems and heater mufflers; frayed ignition harness or air ducting; security of engine control linkages; and chafed oil or fuel lines. Fuel leaks may be evidenced by staining and signs of washing on cowls. Check security of all inspection panels.

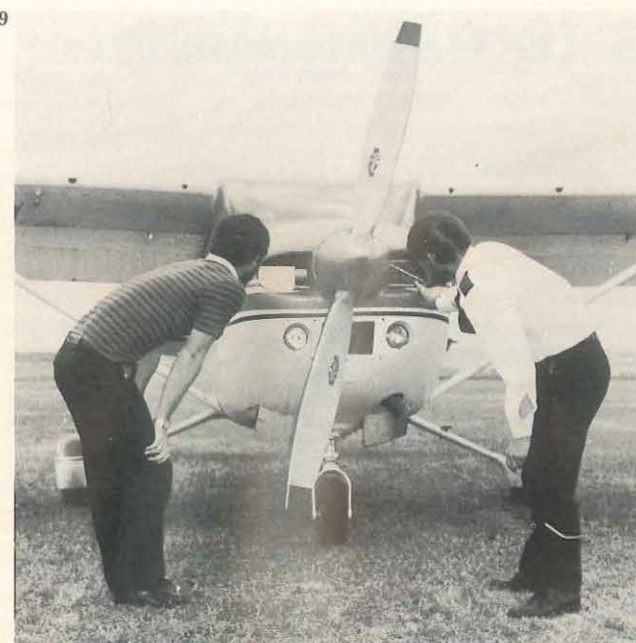
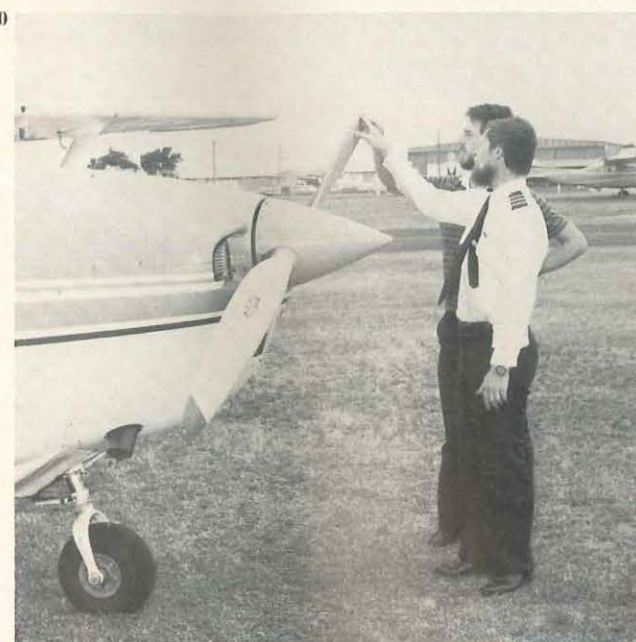
19,20. The oil cooler and induction air filter must be secure, clean and unobstructed. Landing lights should be clean. Check propeller for tip damage, leading edge nicks and cracks and spinner security. Even apparently minor nicks can lead to fatigue cracking and blade failure, so ensure that they are properly dressed out by a qualified person. Pull propeller through backwards to check compression. If all cylinders are not equal, have it checked. Do not compression check a hot engine.

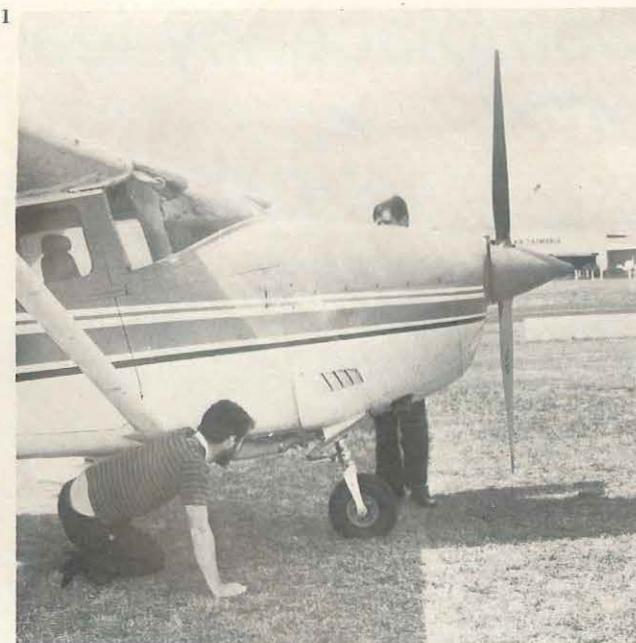
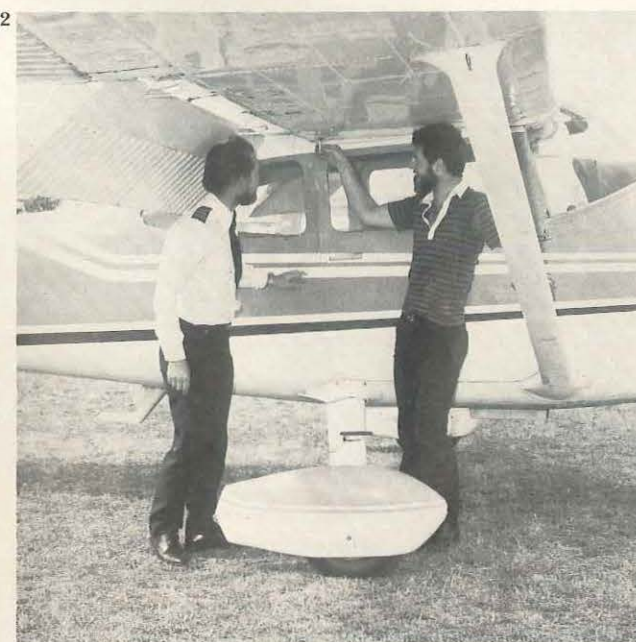
21, 22. Contaminated fuel is deadly! Take samples from all tank drains and the strainer drain. Check for contamination by water or other foreign matter (methods of checking for water contamination are given in ANO 20.2). Check grade of fuel by colour. Ensure all drains are properly closed and not leaking. Do not return fuel to the tanks — discard it downwind clear of aircraft, smokers etc.

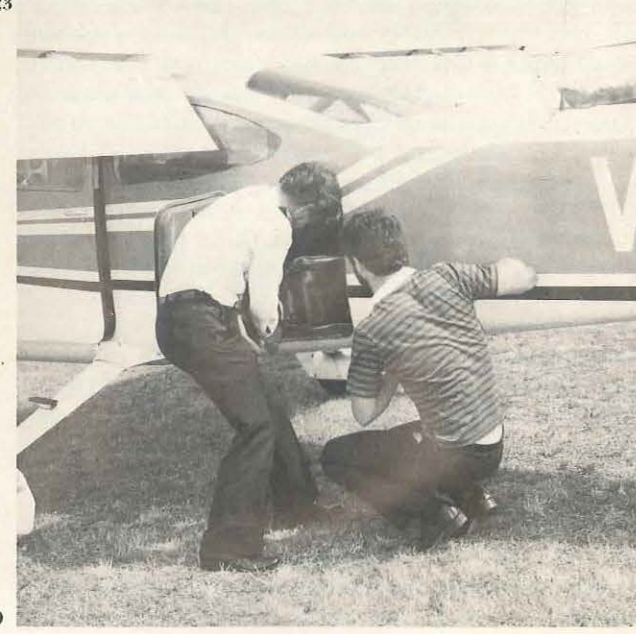
23

23. Stow baggage, equipment, chocks etc., tie them down securely and you are ready to go, with the assurance that your aircraft is mechanically sound ●
