Aviation Safety Digest

BUREAU OF AIR SAFETY INVESTIGATION

115/1983

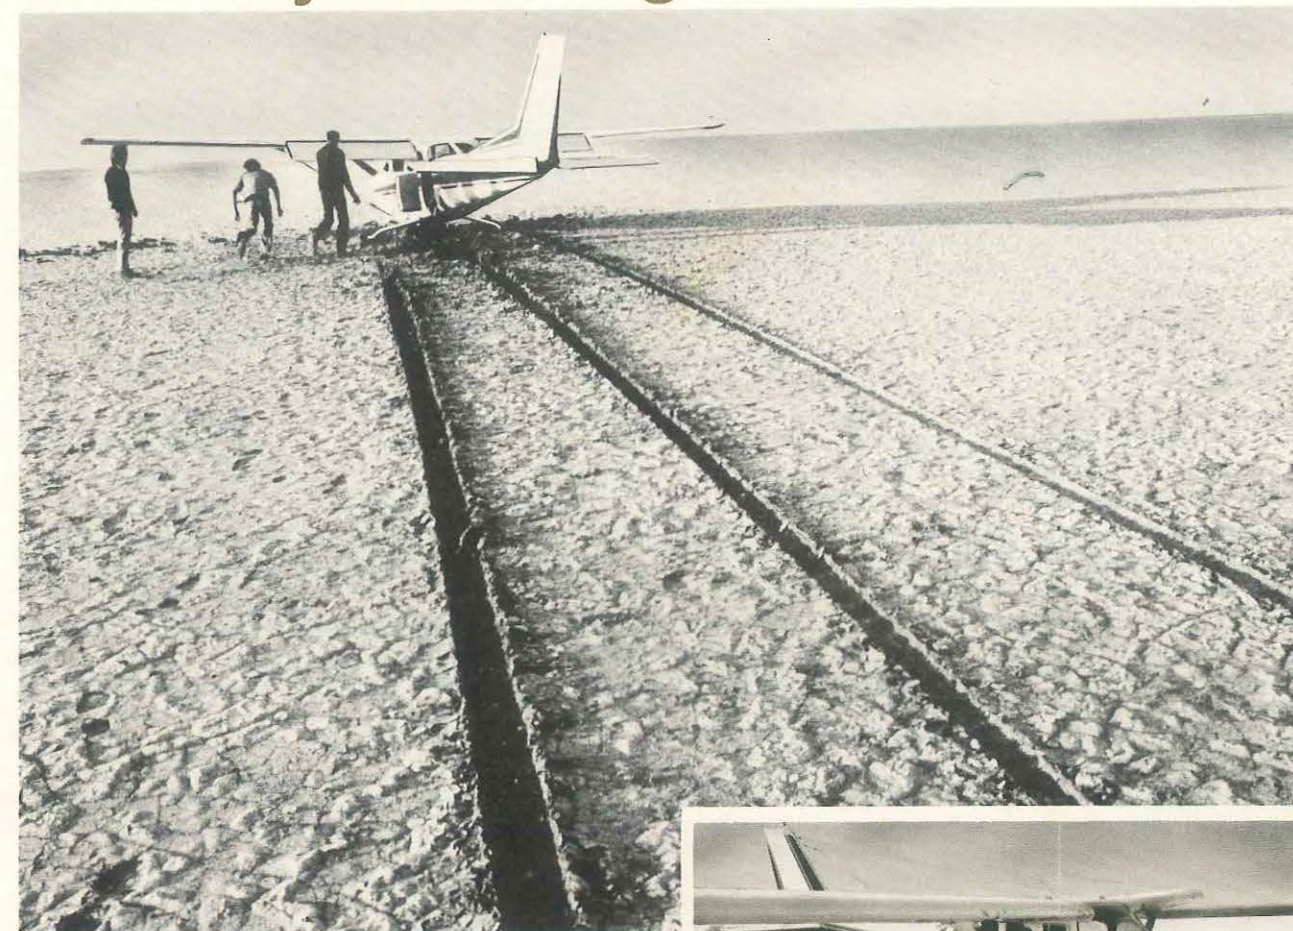
View of wheel marks in lake surface.

Right view of aircraft. Note how the nosewheel has dug in.

Weather conditions were fine as the pilot touched down gently into a 20 knot headwind. He had asked his passenger to monitor wheel penetration of the surface. Initially the surface seemed firm but, as the aircraft decelerated, the wheels started to dig in slightly. Just as the pilot decided to initiate a go-around at about 40-50 knots, the main wheels dragged more heavily and forced the nosewheel through the surface of the lake, eventually to a depth of about 30 centimetres. The aircraft rolled only about seven metres after the nosewheel dug in before the propeller struck the surface, stopping

the engine. Although subsequent examination revealed only superficial damage to the aircraft, its recovery presented considerable difficulties.

Because there was nobody on the ground to assess properly the suitability of the area, the pilot would have been wise to have declined the photographer's request to land. After the incident the pilot surveyed a larger area of the lake and found that while there were some hard areas, the surface generally was soft to a depth of about 10 centimetres. This incident, like previous similar occurrences, showed that the only safe way to assess a proposed landing area is from the ground, and that a low-level flypast is no substitute for a thorough ground-level survey.

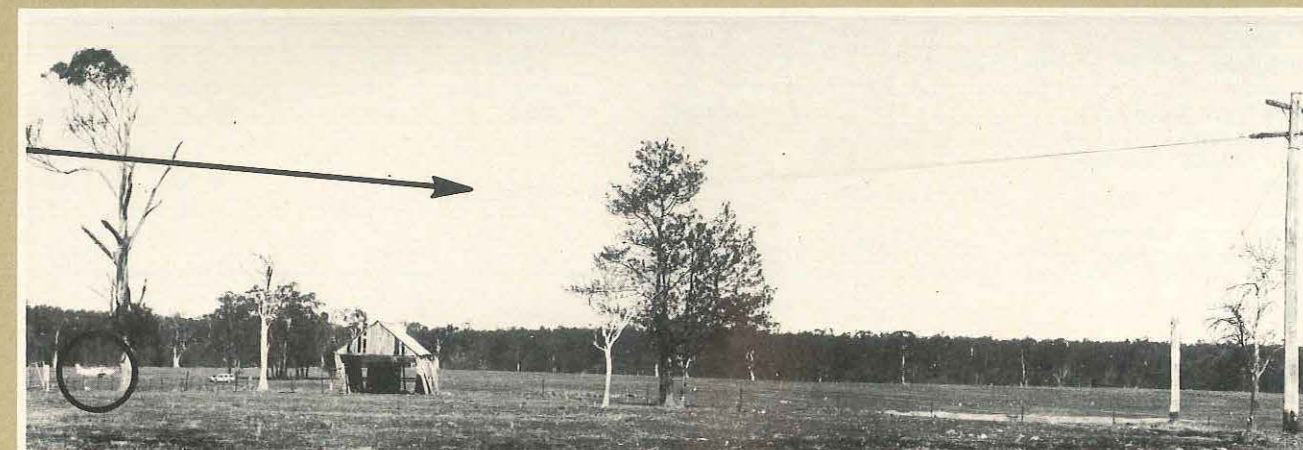
respond. A second attempt achieved the desired result but by then the aircraft had hit power lines, which the pilot had not seen. Trailing three lengths of cable, the aircraft stayed airborne but would not climb. The pilot commenced a left turn to avoid trees and silos, but after turning through 180 degrees the aircraft touched down. Realizing that further flight was impossible the pilot closed the throttle and managed to stop the aircraft without incurring any additional damage.

The power lines struck by the aircraft, replaced by the time the photograph was taken. Direction of approach is arrowed and the aircraft is circled at left of the photograph.

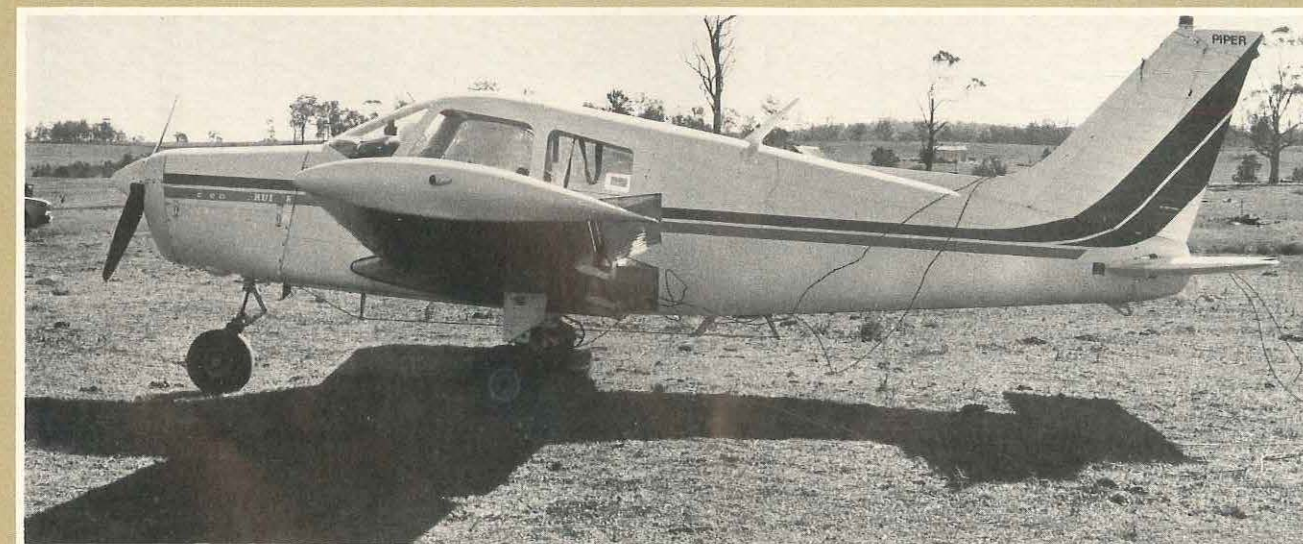
The aircraft as it came to rest. Broken power lines are shown wrapped around the left undercarriage, rear fuselage and right stabilator.

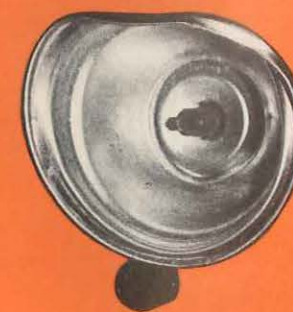
This pressure can of insect spray exploded when it was left in the closed cabin of a helicopter which was parked in the sun.

WARNING: The temperature in a closed aircraft cabin can easily reach and exceed the 50° Celsius temperature limitation prescribed to ensure pressure can safety. Temperatures as high as 80° Celsius have been recorded.

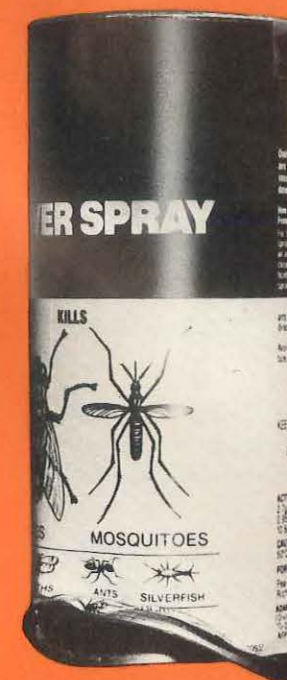
The ruptured can made a deep imprint in the metal liner of one of the aircraft's doors before it punched a hole in the windscreen.
