Aviation Safety Digest

Contents

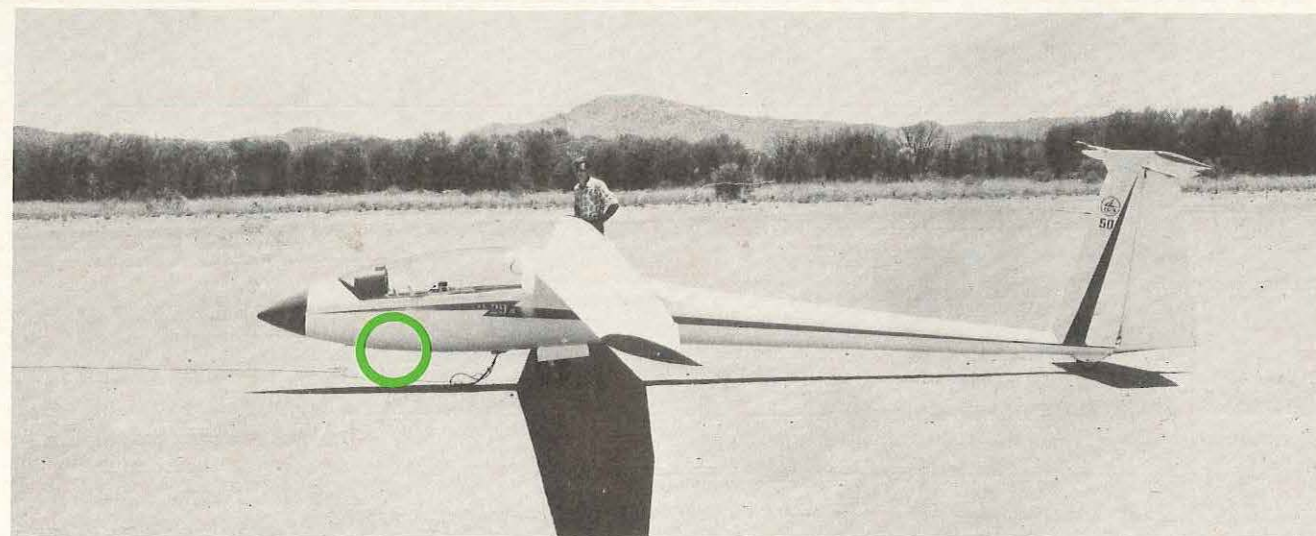
This glider was constructed with two towing hook attachment points: a forward point for aero-tow launching and a rear point for winch or auto-tow launches. The glider's flight manual states that if winch or auto-tow launches are made utilising the forward tow point, and full elevator deflection is applied during launch, then pitching instability (porpoising) may occur. To counter this a reduction of airspeed or elevator deflection is recommended. At its home base this particular glider was normally operated by an aero-tow launch, and only the forward hook was fitted. A cover plate had been fitted over the rear attachment point.

Glider being towed by belly hook position. Forward hook is circled.

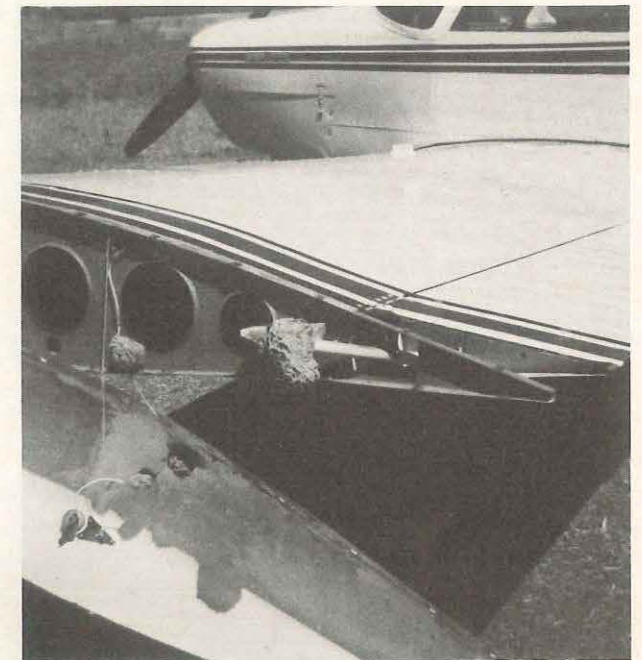
The pilot had not flown his aircraft for one month and during his daily servicing found that there was very little movement in the ailerons. He traced the problem to the port wingtip where he found that mud-dauber wasps had built a nest on the balance arm (see the photographs). The nest was a very solid construction and required considerable effort to remove it. The pilot believed he could not have operated the ailerons simply by using the control column.

The application of insecticides to discourage mud wasps is unlikely to be successful, for the only suitable chemicals would degrade, and lose their effectiveness, if exposed to the elements. The best deterrence is provided by the regular use of physical

barriers such as netting, covers, caps and plugs. Good housekeeping around hangars and parking areas is also important: not allowing taps to drip, for example, will deny the mud-daubers one part of their building material.

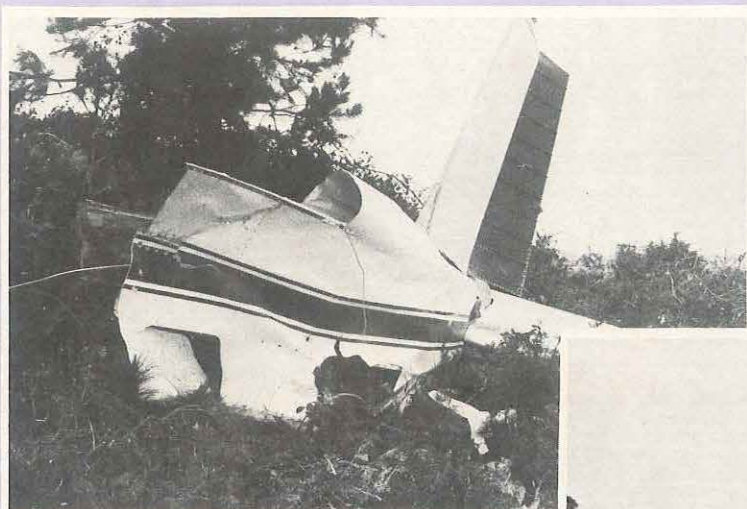
There was no flight manual in the aircraft so the pilot 'eyeballed' the length of the strip and decided it was adequate . . .

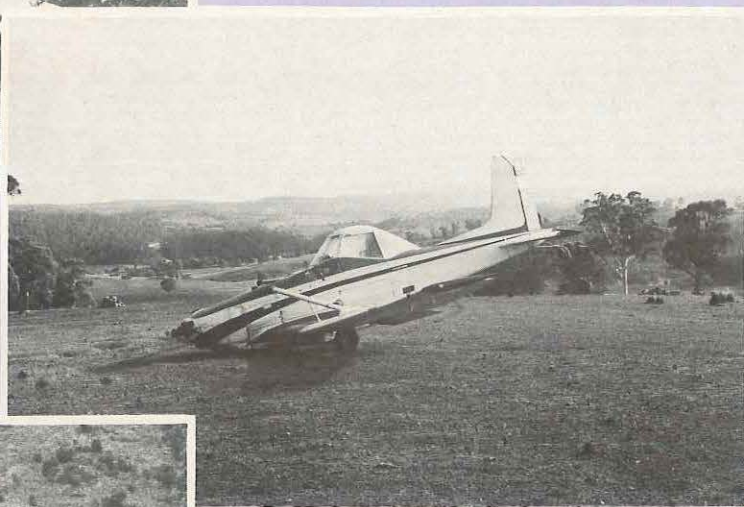
. . . takeoff weight exceeded the climb weight limit stipulated in the P-charts . . .

. . . the pilot did not use his P-charts correctly . . .

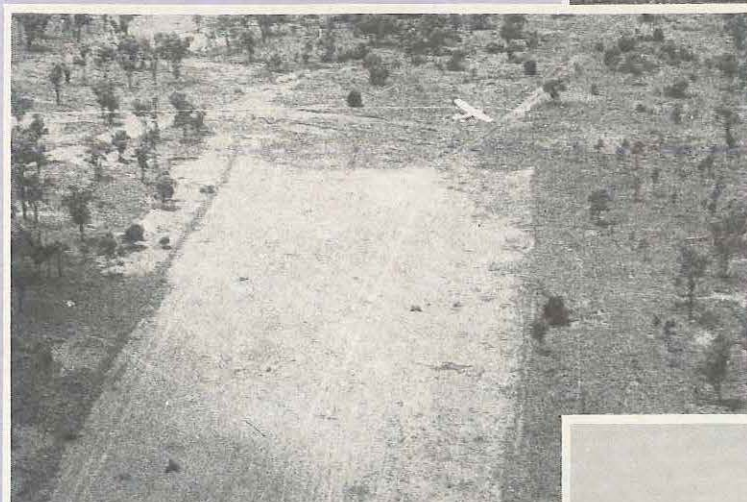
. . . this ALA was too short for the particular aircraft to use for takeoff . . .

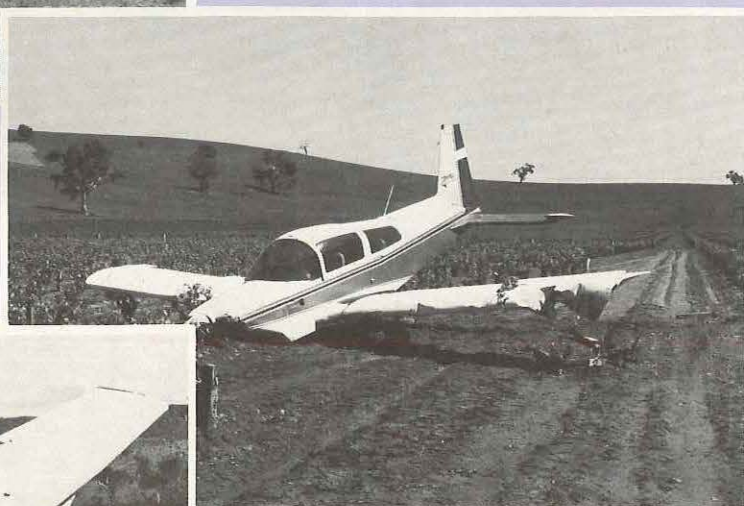
. . . and this one too short for landing.
