Aviation Safety Digest

AIR SAFETY

119/1984

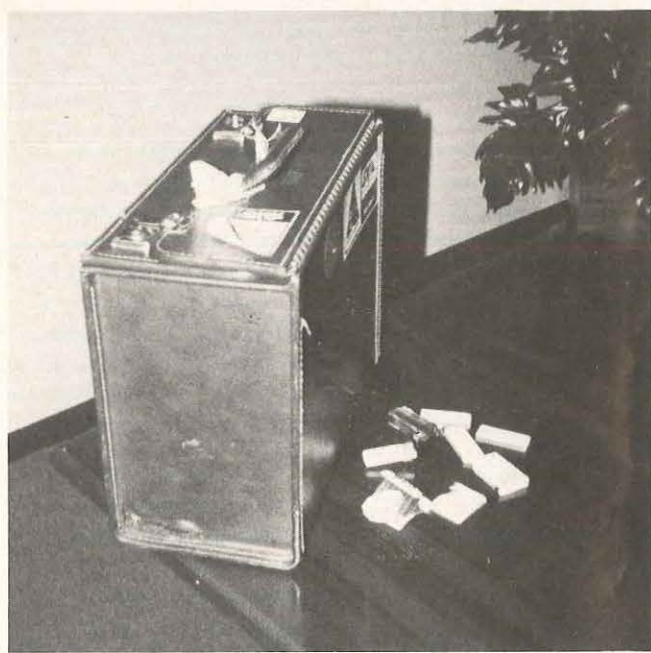
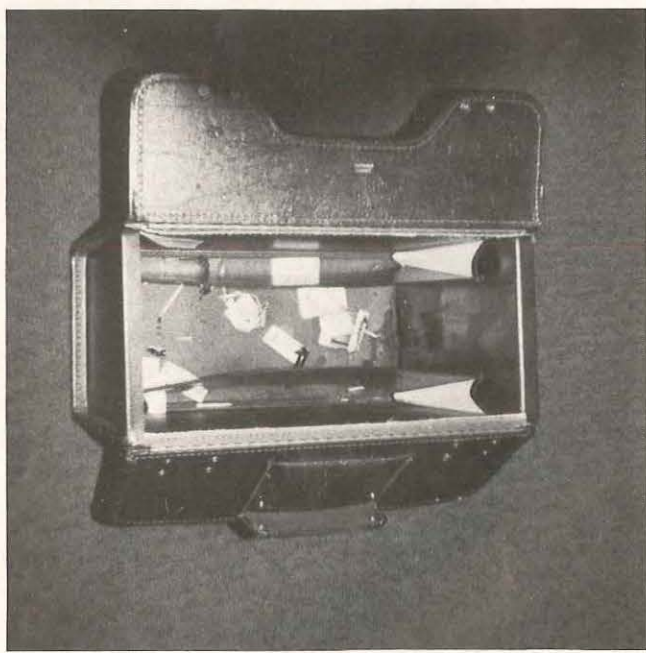
During loading of a B727, portering staff discovered that a briefcase in the forward locker of the aircraft was smouldering. A book of matches was subsequently found to have ignited spontaneously.

Readers should note that, while passengers and crew are permitted to carry matches on their persons, they are not allowed to carry them in luggage unless the matches have been packed and declared in accordance with Dangerous Cargo Regulations. While book matches are the most dangerous, these regulations apply to all matches, including those in boxes and labelled as 'safety matches' ●

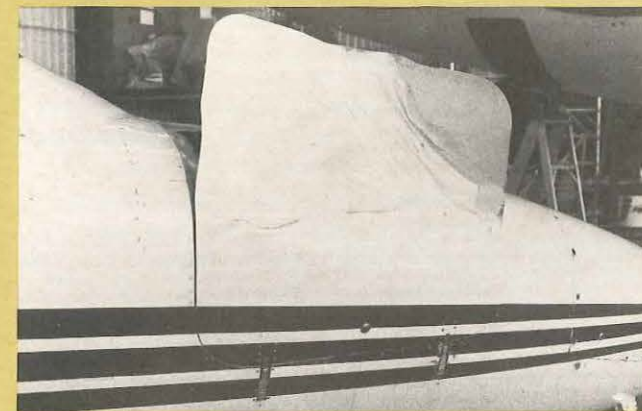
During the technical investigation it was determined that the door and all latches were fully serviceable. If the door had been correctly latched it would not have been possible for it to have come open and separate in flight.

View of right nose locker door in position. Notice damage to door and that it can still be latched.

A comment on the procedure used to check the security of the nose door is also warranted. The prime devices for keeping the nose door secure in flight are the two latches, not the key lock. Therefore, to open the front latch to check the key lock would seem to serve little purpose. Indeed, it only increases the possibility of leaving the front latch unlocked and, if that happens, the key lock will not necessarily prevent the nose door from 'peeling' when subjected to airflow and eventually separating from the aircraft ●
