Contents

Aviation Safety Digest is prepared by the Bureau of Air Safety Investigation in pursuance of Regulation 283 of the Air Navigation Regulations and is published by the Australian Government Publishing Service. It is distributed free of charge to Australian licence holders (except student pilots), registered aircraft owners and certain other persons and organisations having an operational interest in Australian civil aviation.

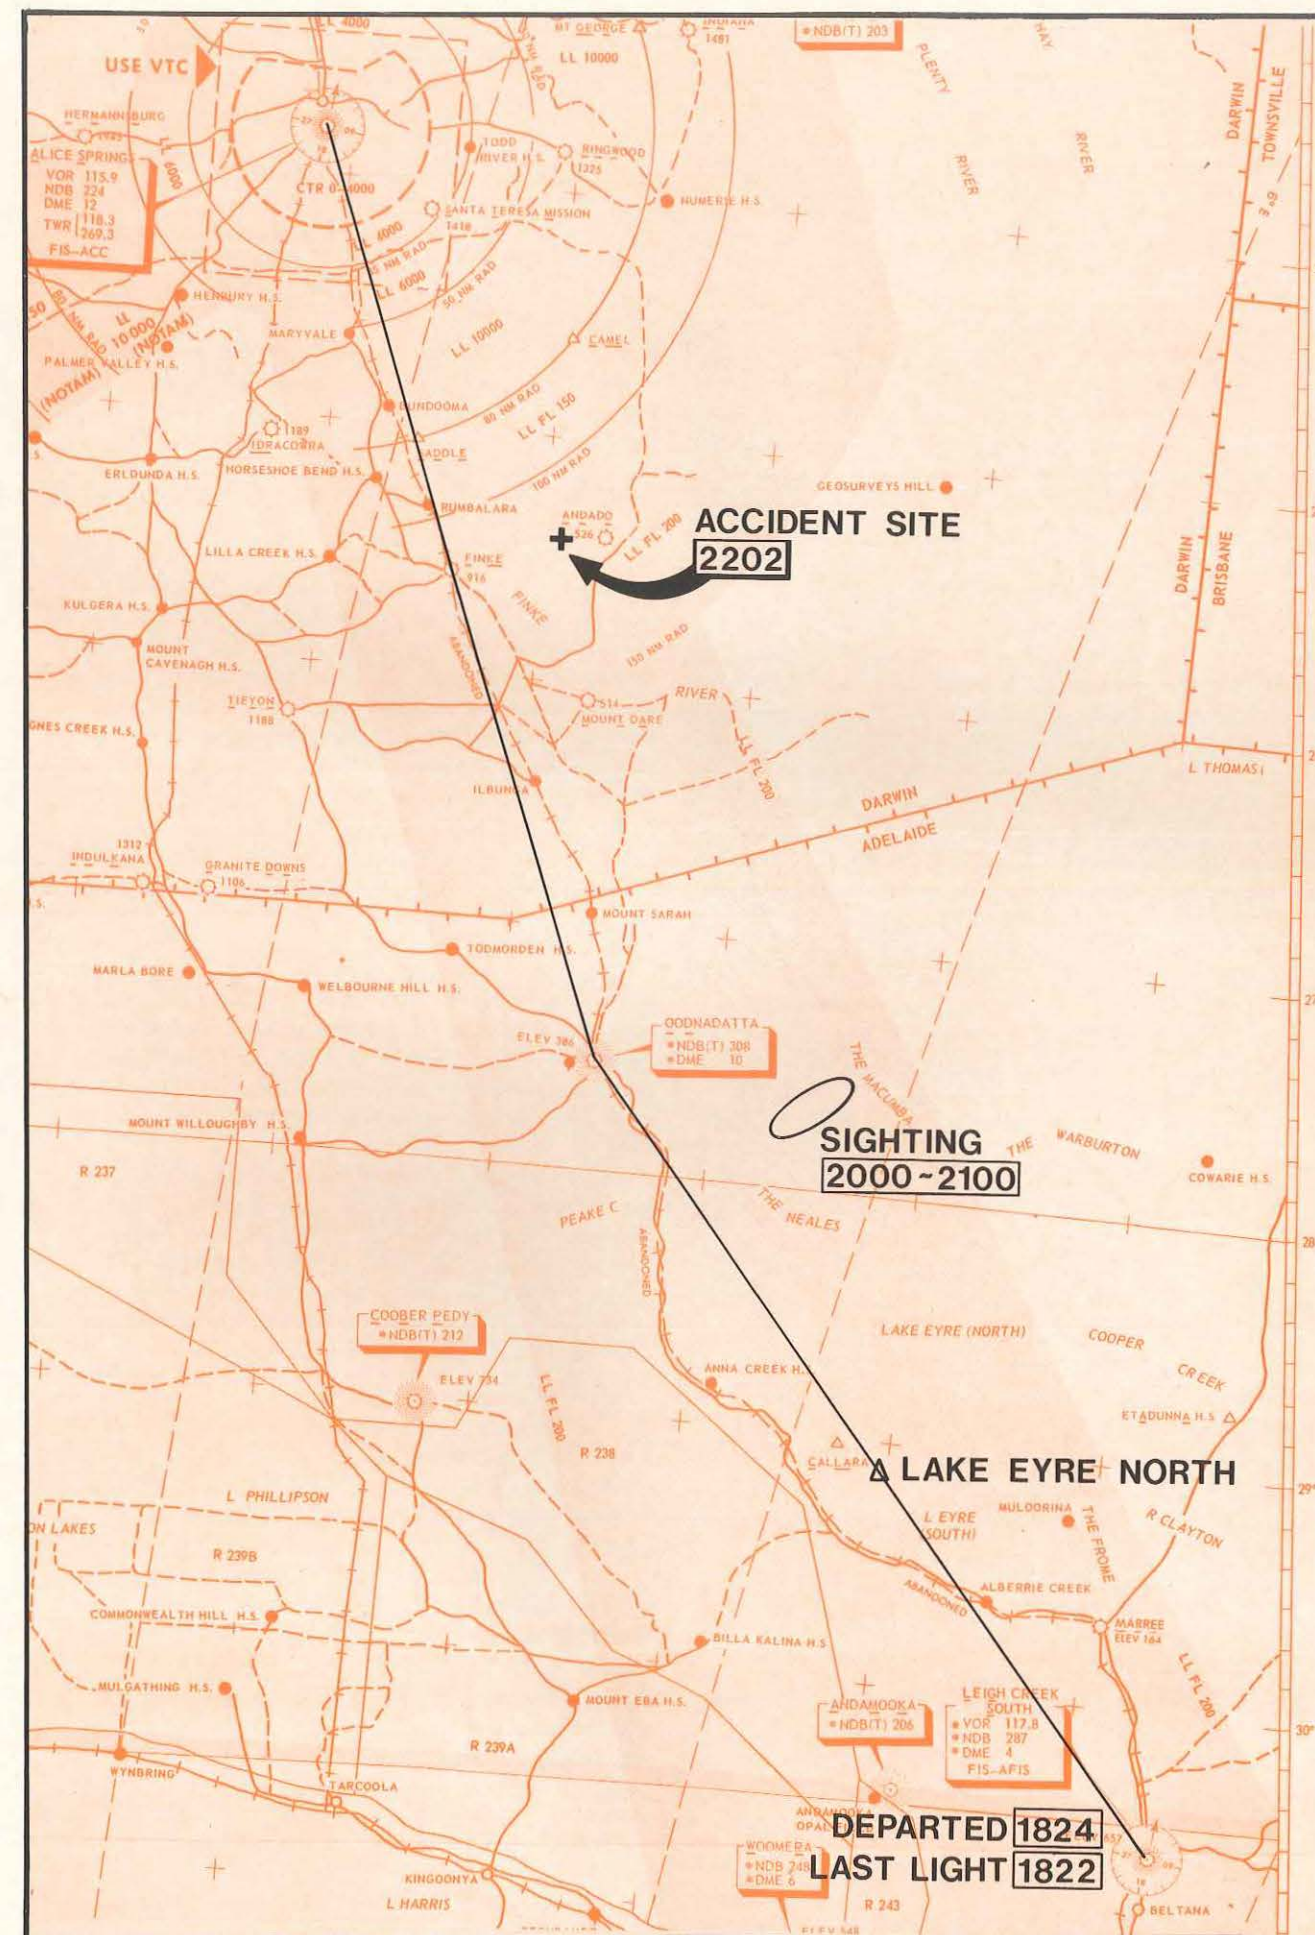
Parts of the aircraft were spread over a considerable area. A trajectory analysis of the various components revealed that the aircraft had broken apart while heading 050 degrees magnetic, in a steep dive of at least 46 degrees, and within the altitude range of 2750-3850 feet. Examination of the wreckage found no evidence of pre-existing defects. The left wing, both left and right stabilizers, and the rudder and fin had

separated from the aircraft as a result of overload forces in excess of the design strength of the aircraft. Permanent torsional deformation of both stabilators indicated the aircraft speed was in excess of 204 knots prior to break-up. There was evidence that the engine had been operating and the aircraft's electrical system had been powered at the time the fuselage struck the ground.

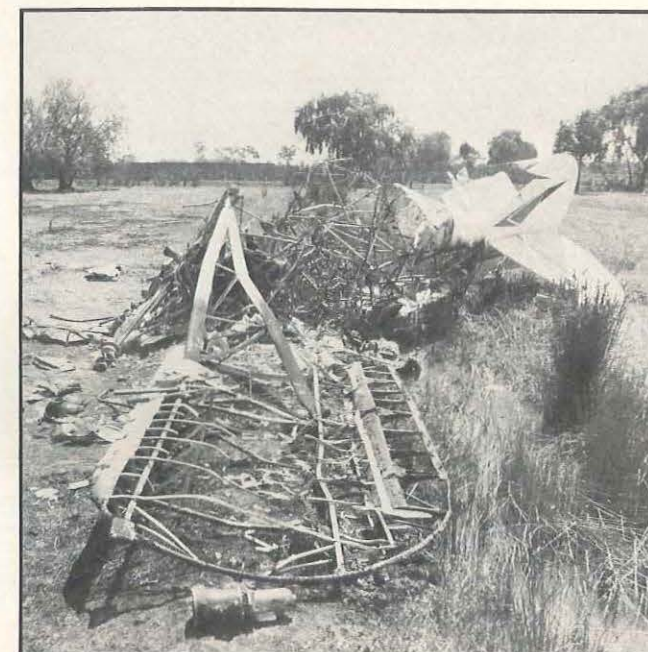
Because of the fire damage, it was not possible to determine the cause of the apparent engine failure. It was found that the aircraft was illegally fitted with both liquid-spraying and solid-spreading equipment (only one should be fitted at any time) which would have significantly affected glide performance.

However, notwithstanding the loss of engine power and the illegal equipment configuration, the low cruise height was identified as being a crucial factor in the catastrophic outcome of this accident. Based on the position, heading and height of the aircraft at the time

of the apparent engine failure, the most suitable forced landing area was located ahead and to the right. It seems probable that the pilot was attempting to reach this area when the collision with the tree occurred. The collision was a consequence of the pilot not having time for any course of action other than that which immediately presented itself: unless he happened to be virtually on top of a clear area, he simply did not have sufficient height to effect a safe forced landing.

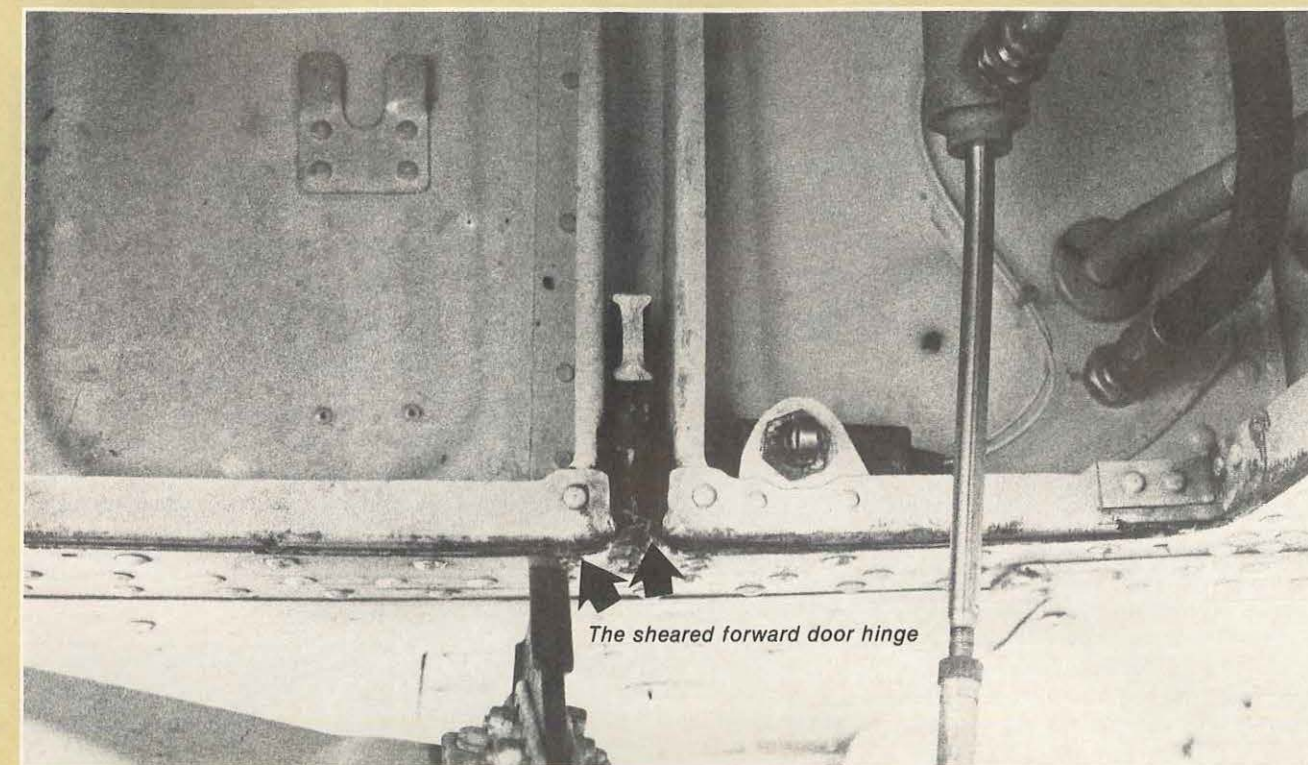
On downwind for a night landing, the pilot of a Piper PA31 Navajo selected the landing gear down. The nose wheel and port main wheel green lights illuminated but the starboard main wheel red 'gear unlocked' light remained on. Climbing to 2000 feet to clear the circuit area, the pilot attempted to rectify the problem by recycling the gear several times, but to no avail. He then tried to lower the gear using the emergency system but this too was unsuccessful.

An airborne inspection by another aircraft, which was able to illuminate the underside of the Navajo with its landing light, confirmed that the port main wheel and nose wheel were both down, and that the starboard main wheel was partially down and appeared jammed. The Navajo pilot then attempted to dislodge the jammed wheel through the application of g forces to the aircraft, but had no success.

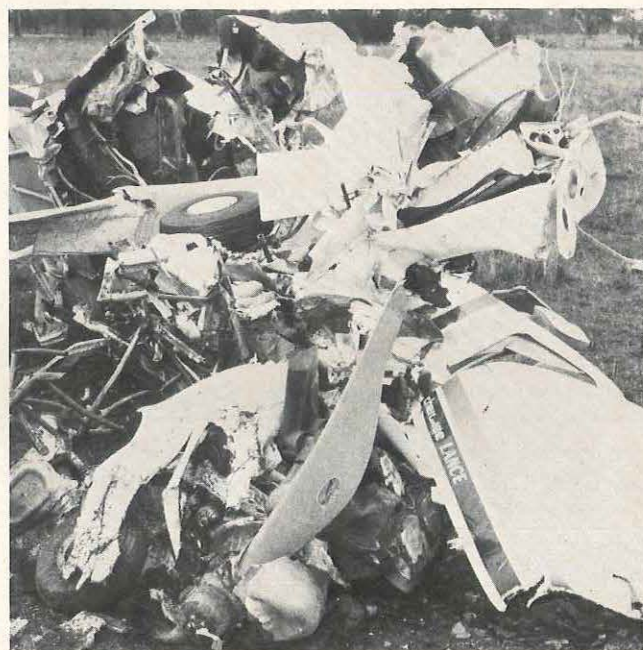
It was apparent from wreckage distribution and witness statements that the Cherokee had broken up in flight. Investigation resulted in the discovery of fatigue cracking in the stabilator. It seems probable that this cracking eventually affected the skin panel to the extent that the skin disrupted airflow over the right stabilator. This then led to a loss of control, and eventually the inflight breakup of the aircraft. The following photograph shows the catastrophic consequences.

In detailing the factors relevant to the accident, the BASI report made reference to the fatigue crack as follows: *'Although the crack was not located in an easily visible position it should have been detectable in previous routine maintenance and preflight inspections'*. The failure to detect the crack cost the pilot and his passenger their lives.

As a final thought on preflights generally, pilots must always resist any pressures to 'abbreviate' this crucial check. The temptation to rush through a preflight inspection or to take a short-cut is experienced sooner or later by all pilots: when we're running late the preflight seems a natural 'target' for saving time. But to do so is never worth the risk. It is better to spend a few minutes extra on the ground than to realise — at the possible expense of your life — in the air that a vital preflight check has been omitted ●

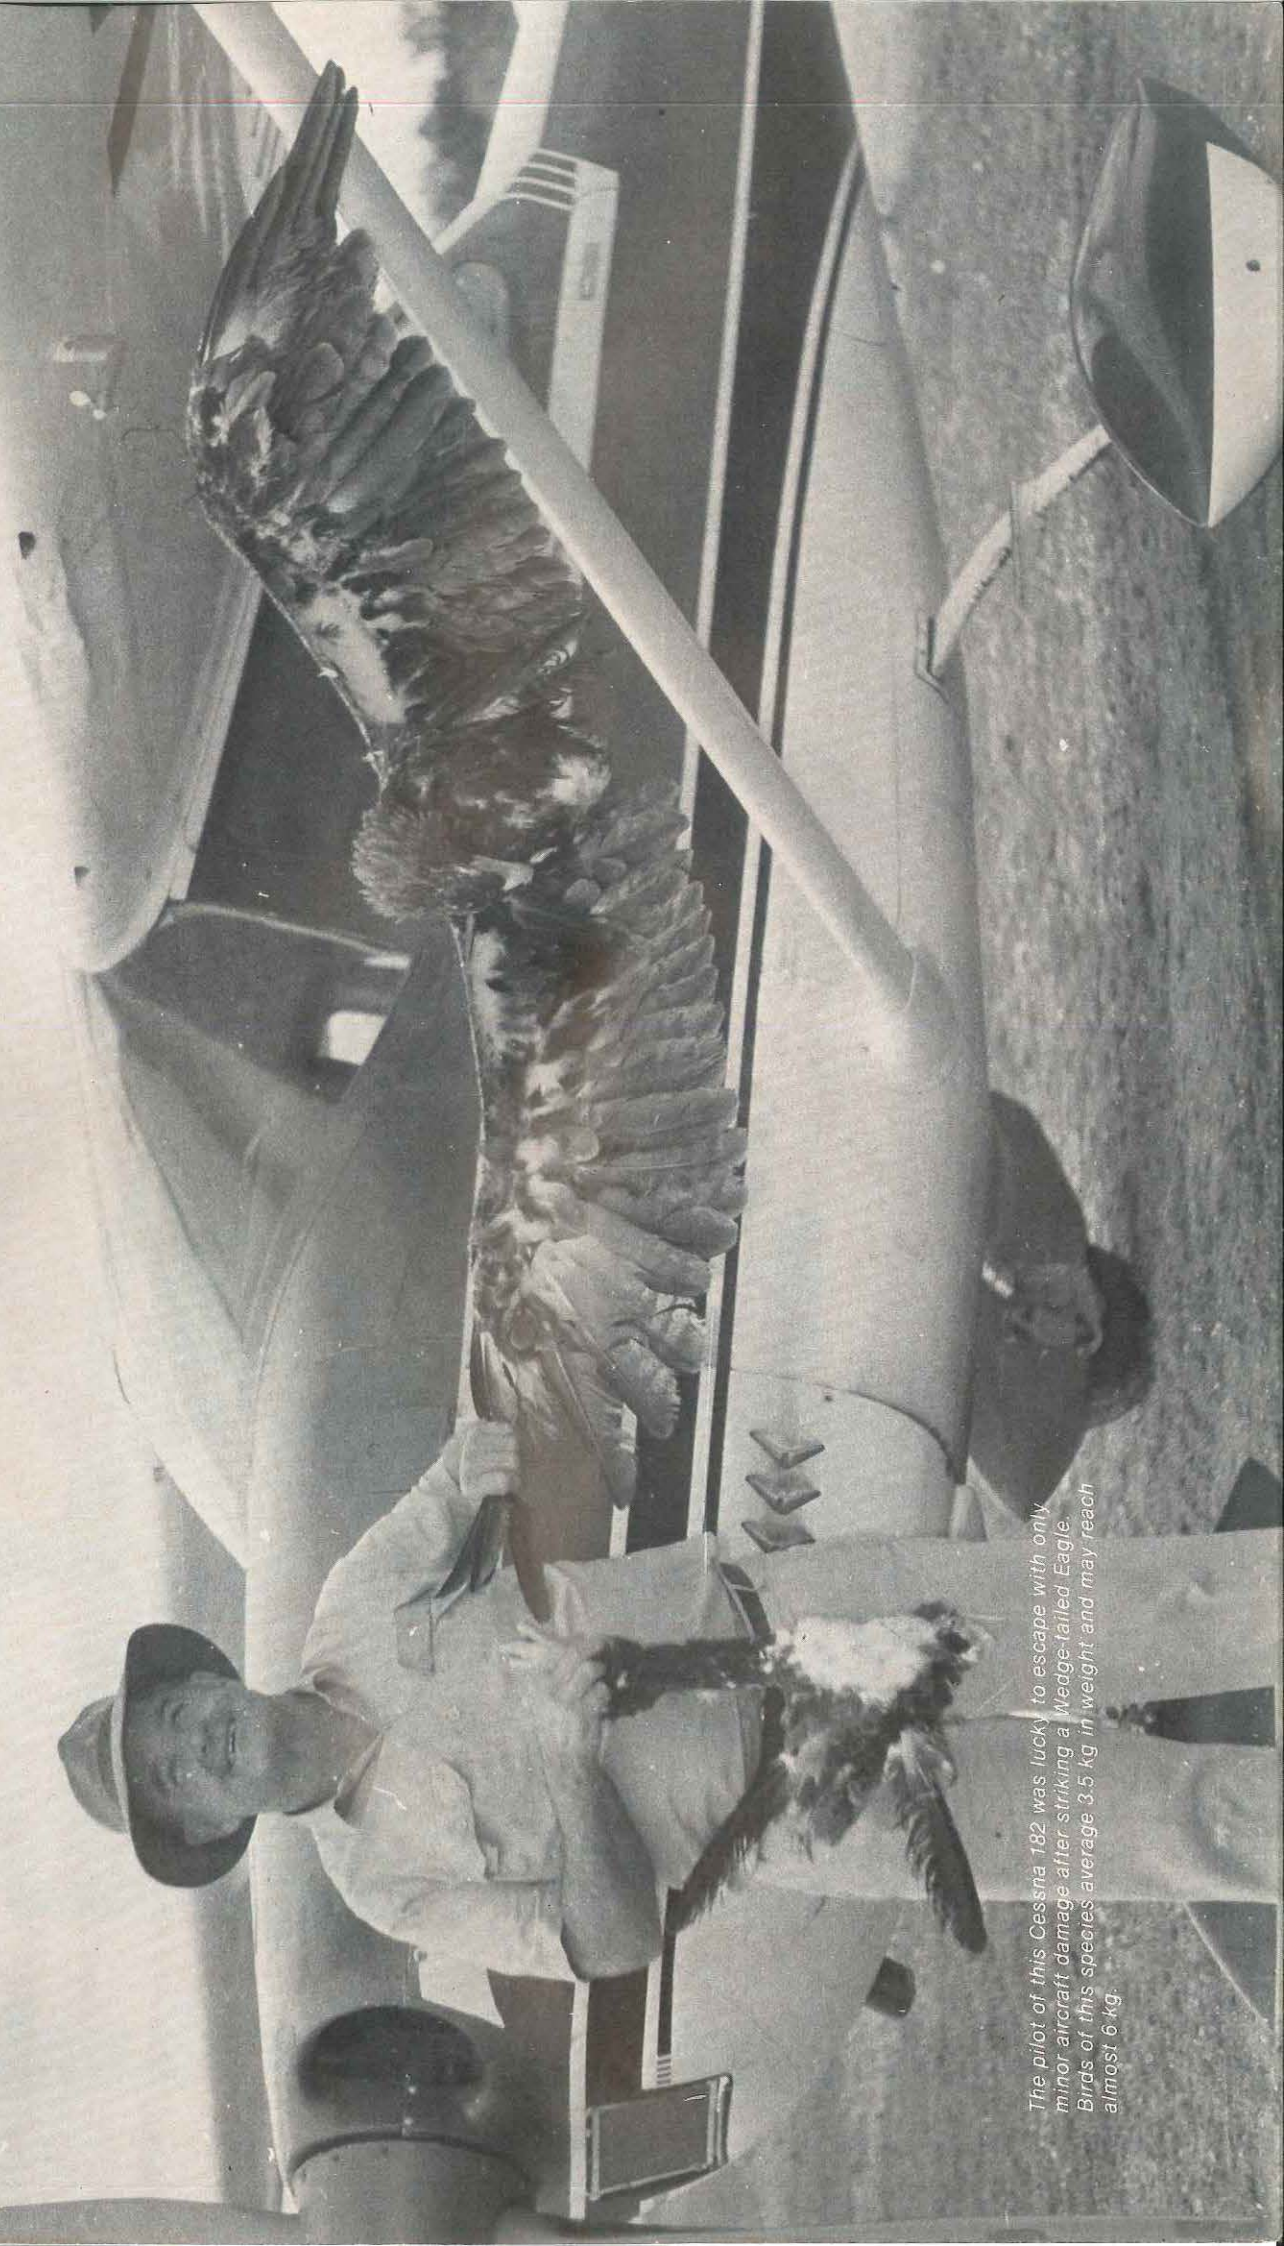
The pilot of this Cessna 172 was lucky to escape with only minor aircraft damage after striking a Wedge-tailed Eagle. Birds of this species average 3.5 kg in weight and may reach almost 6 kg.
