# Aviation Safety Digest

# Helicopter wake turbulence

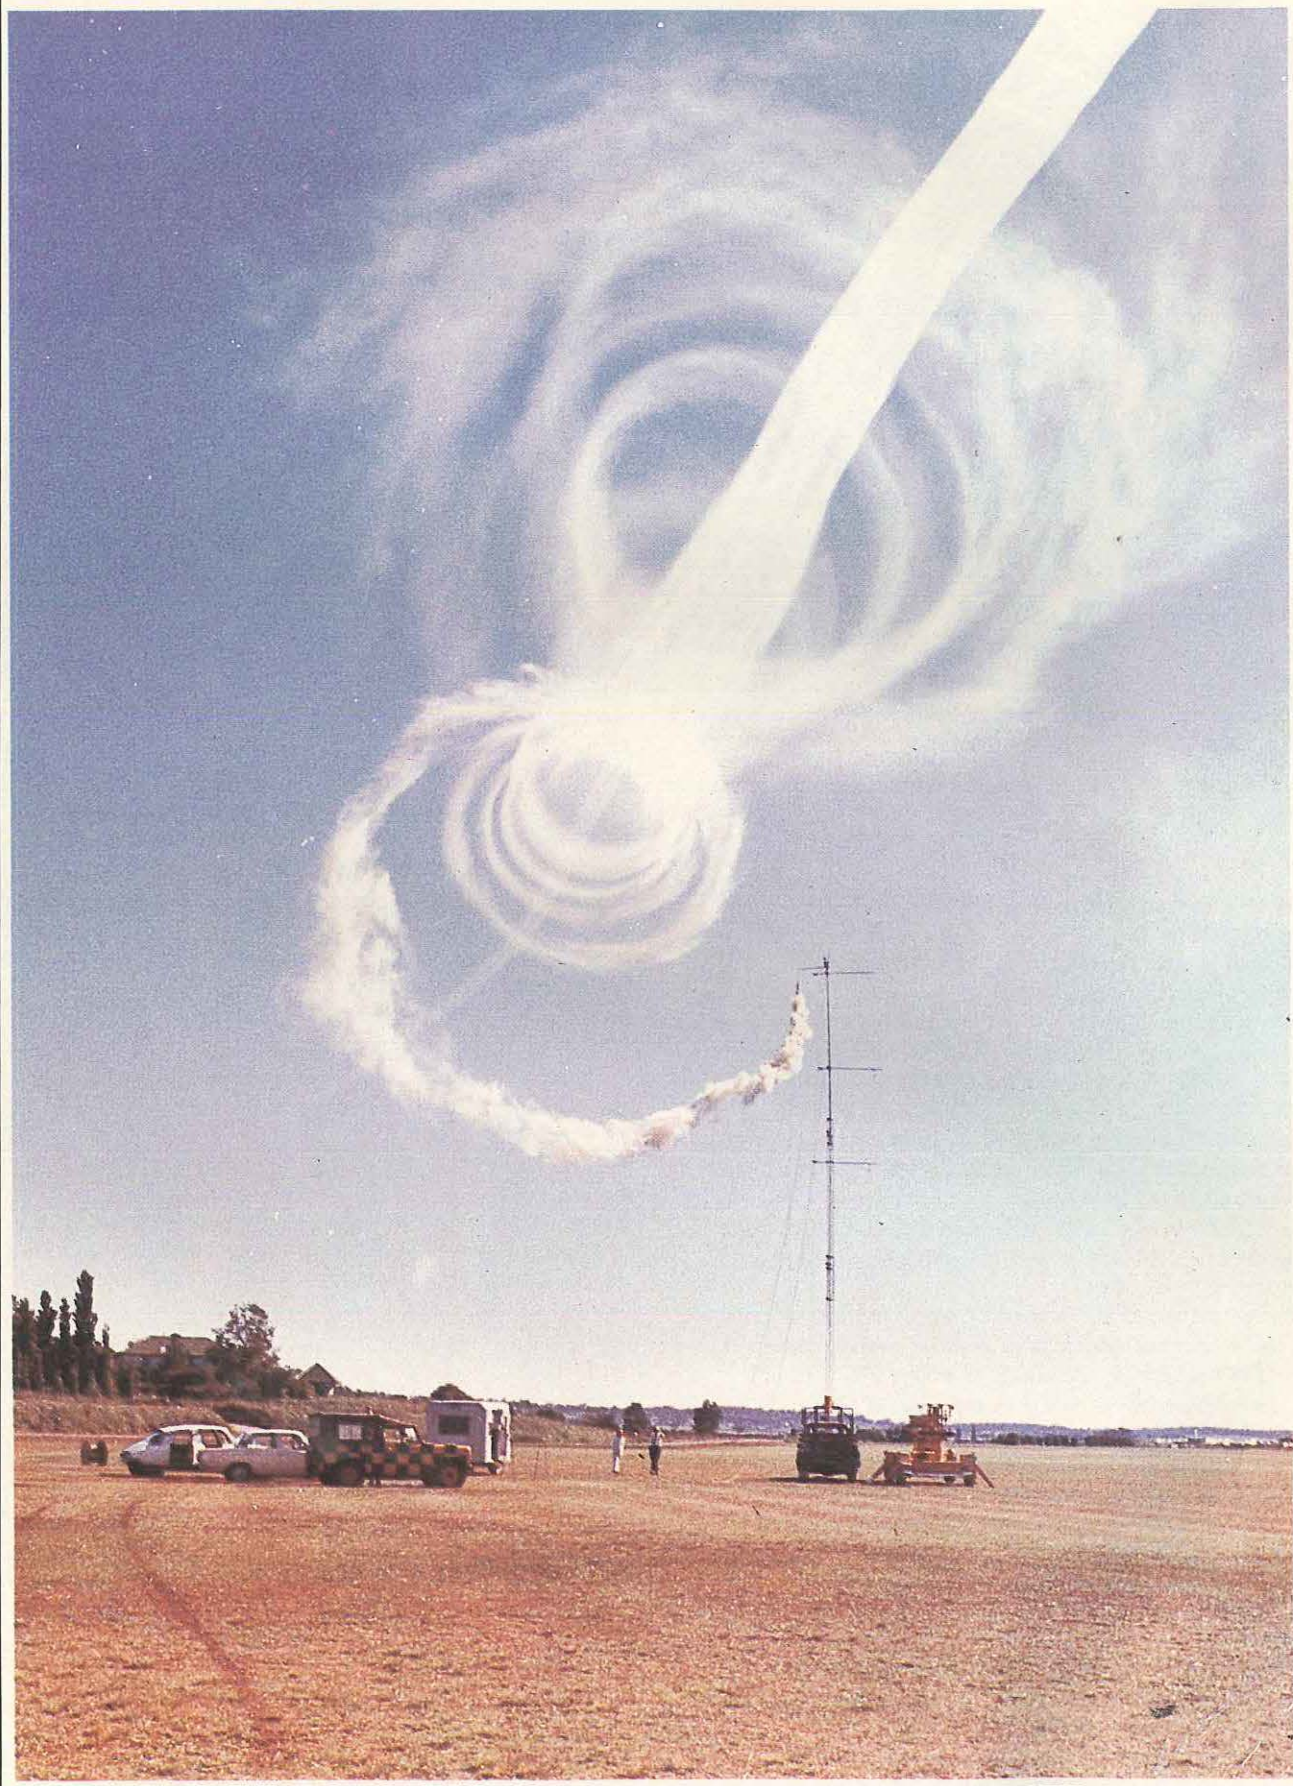
A Lockheed Hercules flew through smoke from a smoke generator fixed to a mast to produce this visible wingtip vortex. The intensity of the vortex is obvious.

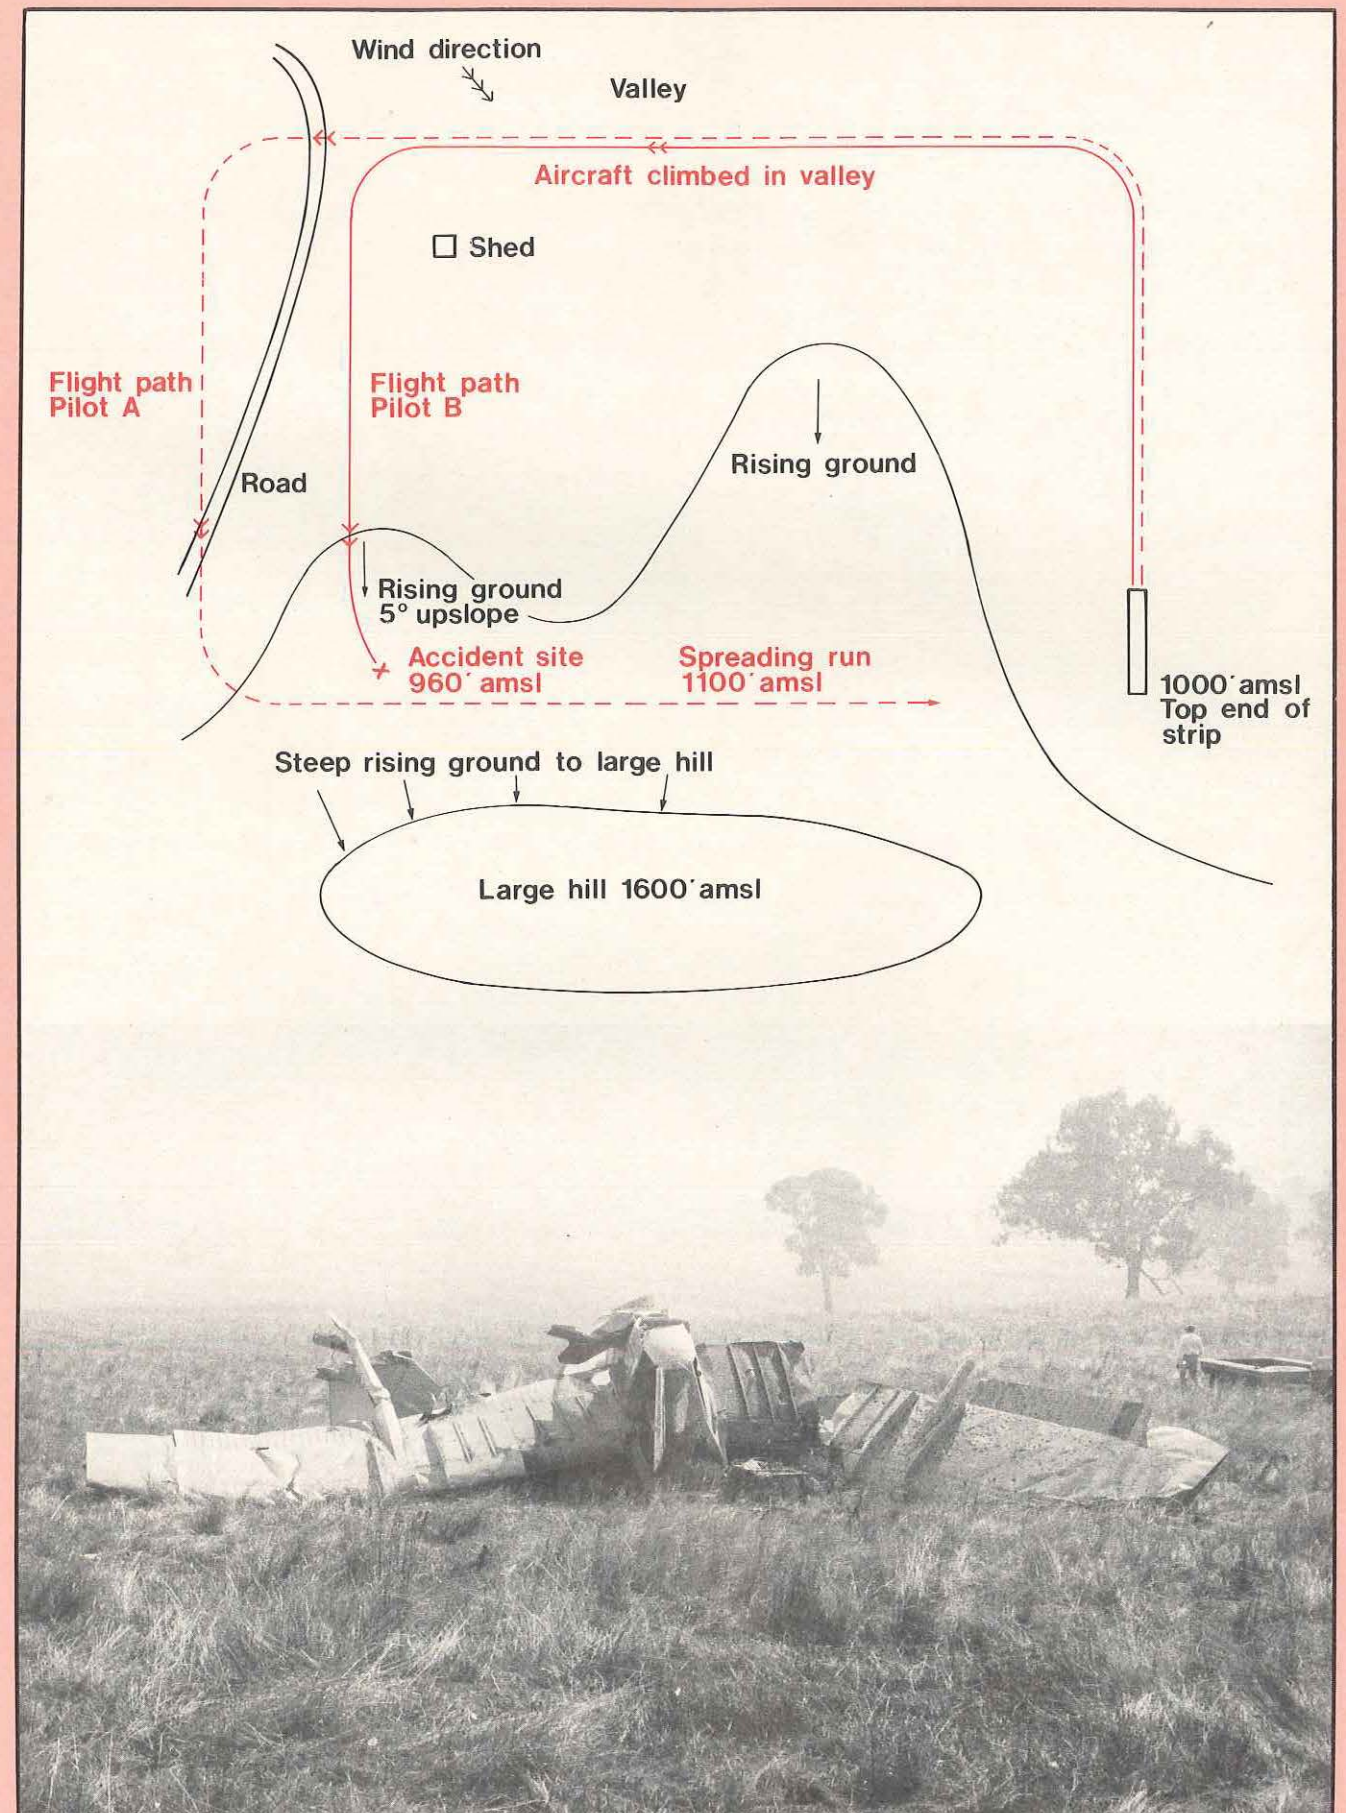
The cause of this accident was straightforward: notwithstanding his experience and qualification as an instructor, the pilot had allowed his aircraft to stall.

Assuming an angle of bank of between 40 degrees and 60 degrees was used, the load factor on the aircraft would have increased by between 1.4 and 2.0. As stalling speed increases proportionately to the square root of the load factor, the stall speed in this case would have risen to between 64 and 79 knots. Further, the turn on to the spreading run was made over rising terrain (see diagram) and it seems possible that airspeed may have inadvertently been allowed to decay slightly as a constant height AGL was maintained.

*Looking back along flight path showing valley and rising terrain (right).*

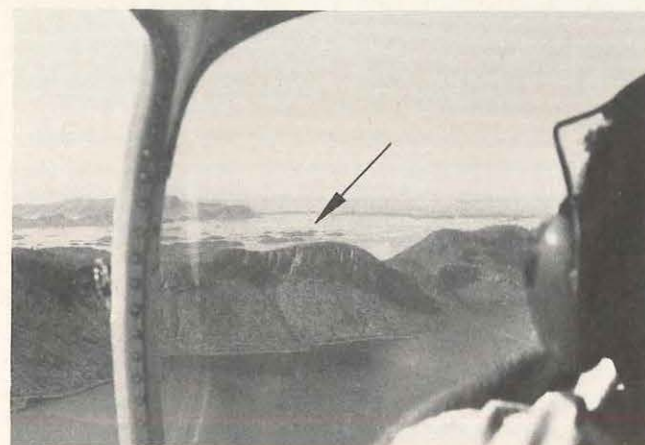
When I crossed the hills prior to the lake, I was about 1000 ft AMSL or about 500 ft AGL. I wasn't contour flying. As I flew out over the lake I remember sighting Mt X and checked that the track took me to the south-west of Mt X and I looked back in an attempt to sight the dam wall just to confirm my position. The next thing I remember is being in the water.

It seems significant that there was evidence that the pilot had been under stress from personal problems for some days, while at the time of the accident he had been working for 10½ hours. Although he had only been flying for 25 minutes of this time, the low-level flight over changing terrain of hills and water would have been very demanding. In the opinion of an aviation psychologist the pilot's action in looking back over his left shoulder to check the dam wall and thereby losing his forward visual reference may have led to an unperceived loss of height; that is, where the rate of angular acceleration of the aircraft was below the threshold level required to enable it to be detected by the pilot's organs of balance. The aircraft's configuration at the point of impact (slightly nosedown, slight left bank) was consistent with this low rate of descent and the pilot's actions in the cockpit just prior to the accident.

View from helicopter cockpit showing flight path and point of impact with the water.

Know what kinds of flying conditions for *you* as an individual will constitute high workloads.
