# Aviation Safety Digest

# Hand portable fire extinguishers

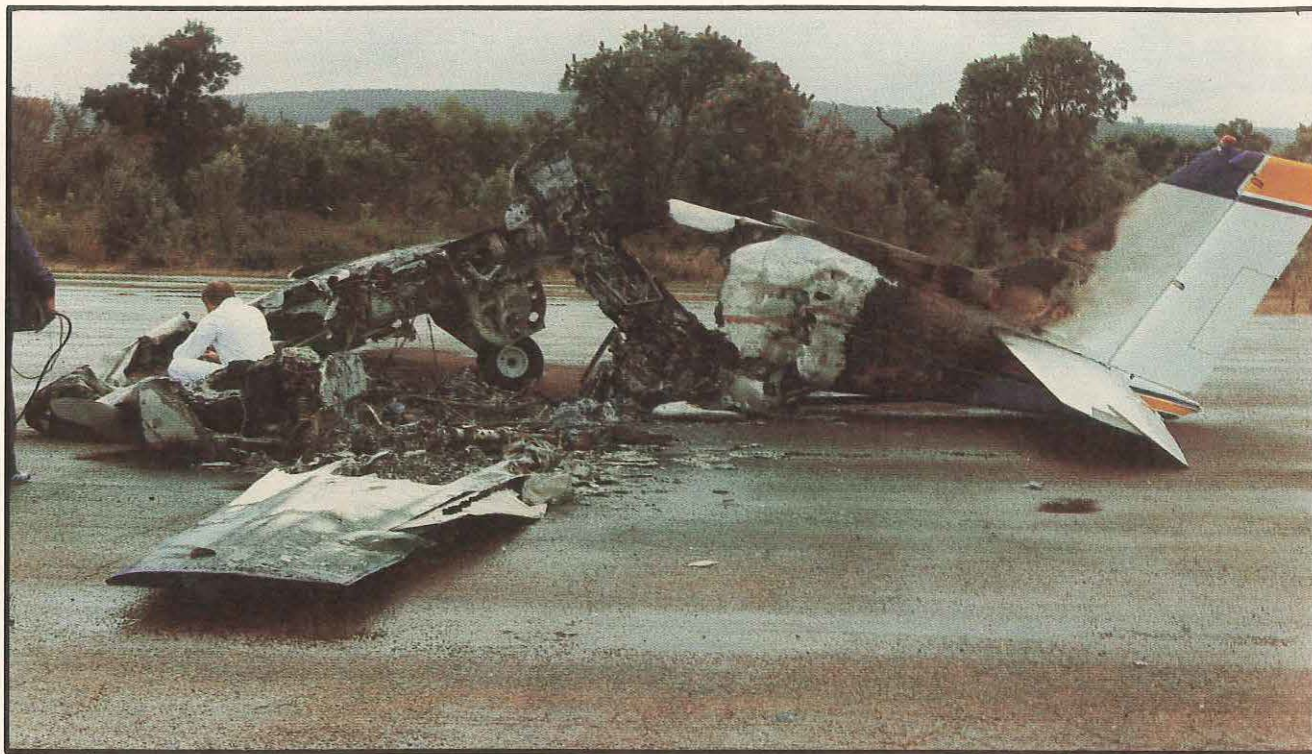
A light twin was cruising at 7500 feet when the pilot became aware of a fire behind the throttle quadrant. A descent was commenced immediately and the pilot began to run through emergency checks and procedures. The fire continued to burn. Shortly after starting the descent the pilot sighted a disused sealed strip and started an approach to land there.

With the fire still burning the pilot took the portable fire extinguisher, intending to discharge it into the throttle quadrant. The extinguisher would not work. By this time the pilot had to concentrate on getting the aircraft safely onto the ground, so the extinguisher was passed to one of the passengers to try to get it to operate. In his words: 'I read the instructions on the fire extinguisher — followed the instructions but nothing happened. I then shook the extinguisher and heard what I believed to be a liquid slosh around in the canister.'

In the event the aircraft was landed and the passengers safely evacuated. The fire, however, continued to burn, the eventual outcome of which can be seen in the accompanying photograph. (overleaf)

This light twin was destroyed by fire after the extinguisher was found to be unserviceable.

For those operators not involved in RPT or Charter work but who take the sensible precaution of fitting an extinguisher, their safety initiative may come to naught if they do not also ensure that the extinguisher remains serviceable. Note that any overhaul on an extinguisher must be performed in accordance with the manufacturer's recommendations.

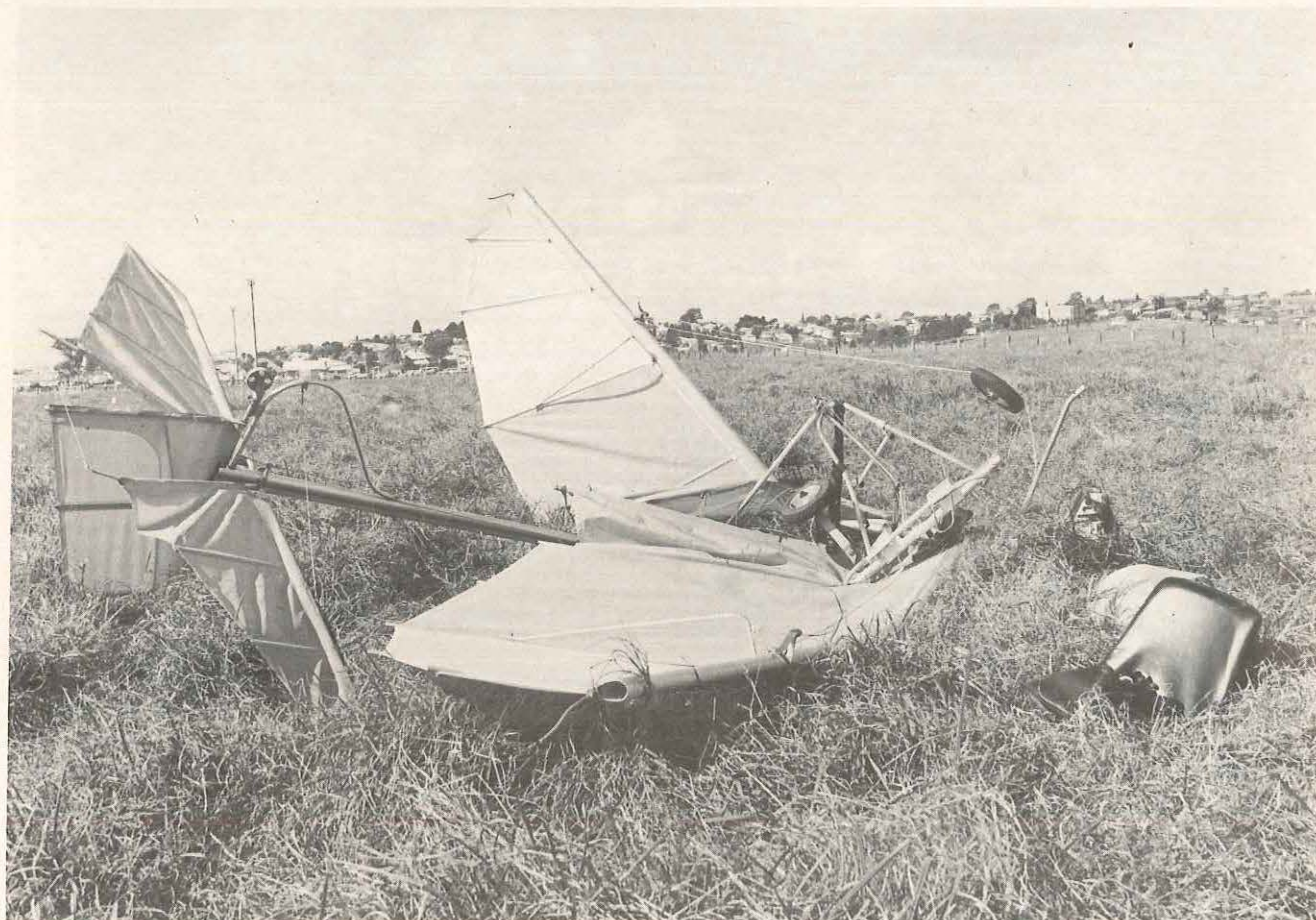
The aircraft was destroyed and the pilot, who was not wearing a protective helmet, sustained serious injuries.

A technical examination of the aircraft wreckage failed to reveal evidence of any pre-existing mechanical fault or failure. In conjunction with witness reports and the on-site investigation, this finding made it clear that the aircraft had indeed stalled.

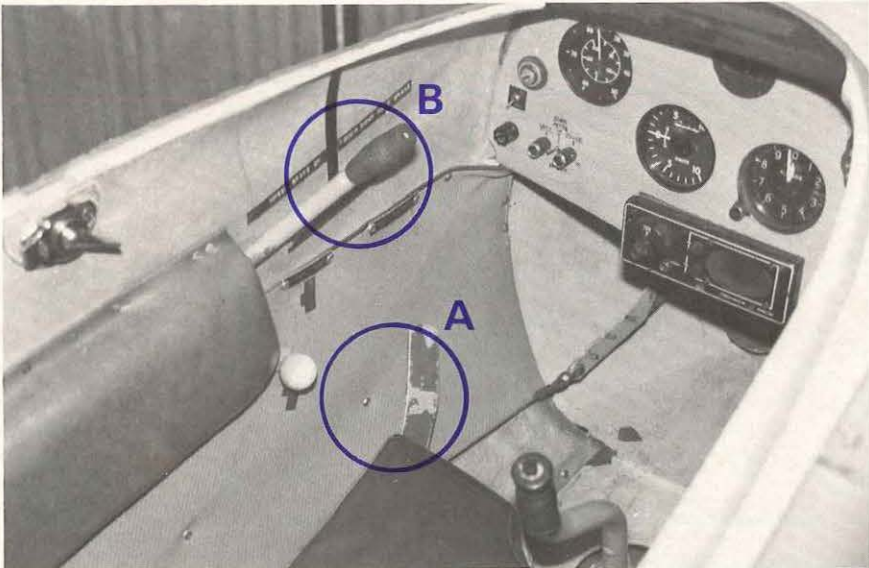
A glider pilot operated the tow cable release rather than the airbrake release to control his final approach. Lack of experience and currency prevented him from recognising the error.

Pilot operated the tow cable release lever (A) instead of the airbrake deployment lever (B).

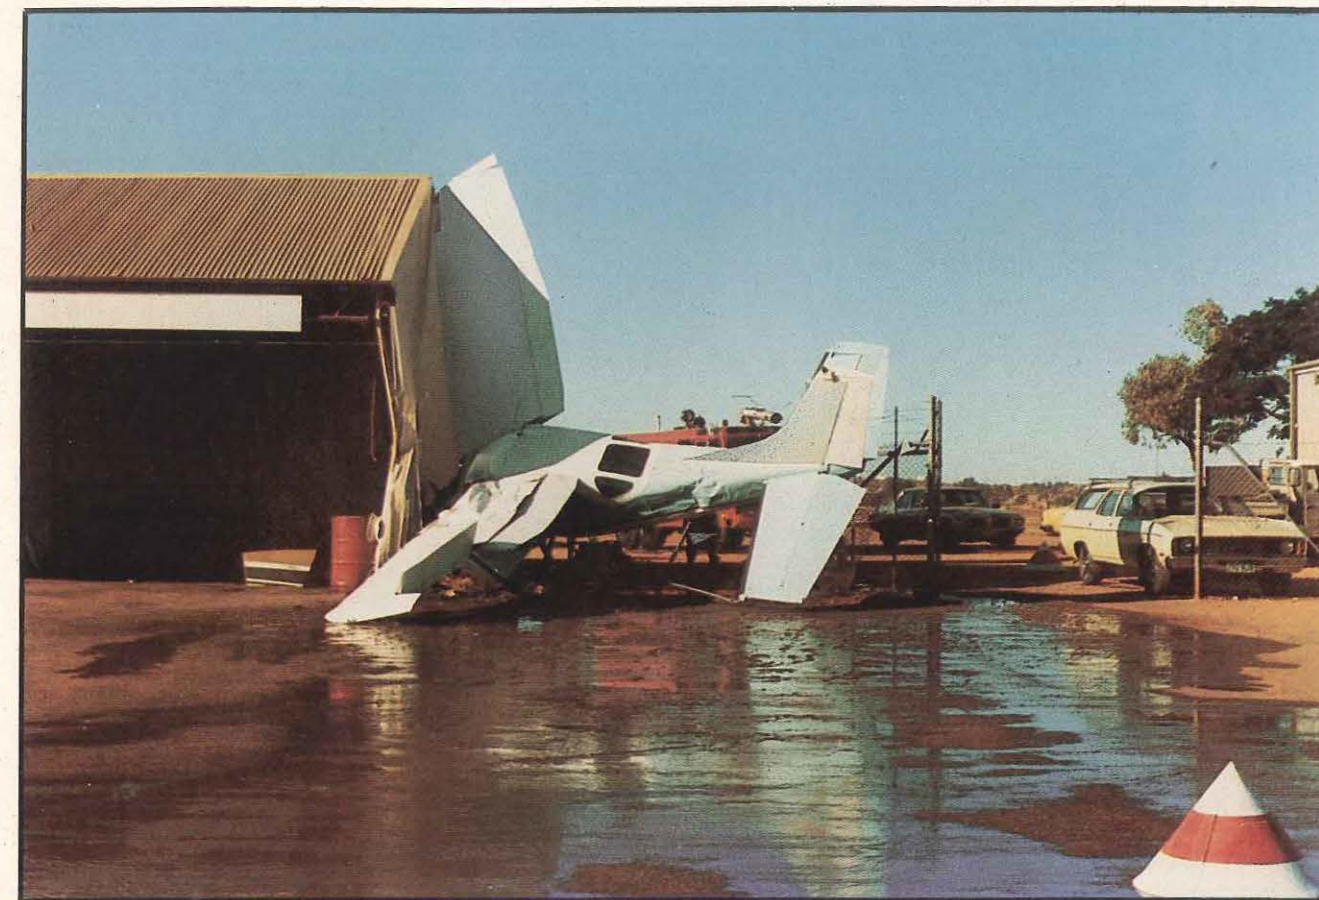
A C206 destroyed as the result of a series of mistakes following the frustration of a delayed departure (article on opposite page).
