Aviation Safety Digest

BUREAU OF AIR SAFETY INVESTIGATION

ASD 126
SPRING 1985

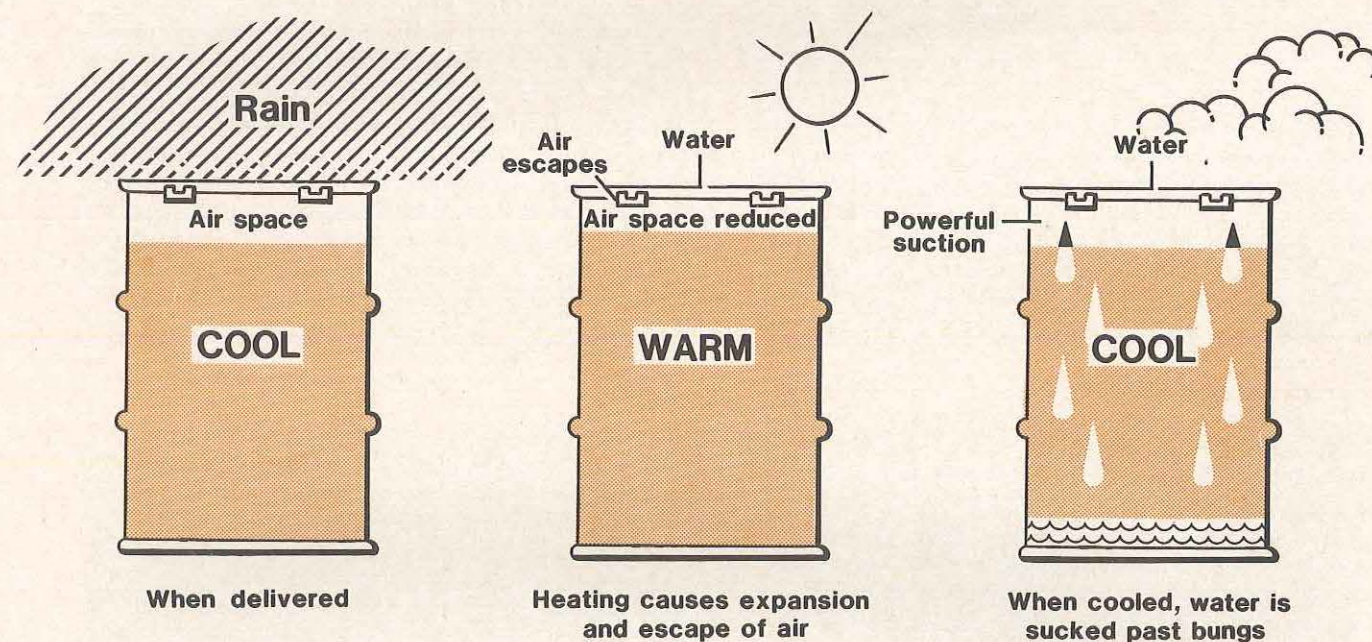
If you must store fuel and oil drums outside, do not store them upright. Even though the bungs are drawn tightly enough to prevent fluid leakage, they still are not airtight. Rainwater that collects inside the rim of drums stored vertically on end can be sucked past the bung into the drum when cooler temperatures cause contraction of the internal air and fluid. This water now contaminates the fluid and also may, in time, form rust under the drum lid which can flake off and add a particulate contamination problem.

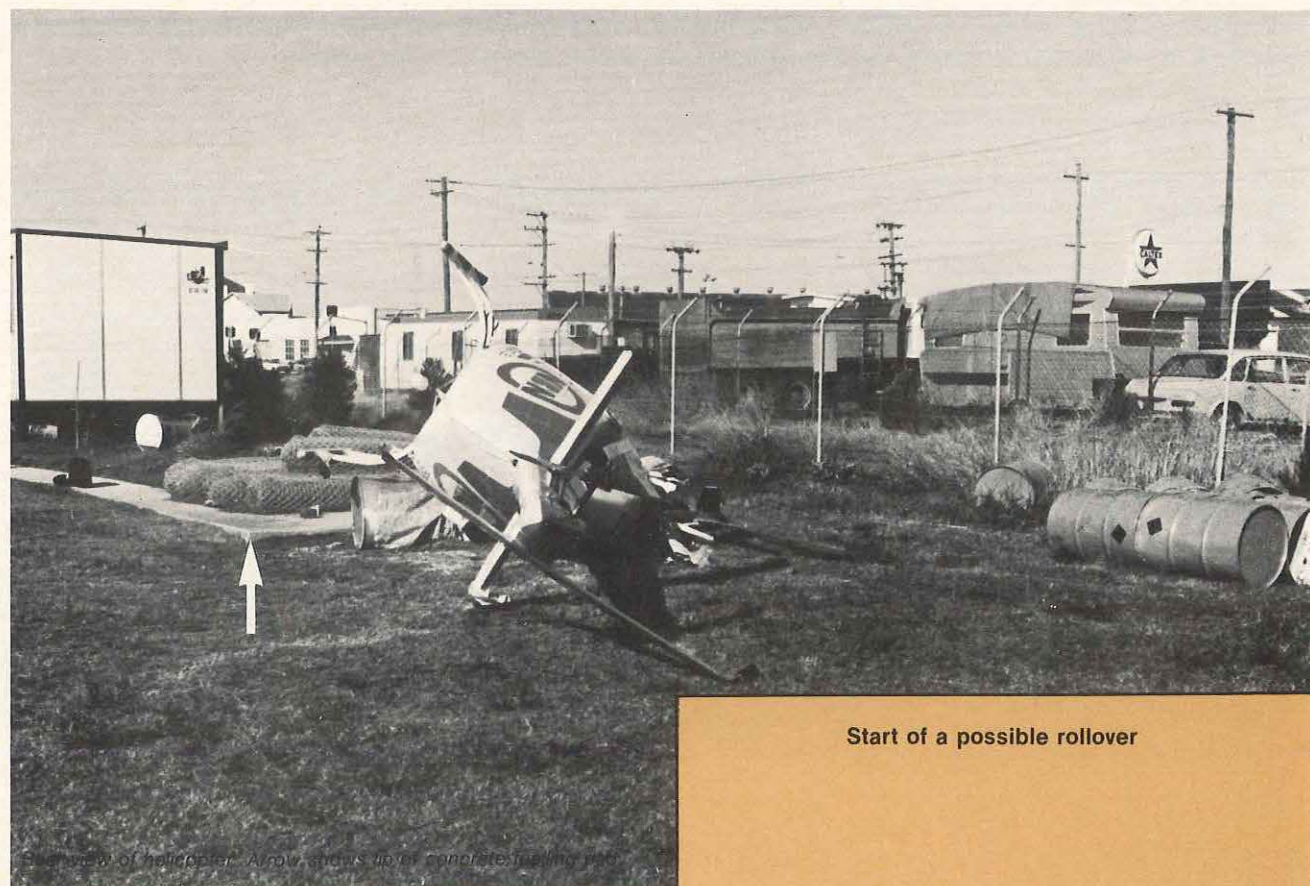
Dynamic rollover

A Bell 206B had been parked adjacent to a refuelling platform 60 millimetres high. As the pilot was bringing the aircraft to the hover prior to takeoff, the right skid contacted the platform. The pilot attempted to correct with cyclic but the helicopter rolled to the right and came to rest on its right side near the platform.

The contact between the skid and the edge of the platform had induced dynamic rollover. Evidently the pilot had not identified the problem in time to take the appropriate corrective action of lowering the collective control in order to place both skids on the ground.

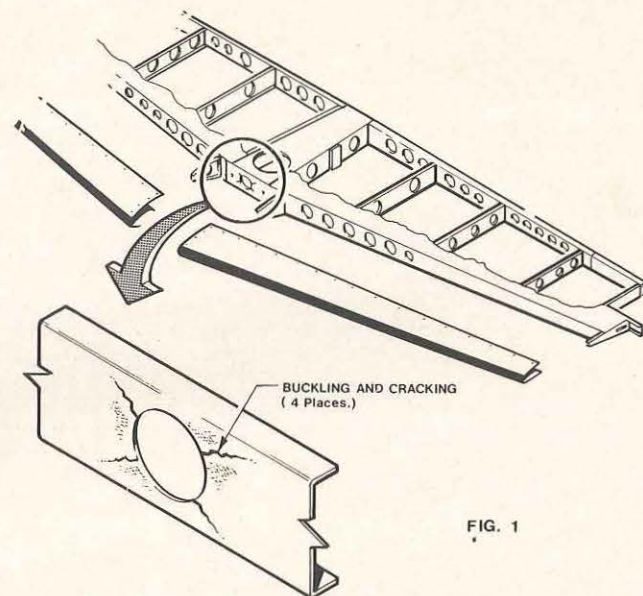
FIG. 1

During disassembly of a C172 for transporting, the horizontal stabilizer front spar doubler plate at the fuselage attachment point was found to be cracked in four places. All cracks originated at the lightening hole and varied in length from 12mm to 18mm (see Figure 1). There also was buckling of the stabilizer centre section skin and spar. Airworthiness engineers believed that this damage may have been caused by incorrect ground handling.

One such method involves pressing down at the horizontal stabilizer front spar adjacent to the fuselage to raise the nosewheel off the ground. With the nosewheel clear of the ground the aircraft is then turned by pivoting it about the main wheels. For example, the Cessna Model 172 series service manual details this technique.

It is important to note that if this method is used, downward pressure should be applied at no location other than the junction of the horizontal stabilizer front spar and the fuselage, as the application of force at locations outboard of this point will generate excessive leverage which could result in structural damage.
