Aviation Safety Digest

Contents

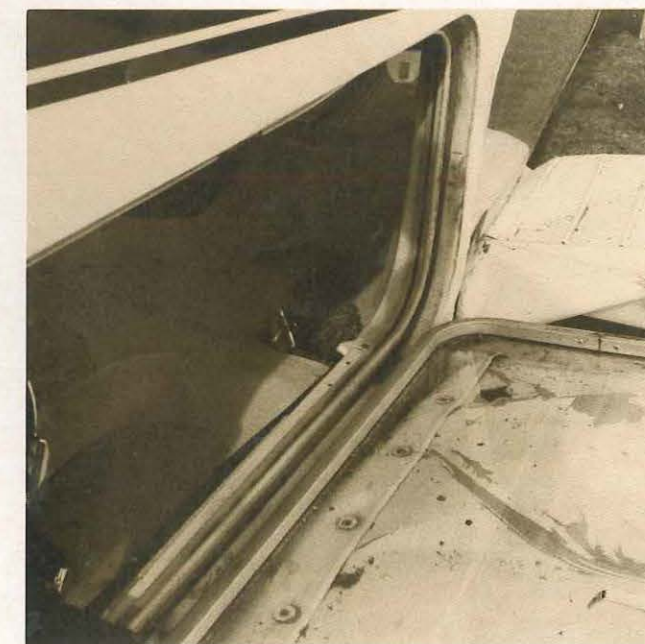
The accompanying photograph is of the window through which the pilot and his passengers escaped. Note the heavy tie-down stake and chain lying loose on the aircraft's roof. There is little doubt that in less fortunate circumstances this dangerous, unsecured object could have inflicted fatal injuries when the aircraft struck the ground ●

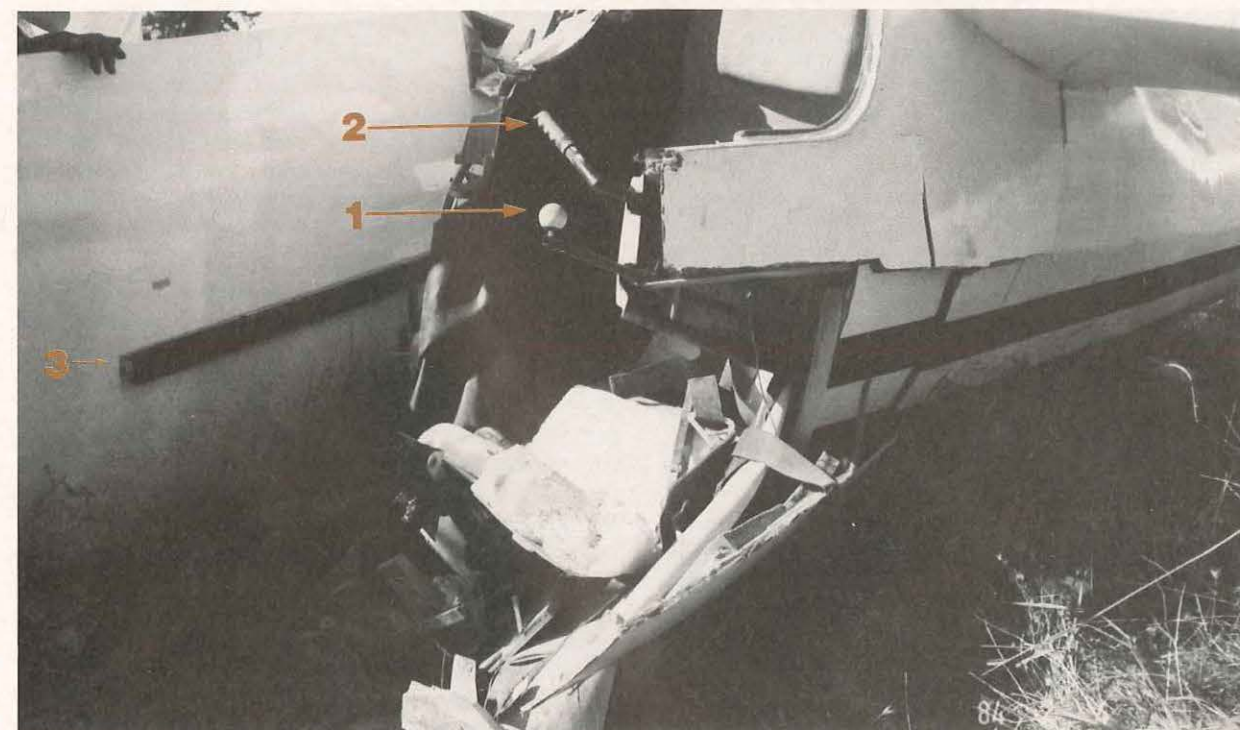
There was, of course, more to the accident than that one factor. Other significant points were noted during the investigation and related to:

- the pilot's general inexperience;
- his inexperience on type;
- the proximity of the trim and airbrake controls; and
- the pilot's failure to analyse the glider's performance loss, and to identify the characteristic airframe buffet associated with extended airbrakes.

Rear of cockpit. Note trim knob (1) and airbrake lever (2). Airbrake on right wing (3) has been pushed in by contact with fuselage after landing.

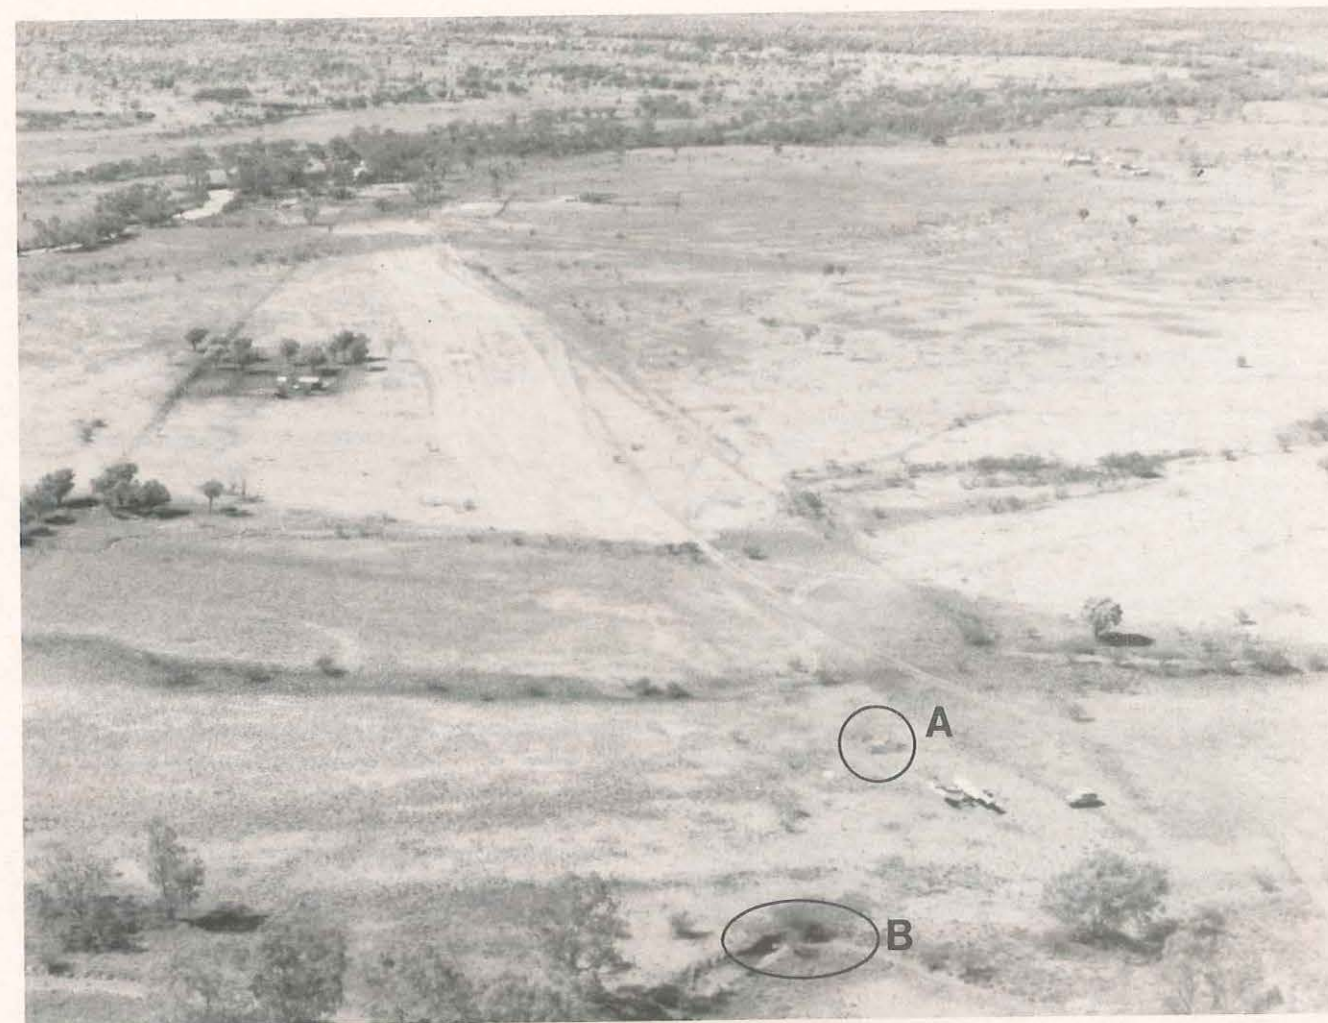
Pilot deliberately hit tree at (A) to stop aircraft before the gully at (B).

The second point deals with the pilot's decision to deliberately run into a tree with a wing to stop his aircraft. As he was travelling at about 40 knots it was a near certainty that the fuel cell in the wing was going to rupture and spray fuel everywhere. This is precisely what happened. Thus, the perceived fire risk arising from running into the gully was exchanged for the almost certain fire risk of smashing the wing. Once the fuel cell was ruptured and a highly flammable cloud of fuel mist and spray released, the fire danger was extreme. Finally, the pilot's action of returning to the fuel-drenched cockpit and restoring electrical power so that he could use the VHF radio again created a high fire risk.

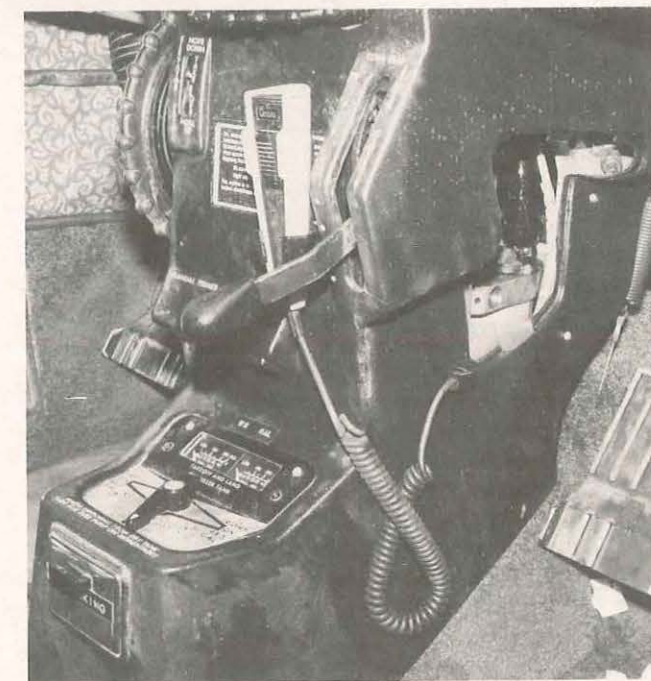
As it happens, a post-accident stripdown of the system revealed that a leaking seal had allowed oil to get into the electric motor, causing internal damage. This damage eventually prevented the power pack from reaching the 1500 psi cutout pressure.

Eventually the overheated power pack fractured its plastic venting system, allowing hydraulic oil to spray onto hot components and so causing thick smoke to billow into the cockpit. This convinced the pilot that the Cessna's engine was on fire.

Plastic overflow sump was resting against electric motor and had been severed (by heat) from the power pack.

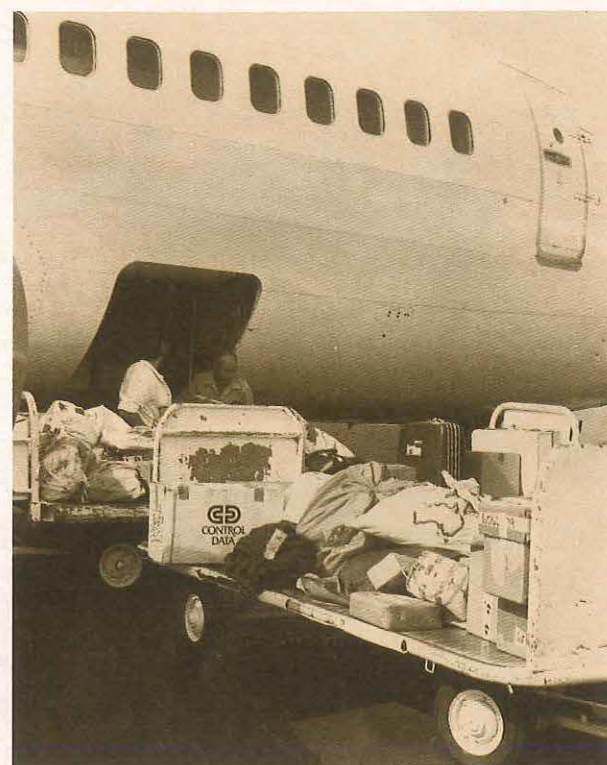
A 310 litre portable oxygen bottle arrived at an Engineering Base following trans-shipment by air. The bottle had been shipped in a purpose-built box which was lined with about two inches of polyurethane foam. Additionally, the bottle had been packed in polythylene 'bubble plastic'. All documentation and labelling was correct.

Apparently the bubble plastic had been used previously, for, on unpacking it was found that one section was contaminated with what appeared to be a synthetic oil, perhaps Mobil Jet 2. In turn, this oil had contaminated an area of about five inches by four inches of the box's foam lining. Oil was also found on the outside of the oxygen bottle.

Oil and 'pure' (i.e. concentrated) oxygen are a very dangerous combination, having the potential for spontaneous combustion. In this instance, a leaking cylinder could have resulted in an explosion, perhaps inflight.
