Aviation Safety Digest

ASD 129
WINTER 1986

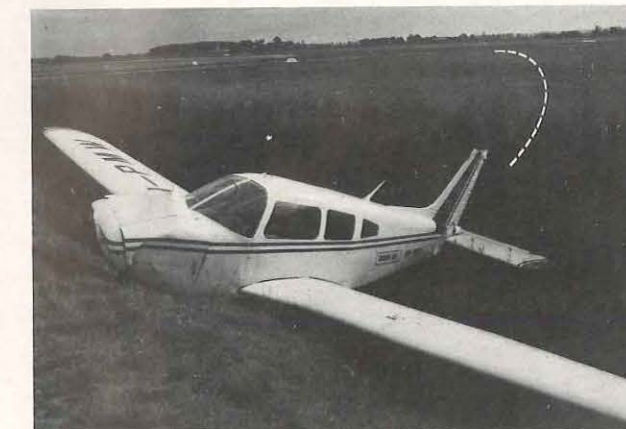
impact because he was not wearing the sash component of the aircraft's lap-sash seatbelt. Looking at the accident photograph, it is clear that the injuries sustained could easily have been worse. The reason given for not using all of the belt was comfort, although this is a little difficult to understand given that the sash was connected to a serviceable inertia reel. The pilot also stated that he had worn the full belt only once, which is a poor reflection on that aspect of his training.

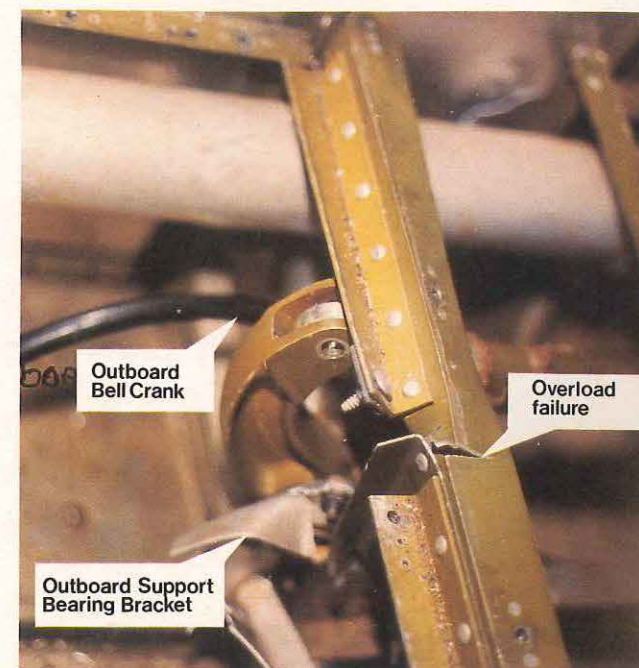
Fuselage nose section structure showing outboard bellcrank and failed outboard support bearing bracket in situ.

Following the accident to the Cessna 401, the company decided to modify its towbars to include shock absorption and steering limit shear pins ●

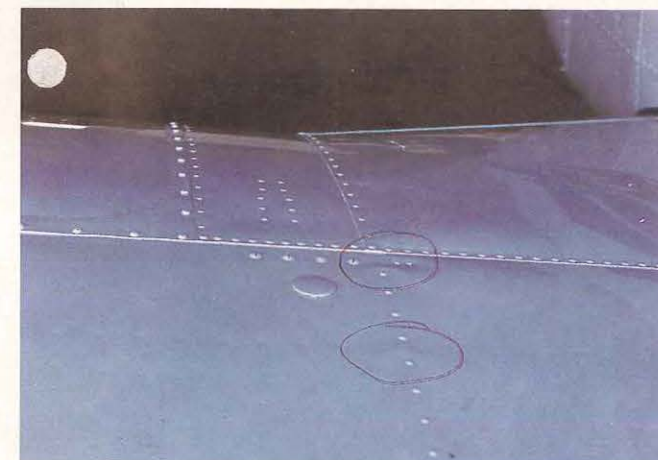
Second, any damage can be hard to detect. A number of pilots failed to see the surface indications of airframe damage on this Warrior (see the photograph). This reinforces the need to have a specialist inspect the machine ●

Two main safety lessons can be drawn from this occurrence. First, the PA28 airframe has a limiting maximum positive load factor in the utility category of 3.8. The pilot thought he applied about 2g; however, as both wings were bent upwards, they obviously had been subjected to much more than that. As anyone who has flown aerobatics, and therefore monitored a direct-reading g-meter in flight, can attest, when it's 'all happening', it is very easy to apply far more g than intended. Clearly, this is likely to be the case during a recovery from loss of control. Indeed, there are numerous recorded occurrences of inflight breakup of GA aircraft because of extreme aerodynamic loads having been applied during attempted recovery manoeuvres. The point is that, following this sort of occurrence, there is good reason to have a thorough inspection made of the aircraft by a suitably endorsed LAME.

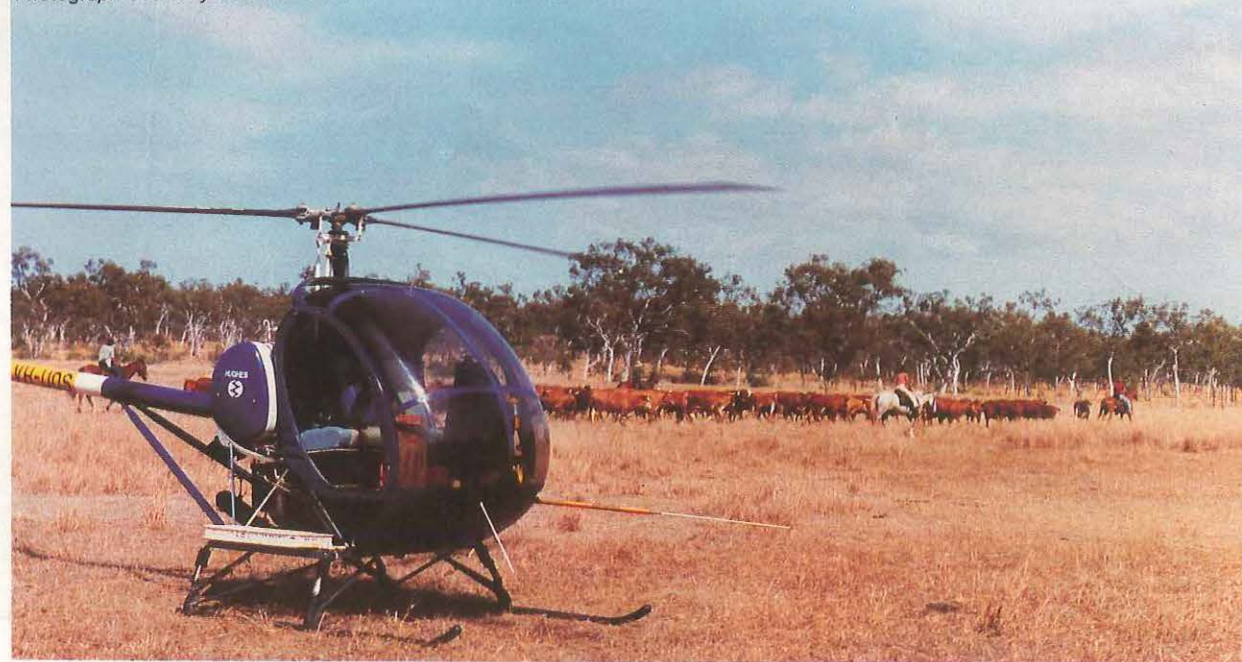
While cattle mustering in the Northern Territory the pilot of a Hughes 269 helicopter suddenly found himself confronted by a cow which refused to move in the desired direction. The pilot dropped down to a few feet agl whereupon the cow began walking slowly towards the herd. It then stopped again and the pilot edged closer. The cow spun around, reared on its hind legs, and attacked the helicopter, catching one of its horns in the skid area. The cow was too much for the helicopter and pilot, and seemed to push the helicopter over in its fury. The helicopter then pitched forward, rolled to the right, and struck the ground causing substantial damage. The tail rotor assembly, major sections of the vertical stabilizer, sections of drive shaft, tail boom and large sections of perspex were scattered up to 9 metres from the main wreckage. When Bureau investigators attempted to find the offending cow to examine its horns, they learned it had been shot and butchered for the evening meal on the day of the accident.
