# Aviation Safety Digest

ASD 131

SUMMER 1986/87

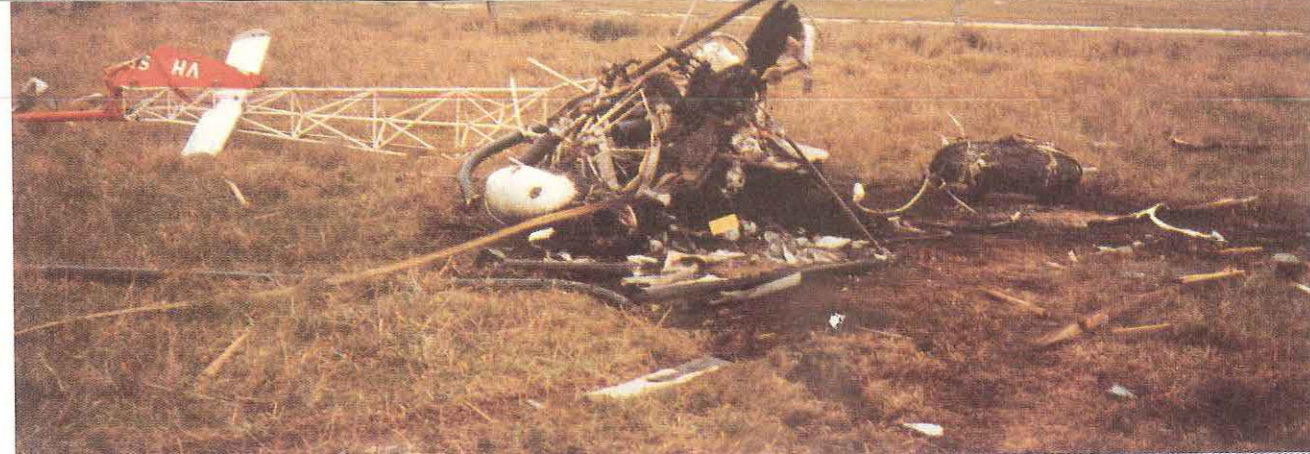
As it approached the house, the pilot raised his right hand and threw something out. As he did so, the right wing dropped slightly and hit the top of a tree next to the house. Impact with the tree occurred 5 metres above the ground and severed the right wing at mid-span. The uncontrollable aircraft hit the ground with a 'thump' and disintegrated.

The pilot had thrown a flour bomb. He had a history of low flying which was considered dangerous to the extent that his colleagues had cautioned him several times. His club had even considered expulsion but thought they might be able to better influence his behaviour if they kept him within the group. The pilot died on impact.

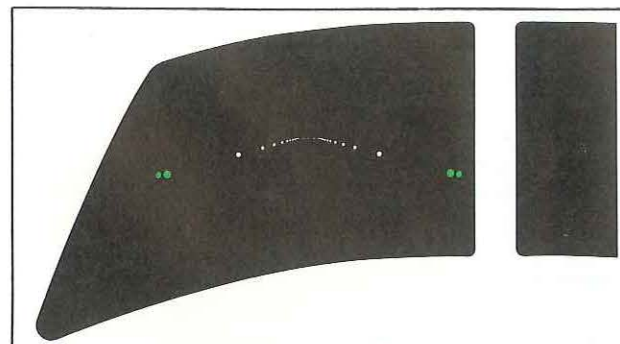
Figure 1: A shallow but constant approach.

Runway aspect constant and position in windscreen constant.

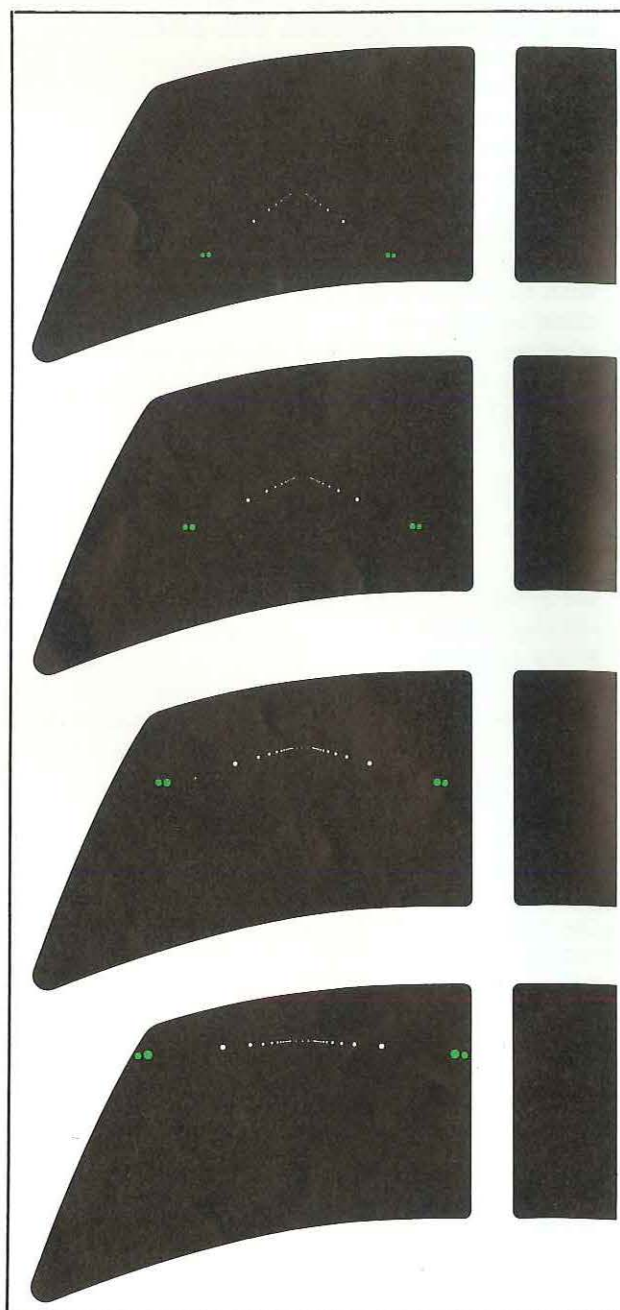
Figure 2: A shallow, undershooting approach.

Runway aspect flattening and moving up in the windscreen.
