# Aviation Safety Digest

ASD 132

AUTUMN 1987

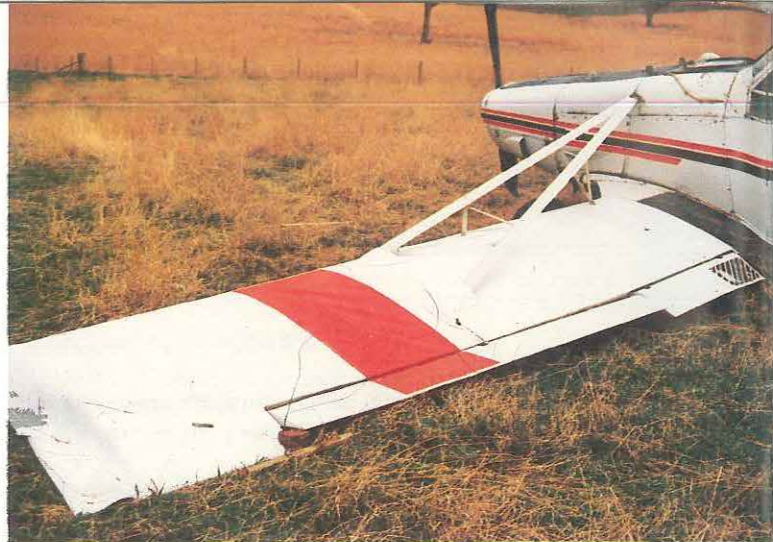
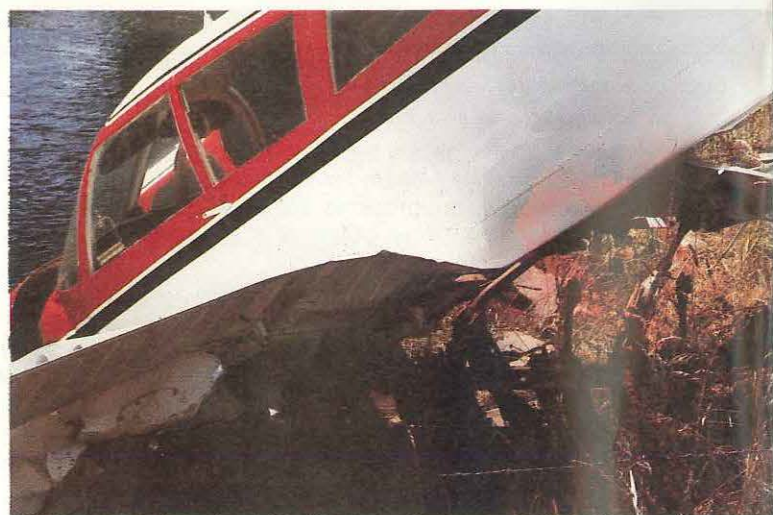
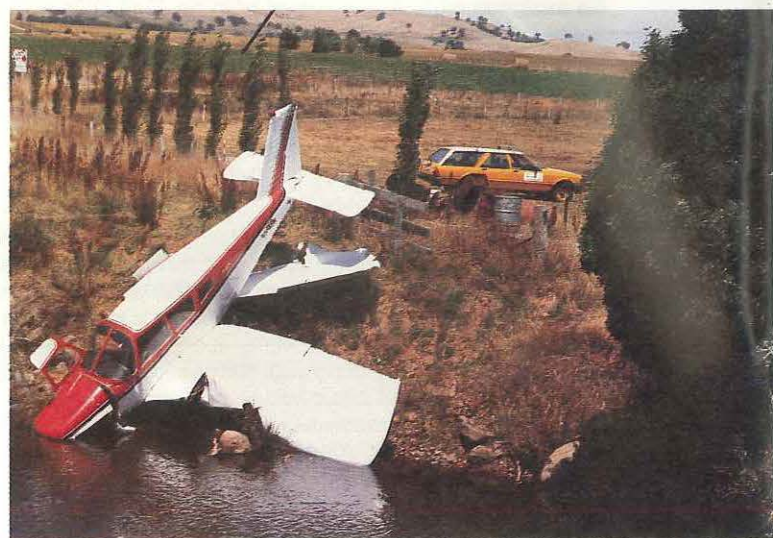
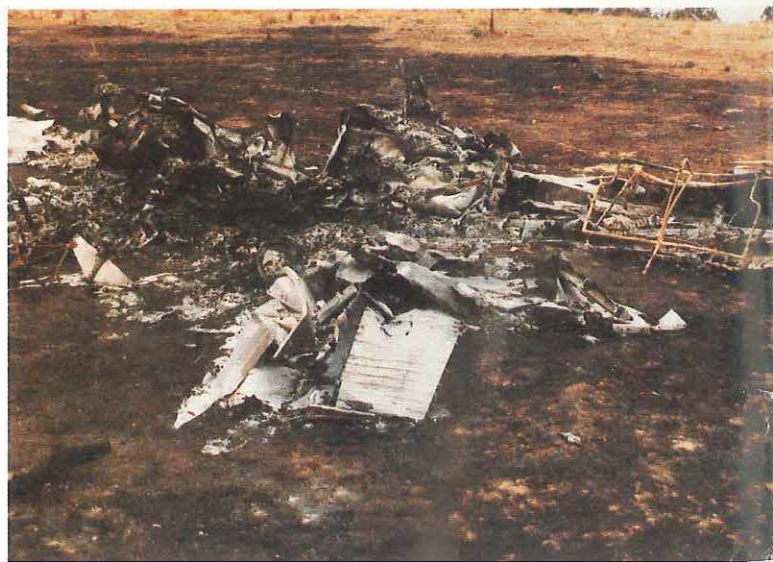
No fault could be found with the engine which was still idling as the aircraft came to rest.

When he had first arrived at the strip, the pilot had left the engine idling for several minutes while the aircraft was loaded with super-phosphate and with the carburettor heat on cold. The conditions at the time were conducive to carby icing. The problem was compounded by this pilot's technique of using only partial power for takeoff. More on this later.

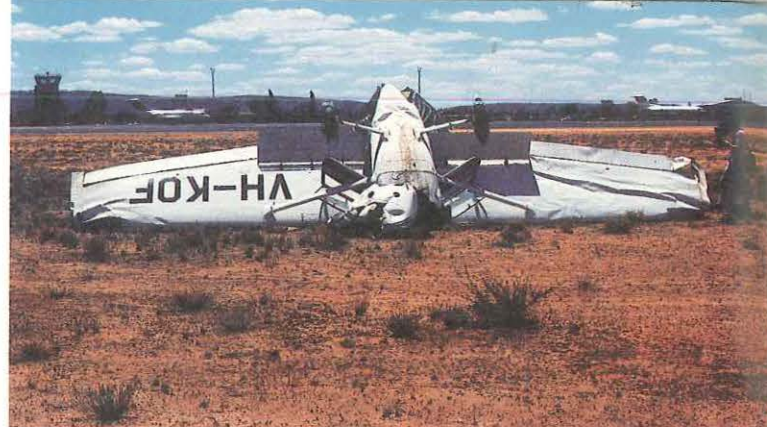
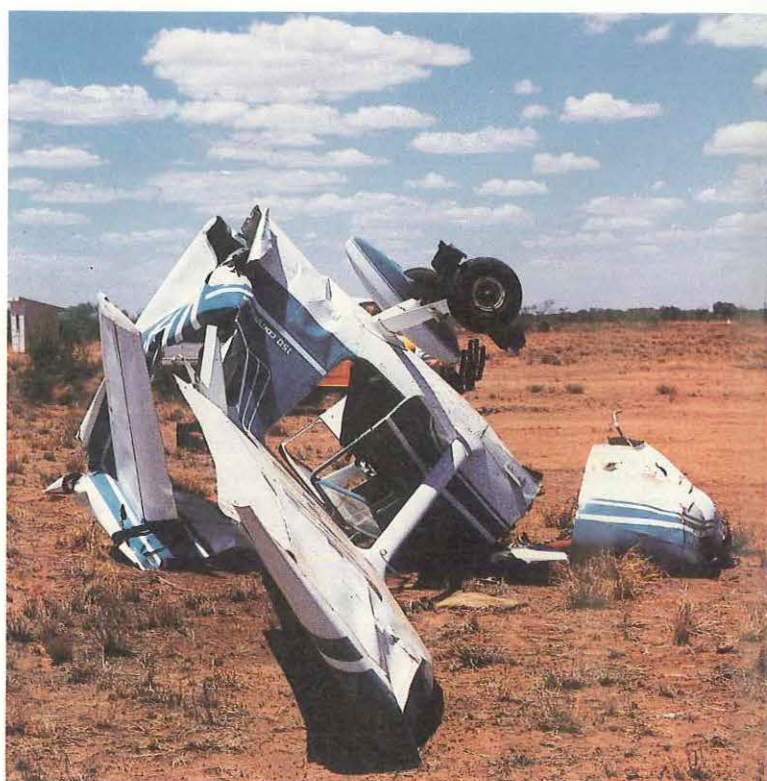
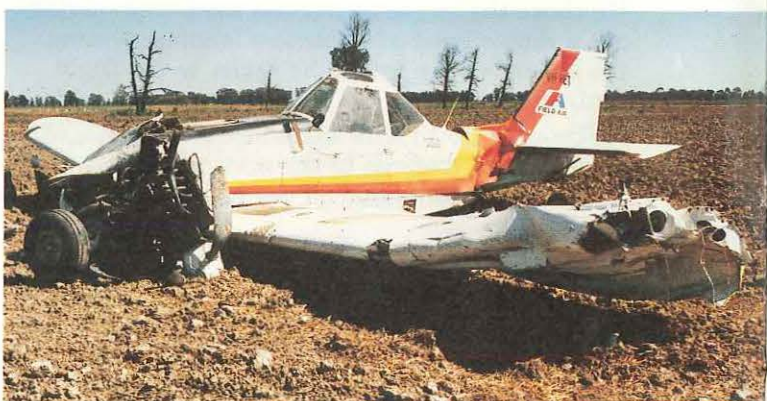
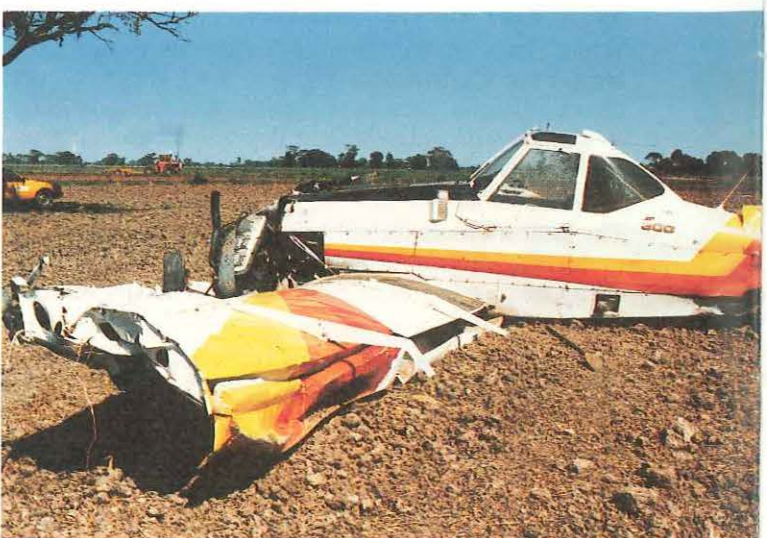
Under the circumstances the pilot could not take any avoiding action and the left wingtip struck a dead tree. The aircraft slewed to the left, touched down and came to rest with the engine and landing gear torn from the fuselage.

No fault could be found with the aircraft or systems which would account for the loss of performance. The takeoff, from a one-way strip, was done with a slight tailwind component and the estimated takeoff weight slightly exceeded the published climb weight limit.

The aircraft had taken off previously with a similar load but on this occasion it had also been refuelled and there was a tailwind. The available strip length was not enough for the aircraft at this weight, with any tailwind at all. The pilot's technique was to progressively select full flap during the takeoff roll from the point when the tail wanted to lift. After liftoff, he then reduced the flap setting progressively to allow the aircraft to accelerate.

On this occasion the combination of factors was sufficient to degrade the aircraft's performance and to cause it to hit the bridge.

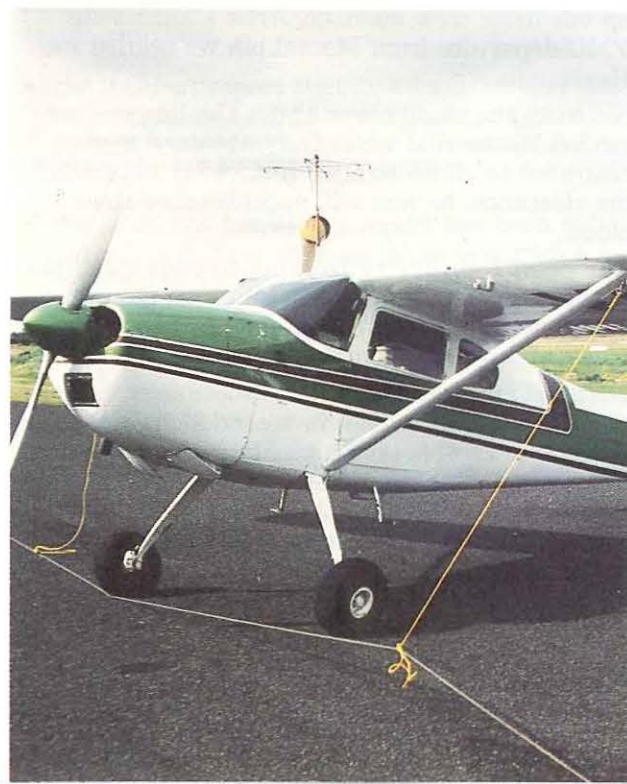
*Unsafe — two*

A not so obvious potential accident is this Cessna. It was tied down but because there was no tie-down at the tail, it has moved in the wind. Where aircraft are parked close together this movement may be sufficient to allow a collision. Also the now slackened tie-down on the far side will allow that wing to lift should the wind change. On this occasion the wind had dropped and there was no significant risk of further movement but it does illustrate the importance of that third tie-down.

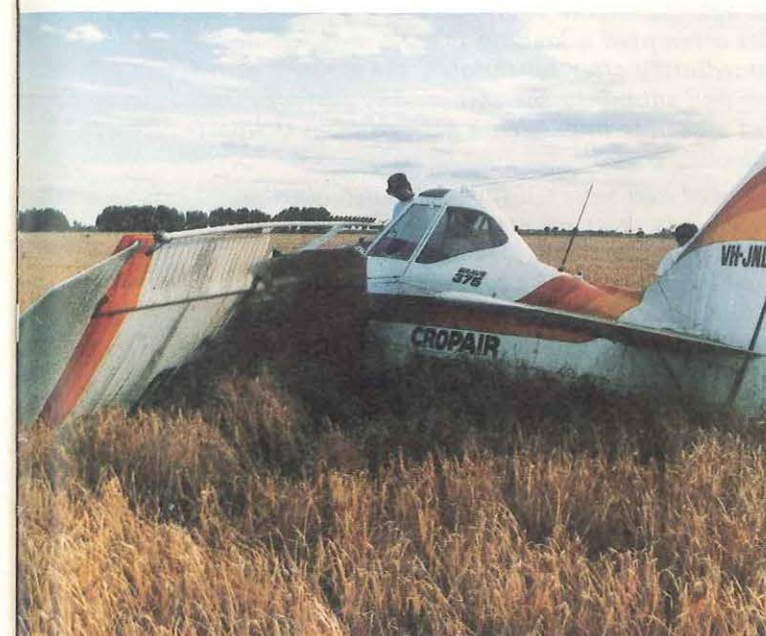
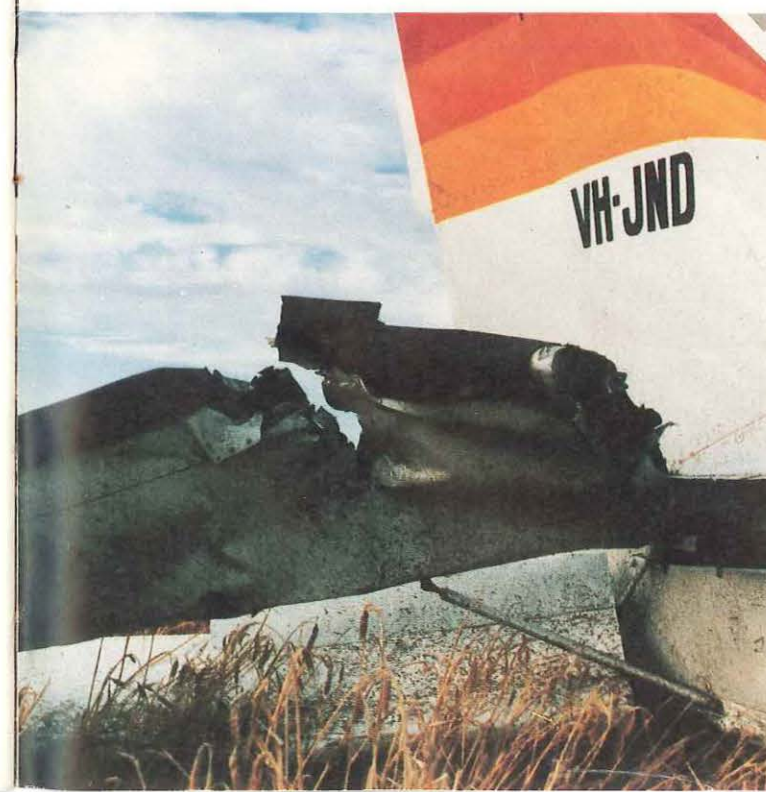
*The inertia reel which was selected to the auto position failed to lock, and during the crash the pilot was thrown forward. (The reel should lock the harness on sensing the deceleration.) The pilot's head impacted the padded instrument coaming, and despite this padding he would have probably suffered serious injuries if he hadn't been wearing a helmet.*

'Six and a half years later I was still using the same helmet when I caught the two wires around the undercarriage of the Pawnee Brave. The wires did not break until the aircraft struck the ground in a nose-down attitude. The front of the helmet was undamaged even though the crash-pad, dash and instruments were badly damaged by it. At some stage of the accident sequence the port wing folded back and a broken spray boom passed through the side window, badly cracking my helmet above the left ear. I am sure that wearing a good quality helmet saved my life twice in the one accident.'

Gavin goes on to say — 'Any pilot buying a helmet should consider spending a few extra dollars on an adjustable strap, suspended type, which gives much better comfort and cooling and probably gives better impact protection.'

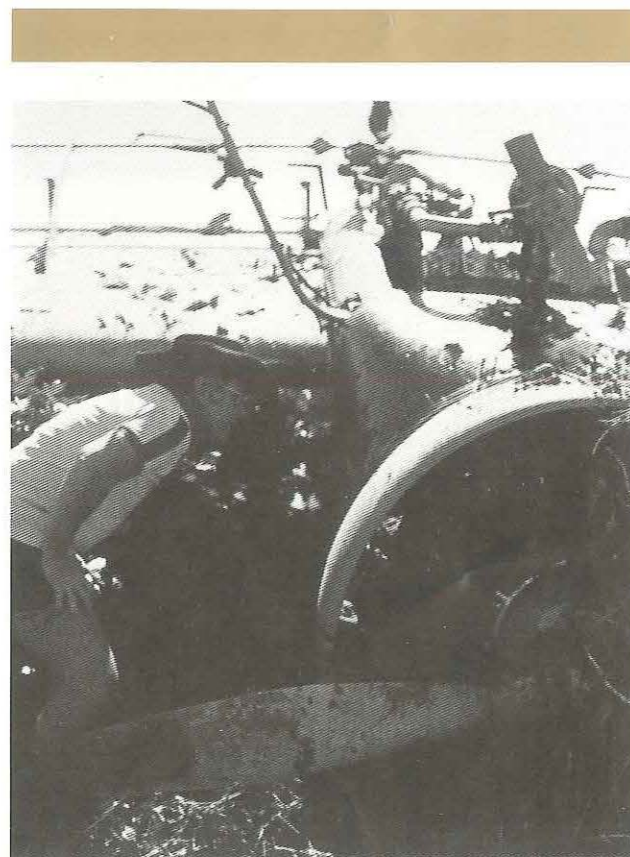
*The pilot was making a night spraying run over a cotton crop. During the third run at about 50 feet agl, the engine suddenly lost all power. The pilot attempted a landing in a flooded paddock. Immediately after touchdown, the aircraft nosed over and sank into the soft muddy surface. The pilot was able to extricate himself from the partly flooded cockpit.*

*The pilot had selected the most suitable area available in the circumstances. When the aircraft overturned, the fibreglass roof of the cockpit failed and cut into the top of the pilot's helmet. Had the pilot not been wearing this protection, it was likely that he would have suffered head injuries and, as a result of this incapacitation, probably would have drowned* □
