Level crossing collision between freight train 8279 and truck, at level crossing 5318

near Yalboroo, Queensland | 29 August 2017

ATSB Transport Safety Report

RO-2017-011

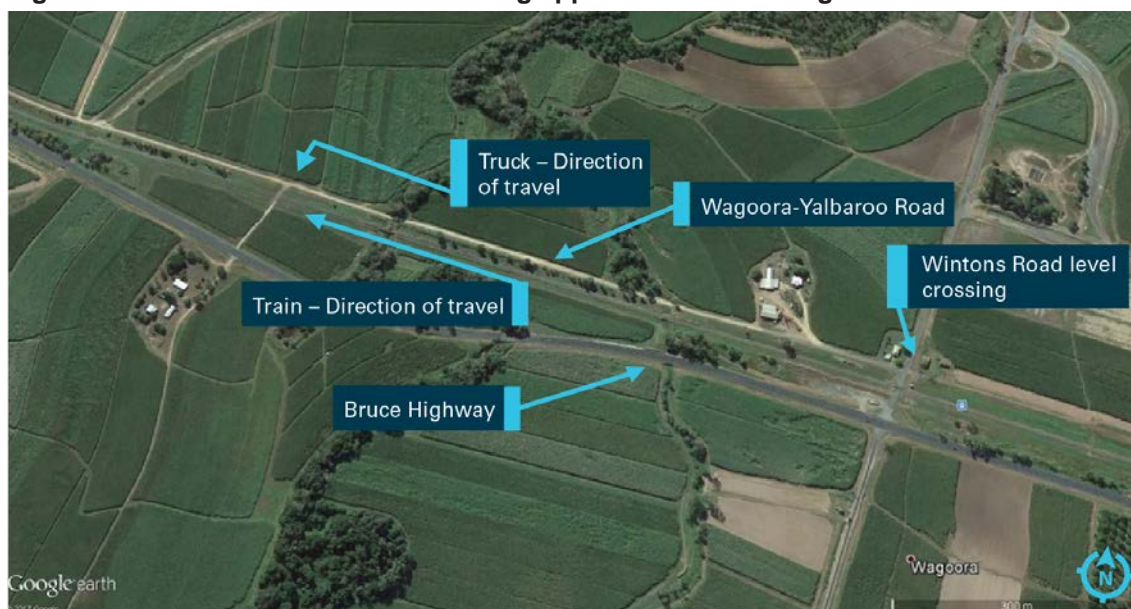
Figure 1: Aerial view of the level crossing approach and road alignment

At about 0945, train 8279 passed over the level crossing at Wintons Road (Figure 1). Soon after, while travelling at about 84 km/h,² the train driver observed a dust cloud ahead and assumed it was a vehicle travelling on the parallel unsealed road to the north—Wagoora-Yalbaroo Road. The train driver then sighted a truck approach the next level crossing (1028.693 km). The unsealed level crossing was equipped with passive traffic control devices (Stop signs).

The truck was travelling west along Wagoora-Yalbaroo Road before turning left towards the railway crossing and the Bruce Highway. The train was also travelling west, parallel to the road. Source: Google Earth, annotated by ATSB

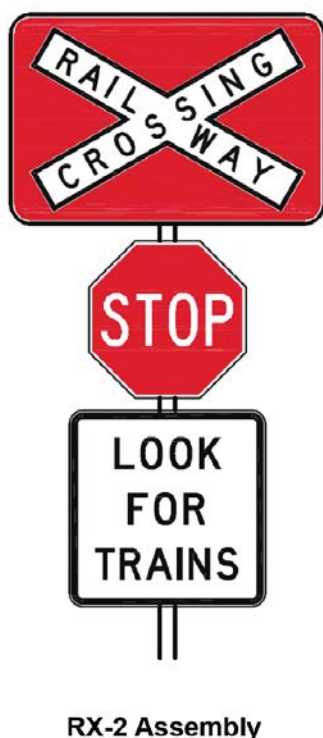
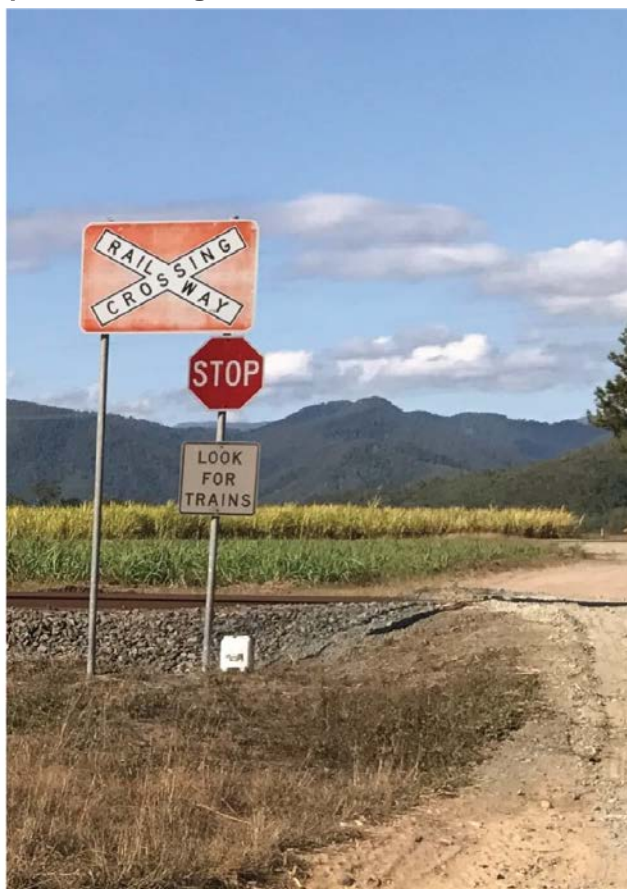
Figure 2: Traffic control devices at occupation crossing ID 5318

In 1997, QR engaged a consultant to develop an organisational standard for all occupation crossings on their rail network. The consultant report recommended a RX-2 assembly (Stop sign) as the standard for all occupation crossings. This recommendation exceeded the minimum treatment requirement of Australian Standard 1742.7:2016⁵ and was consistent with the installation at crossing ID 5318 (Figure 2).

RX-2 assembly (Stop sign) to Australian Standard 1742.7:2016. Source: AS1742.7 and Queensland Rail

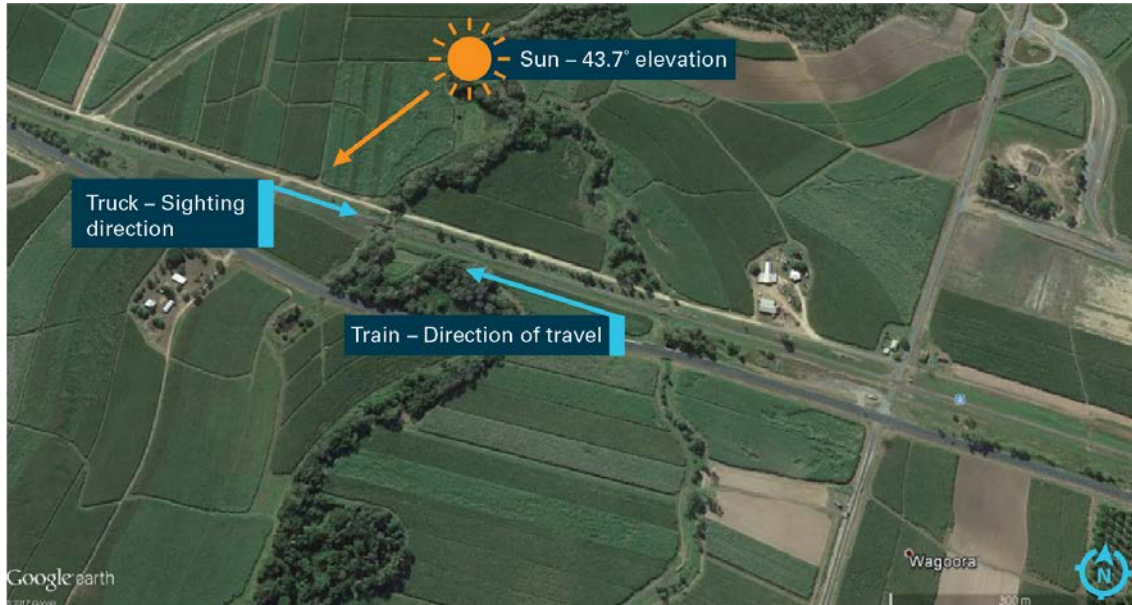
Figure 3: Sun position and sighting direction of truck driver

The sighting direction for the truck driver was towards the east. The sun was almost directly behind the truck driver at an altitude of about 43° above the horizon. Source: Google Earth, annotated by ATSB

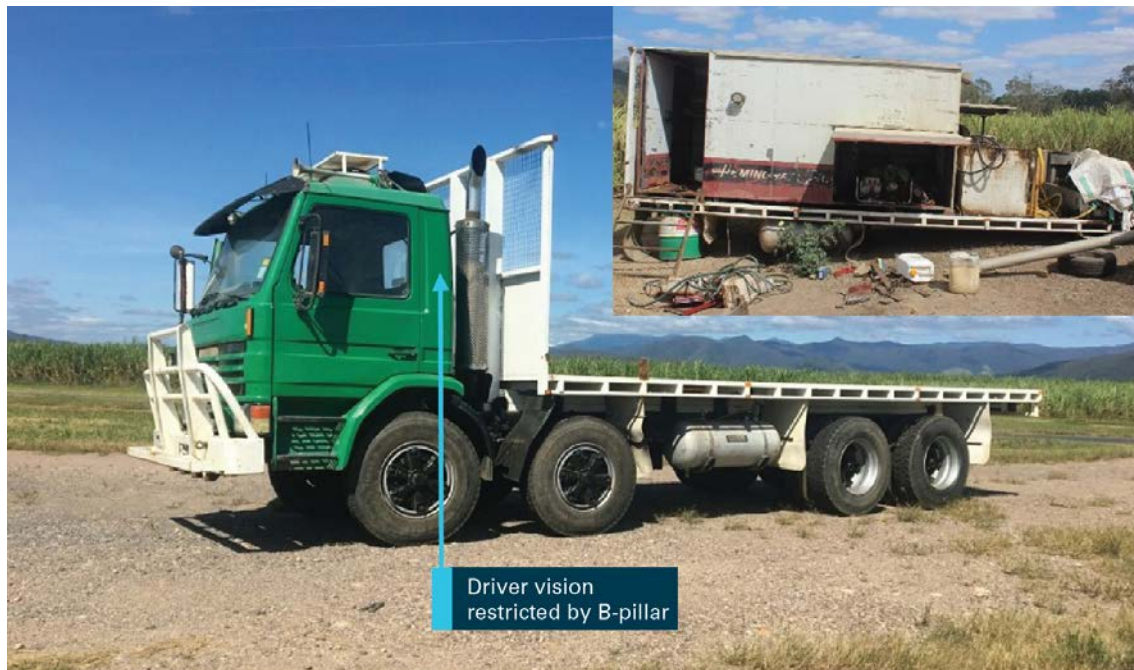
Figure 4: Road vehicle

The ATSB noted that the truck had a relatively prominent B-Pillar (Figure 4). The B-pillar of heavy vehicles is a feature known to obscure a driver's vision. It is likely that, under some conditions, a driver of this truck would experience a restricted view to the left due to the vehicle's B-pillar.

The vehicle was a 1983 Scania model P112 series 2, twin-steer truck fitted with a flat tray body. The vehicle was loaded with a storage container, fuel tank and air compressor (inset). Note that under some conditions, it is very likely the truck driver's vision to the left may be restricted due to the vehicle's B-pillar. Source: Qld Police, Annotated by ATSB

While most vehicles exhibit features that may obscure a driver's vision, it is particularly true for heavy vehicles. Considering the cab-design of the vehicle involved in this incident (Figure 4), it is very likely that under some conditions, the driver's vision to the left would have been restricted due to the vehicle's B-pillar.

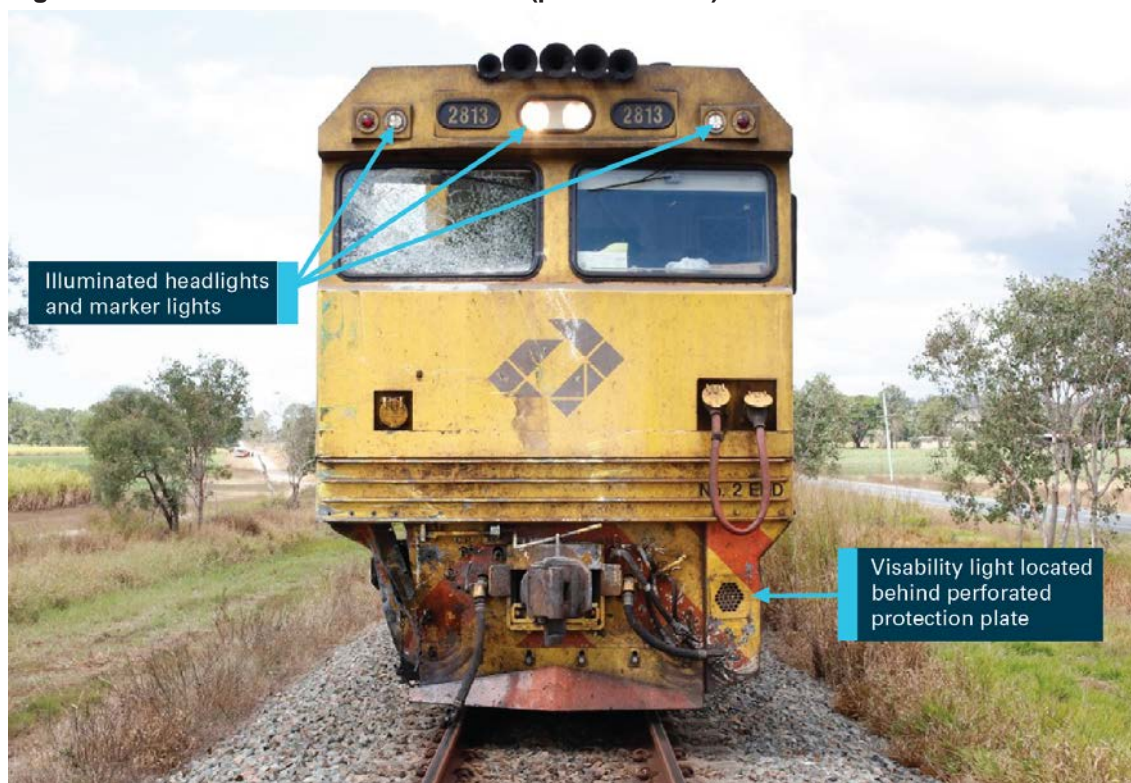
Figure 5: Rail vehicle – Locomotive 2813 (post-collision)

To improve conspicuity, the front of locomotive 2813 was painted yellow and its headlights were illuminated. Source: Qld Police

The 2800 class locomotives also have visibility lights, which sit to the side of the coupler behind a perforated protection plate (Figure 5). The lights are manually controlled by the train driver and operate continuously when switched on, but do not flash when the horn is sounded.

When photographed following the collision, one of the visibility light was destroyed as a consequence of the collision and the other was not illuminated (Figure 5). The ATSB noted that a photograph of the driver's overhead console indicated the switch controlling the visibility lights was

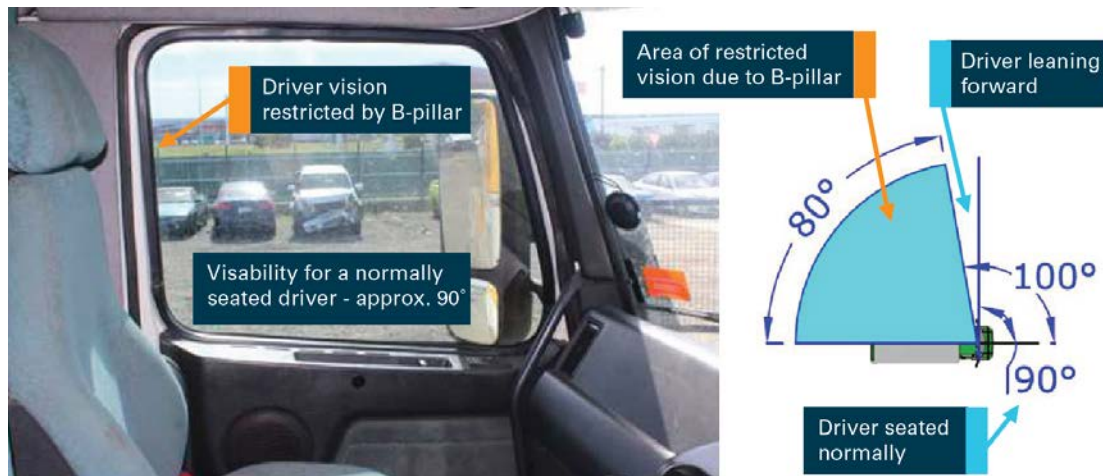
Figure 6: Road vehicle visibility testing

The Queensland Police conducted visibility testing using a vehicle with very similar side window and B-pillar configurations.²¹ Testing showed that clear visibility was available to 90° for a normally seated driver simply turning the head to look out the passenger side window. If the driver was to lean forward over the steering wheel, the angle of vision increased to about 100°. However, vision beyond 100° to the left was not possible through the passenger side window (Figure 6).

Road vehicle visibility testing indicated a complete restriction to driver visibility beyond 100°, when the driver was looking out the left side passenger window. Source: Qld Police, annotated by ATSB

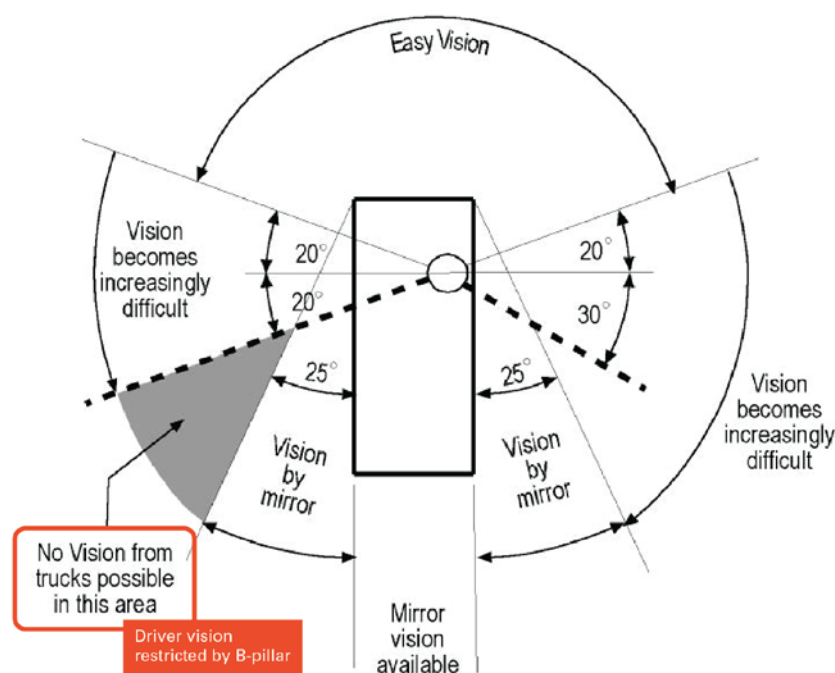
Figure 7: Sight restrictions due to vehicle design

The Austroads guide notes that vision from the cab of a vehicle becomes increasingly difficult to the side and rear of the vehicle. The rectangle represents a vehicle; the circle represents the vehicle driver. Note the area highlighted indicating where vision from a truck may be restricted due to the vehicle's B-pillar. Source: Austroads *Guide to Road Design Part 4A: Unsignalised and Signalised Intersections*, Annotated by ATSB

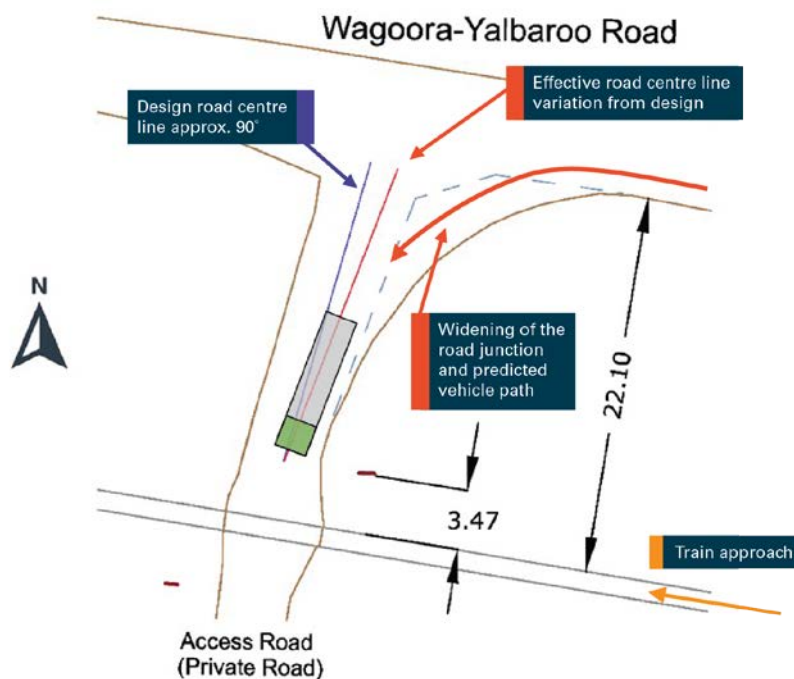
Figure 8: Road angle

At the accident location, the private road intersected the rail line at an angle of about 90°. However, the junction between the private road and Wagoora-Yalbaroo Road (approximately 19 m from the railway crossing signage) showed evidence of widening at its eastern corner. Both roads were unsealed, so widening probably occurred gradually as road vehicles progressively cut the corner when entering/exiting the private road. Consequently, the effective centre line of the road varied from the designed 90° (Figure 8). The ability for a road vehicle to cut the corner and enter the private road at an angle, combined with a relatively short distance to the crossing, may influence the positioning of larger vehicles when stopped at the crossing.

The design angle for the road centre line at the level crossing was approximately 90° to the rail line. However, due to widening of the road junction eastern corner, the effective centre line of the road varied from the designed 90°. Source: Qld Police, annotated by ATSB

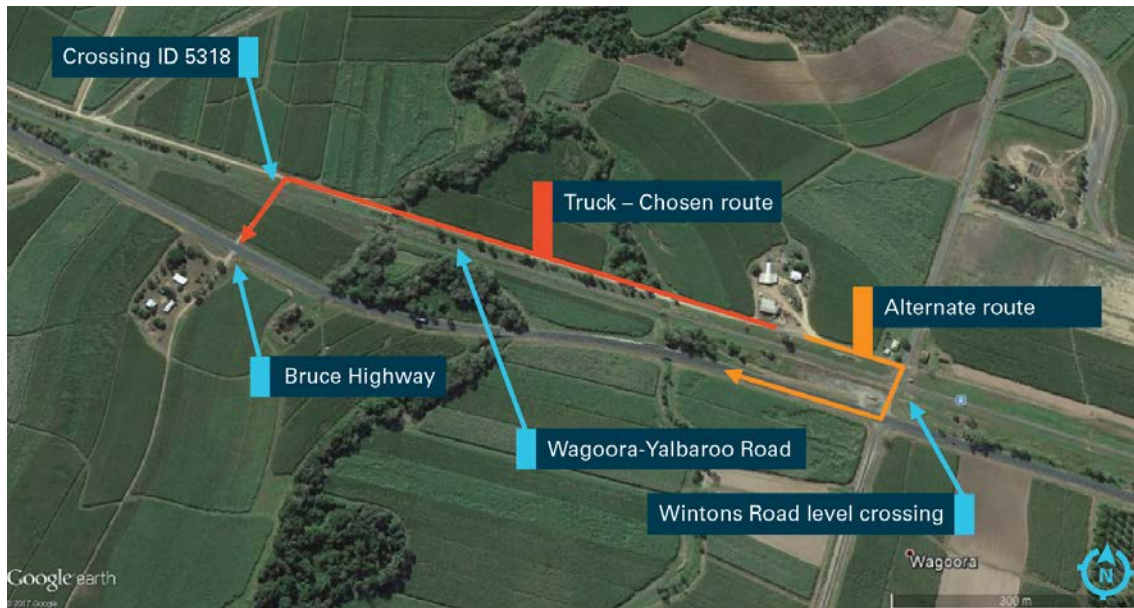
Figure 9: Chosen route (red) and alternative route (orange)

The truck was travelling between properties located on the Wagoora-Yalbaroo Road and another located on the opposite side of the Bruce Highway via crossing ID 5318. There was a viable and safer alternative for travelling to the intended destination via Wintons Road with active traffic control devices (flashing lights) at the level crossing. Source: Google Earth, annotated by ATSB

In the absence of measures preventing unrestricted public access and considering the proximity of an alternative crossing with active traffic control devices (flashing lights), it is possible that crossing ID 5318 might present an opportunity for Queensland Rail to consider consolidation as encouraged by documented level crossing safety policies and safety strategies.
