Loss of control and collision with terrain involving B200 King Air, VH-ZCR

Essendon Airport, Victoria | 21 February 2017

ATSB Transport Safety Report
Aviation Occurrence Investigation
AO-2017-024
Final – 24 September 2018

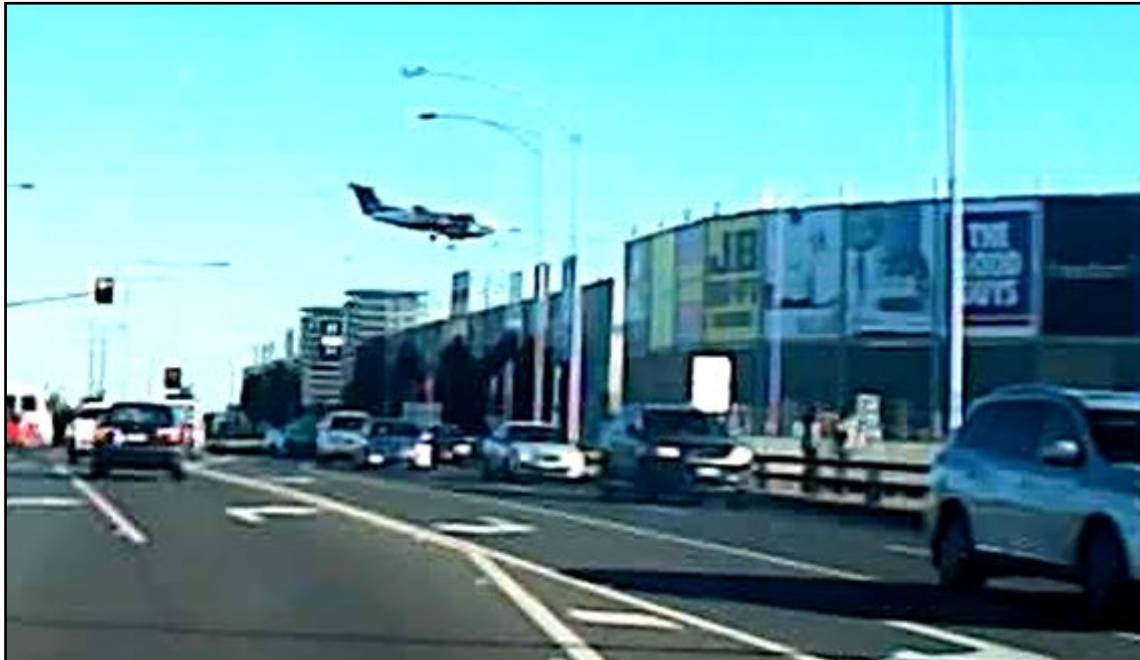
VH-ZCR immediately prior to collision with a building in the Bulla Road Precinct

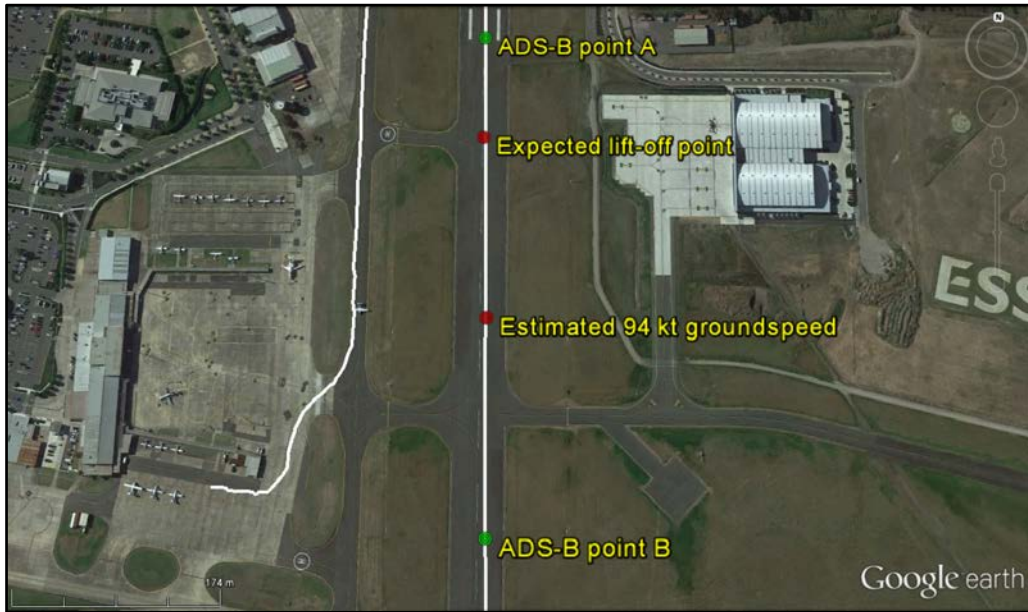
Figure 11: ADS-B data showing initiation of ZCR's divergence from the runway centreline between points A and B

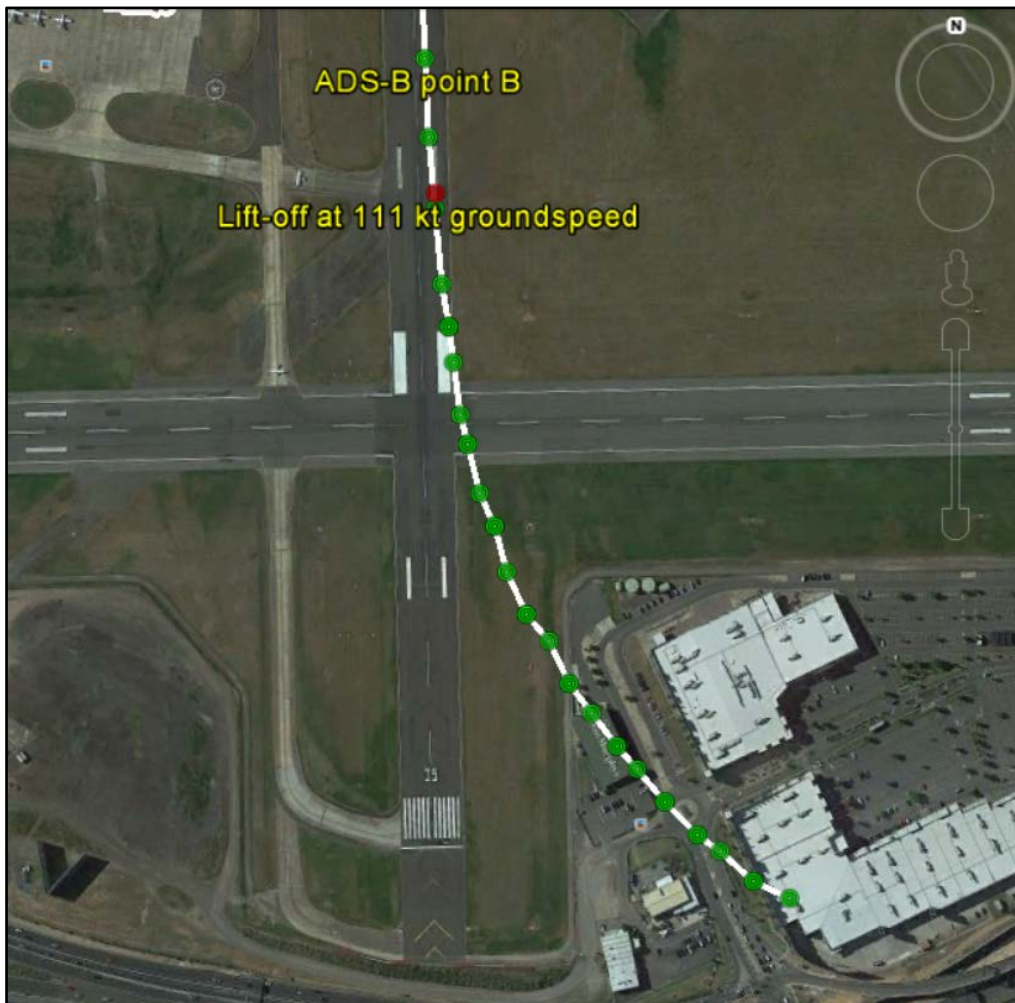
Figure 12: ADS-B data points showing ZCR's increasing divergence from the runway centreline as the flight progresses

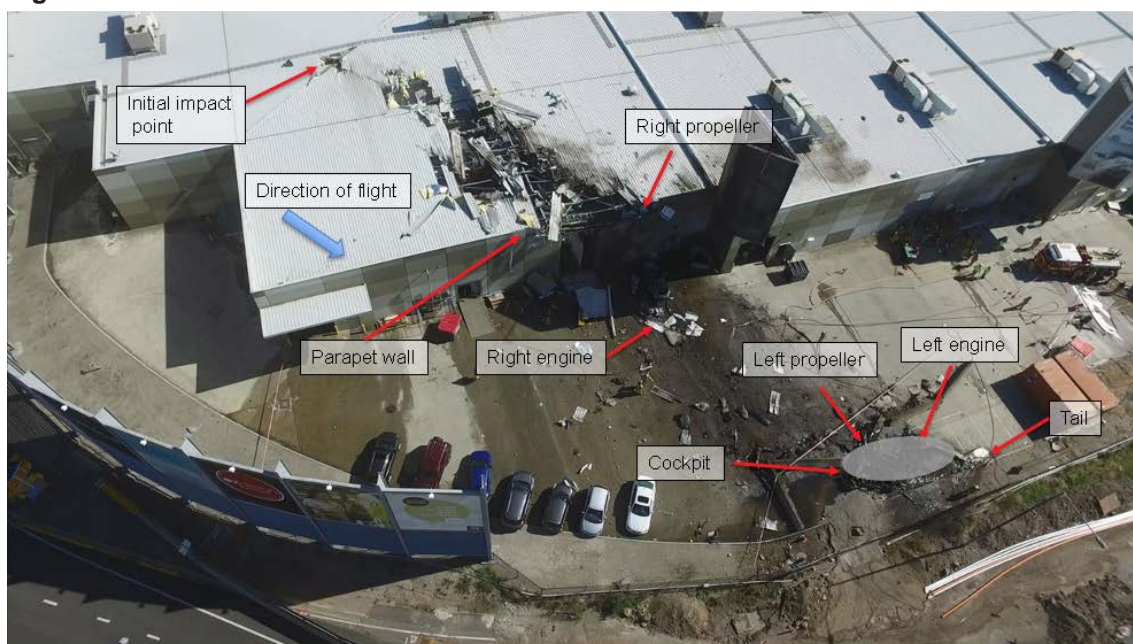
Figure 25: Accident site overview

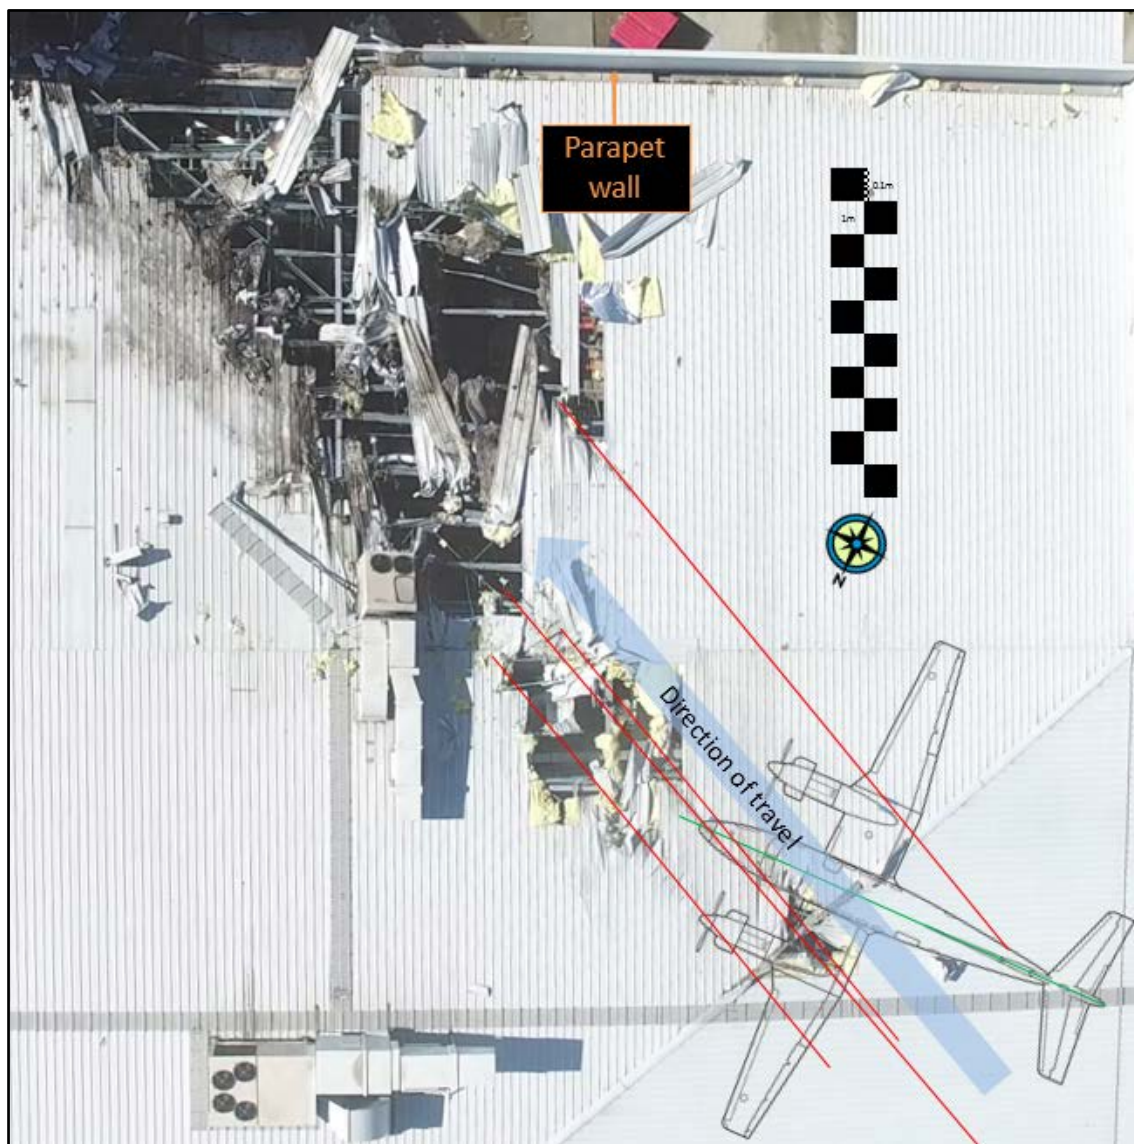
Figure 26: Outlet centre roof impact damage with scaled aircraft aligned with impact marks

Note: Landing gear wheels are offset to the right and apparent wingspan is reduced to allow for a slight left bank.
Source: Metropolitan Fire Brigade (Melbourne), annotated by the ATSB

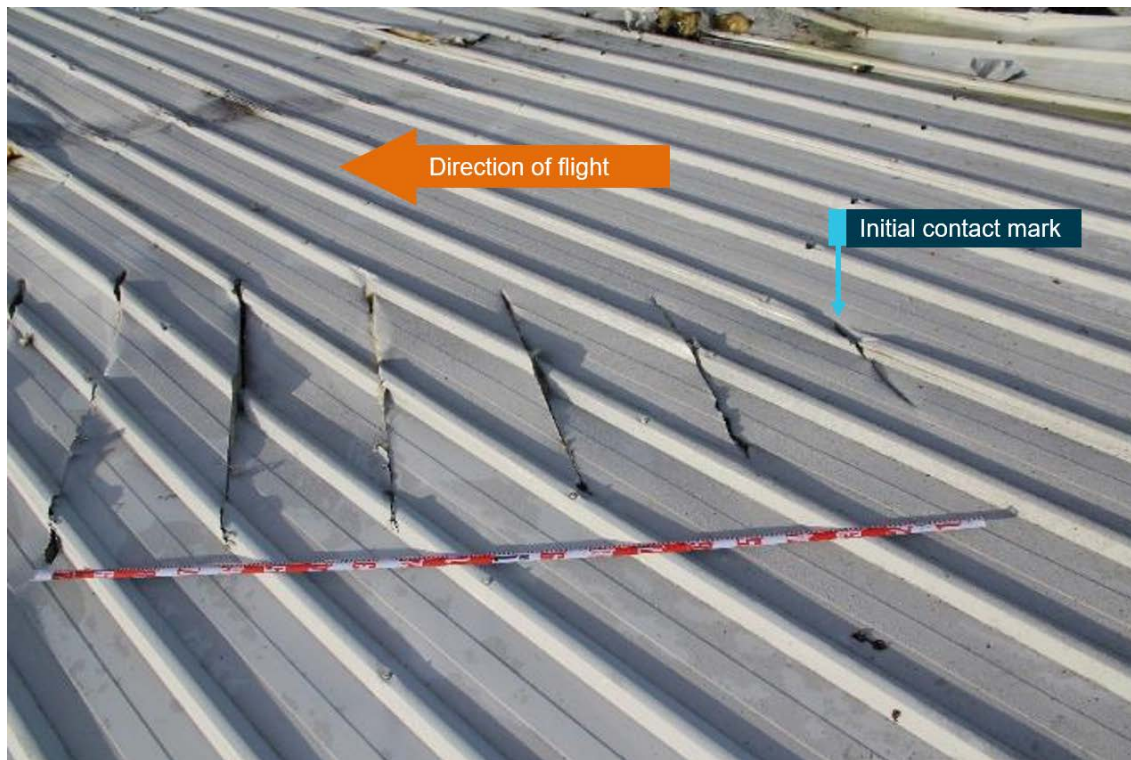
Figure 27: Left propeller slash marks in roofing material with tape measure showing distance between cuts

The last 2 seconds of ADS-B data indicated ZCR's ground speed was about 108 kt. Allowing for potential aircraft deceleration due to the nose landing gear colliding with the roof, prior to the left propeller blades making contact, the left propeller RPM was calculated as being consistent with ZCR's nominal take-off setting of 2,000 RPM. This was consistent with the estimated propeller RPM established from the dashboard camera audio frequency analysis (refer to section titled *Recorded information - Dashboard camera audio frequency analysis*).

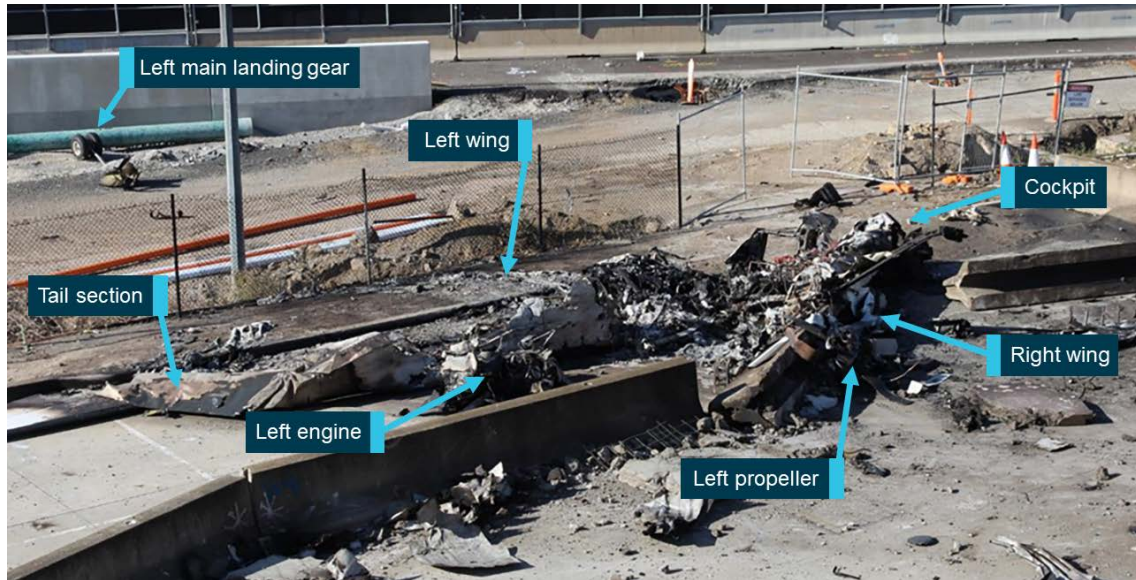
Figure 28: Main wreckage

The outboard right wing sections, main landing gear lower sections, both engines, and both propellers separated from the aircraft during the accident sequence and were located at the accident site. The nose gear oleo and wheel assembly came to rest on the Tullamarine Freeway, about 65 m from the main wreckage, in the direction of the flight.

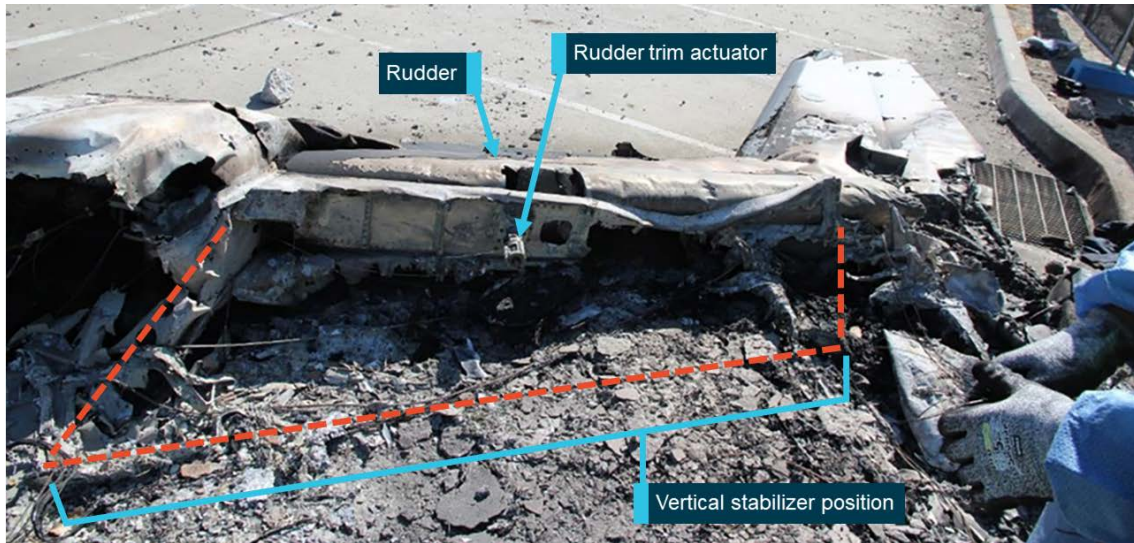
Figure 29: Remains of the vertical stabilizer on its left side showing position of rudder and trim actuator

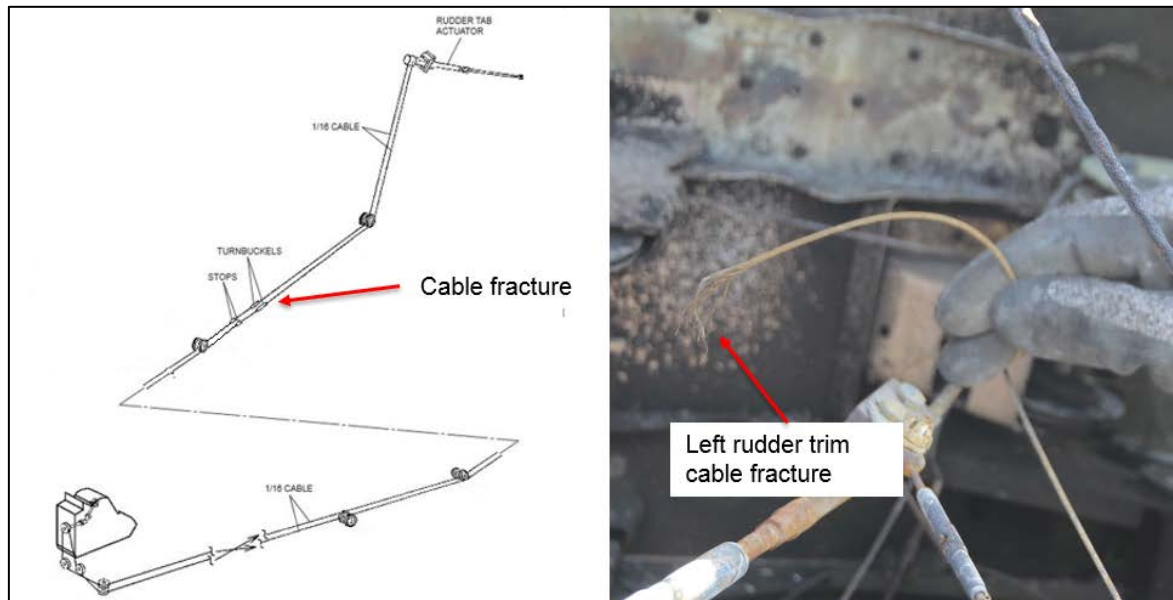
Figure 30: Schematic of rudder trim system showing the approximate cable fracture point (left) and a picture of the left rudder trim cable fracture (right)

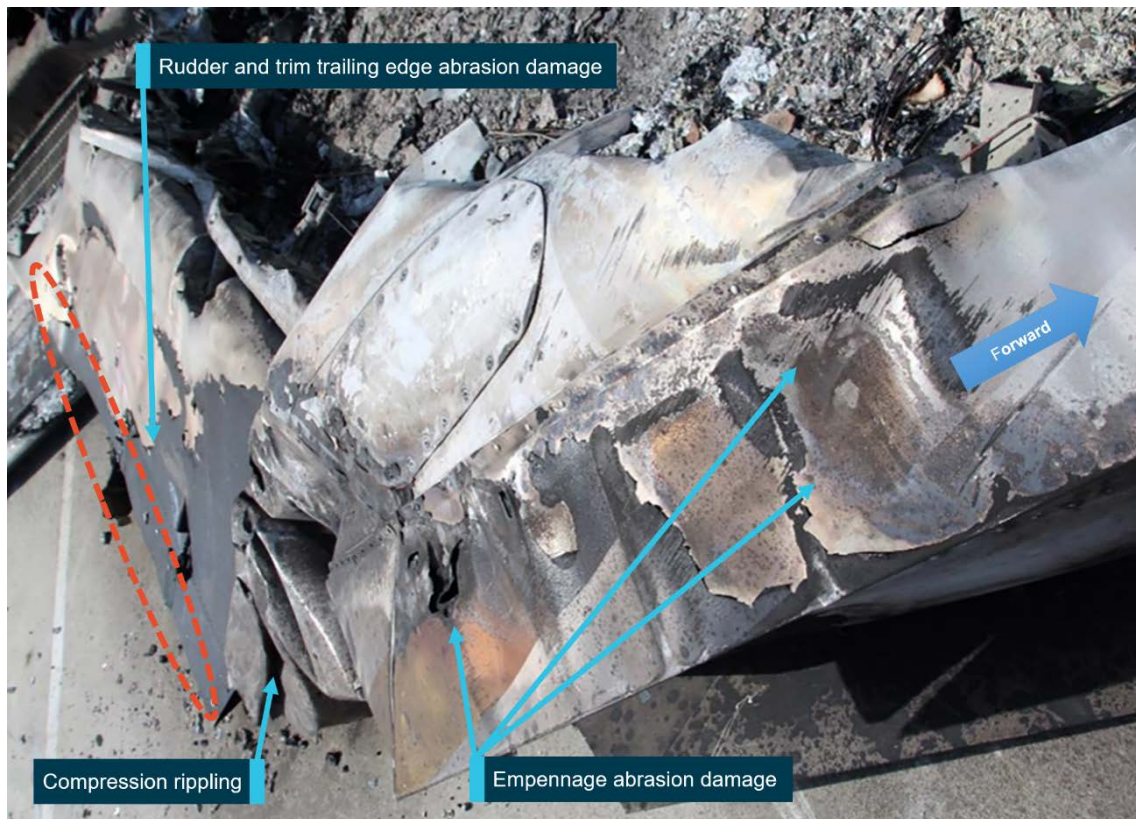
Figure 31: Empennage and rudder viewed from the right showing abrasion damage

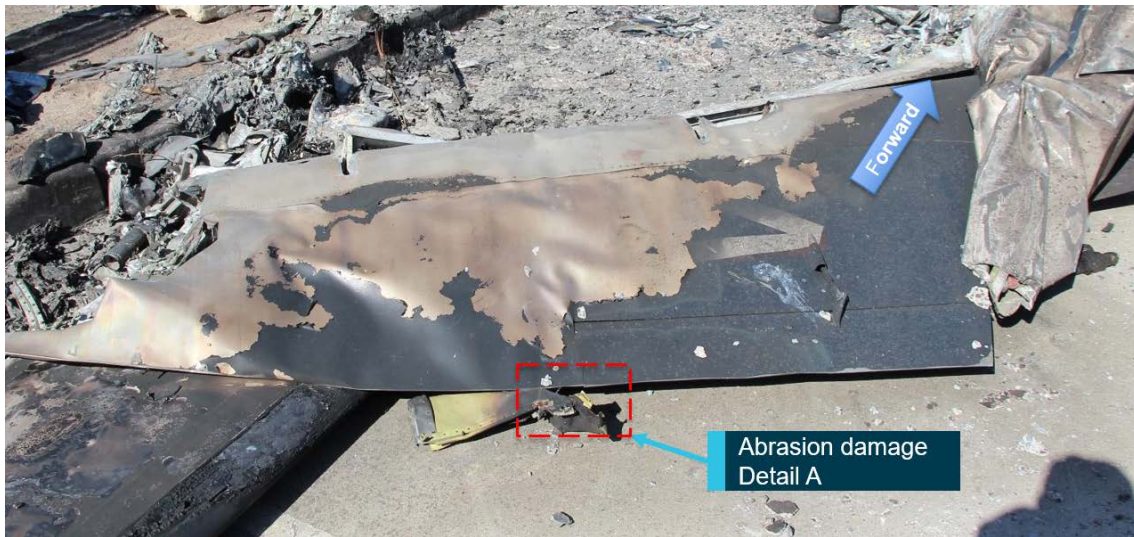
Figure 32: Rudder and rudder trim showing abrasion damage

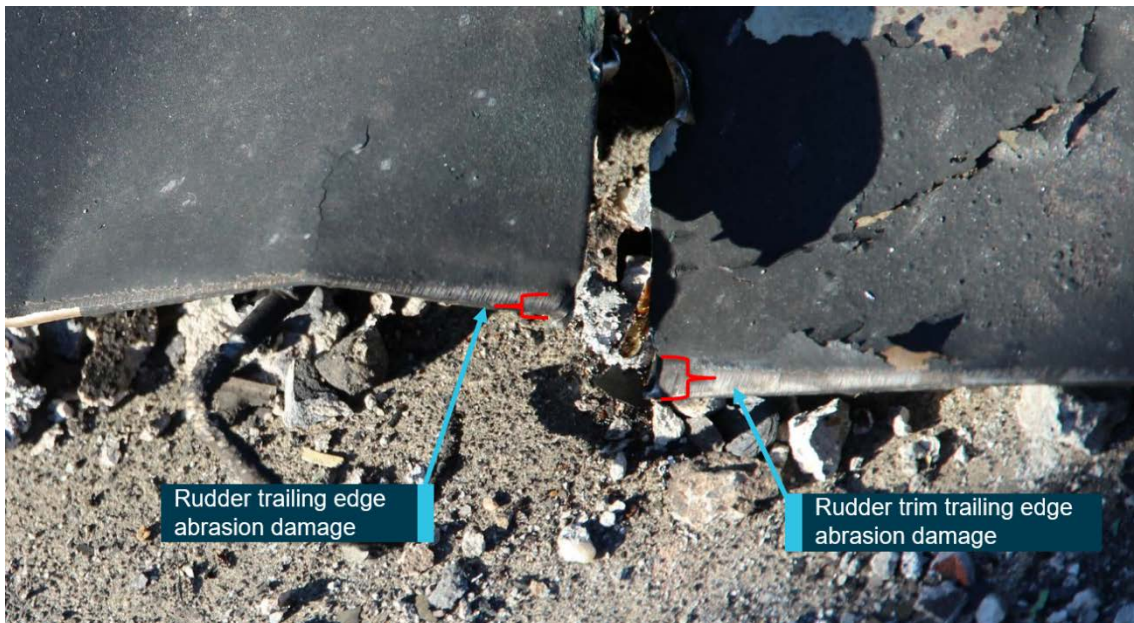
Figure 33: Detail A. Close-up of abrasion damage to rudder and upper surface of rudder trim trailing edge

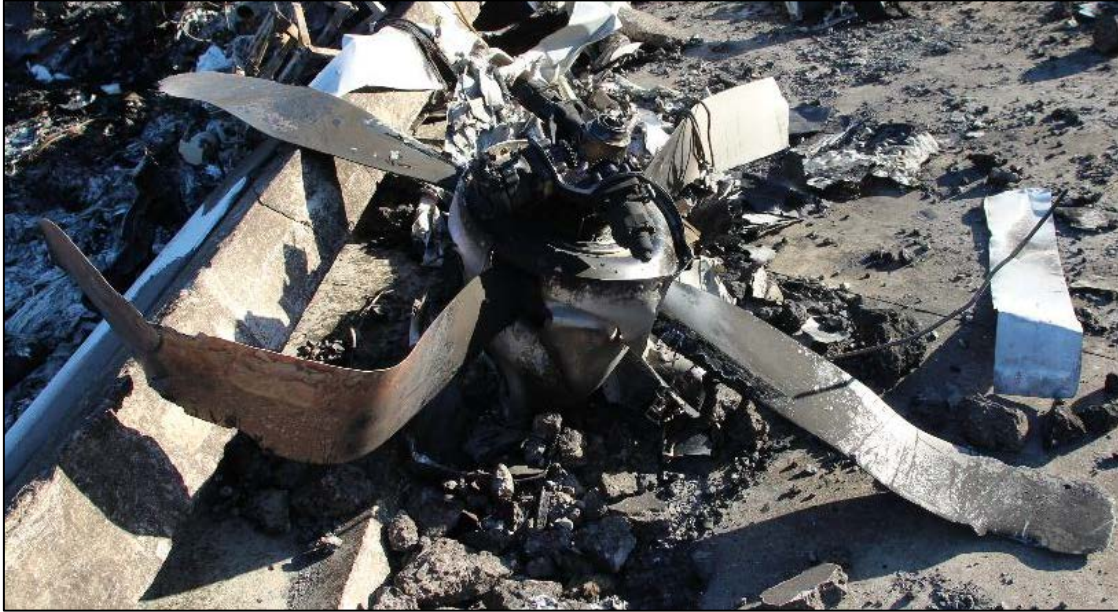
Figure 36: Left propeller viewed from the rear, showing blade-tip fractures, blade gouges and blade bending

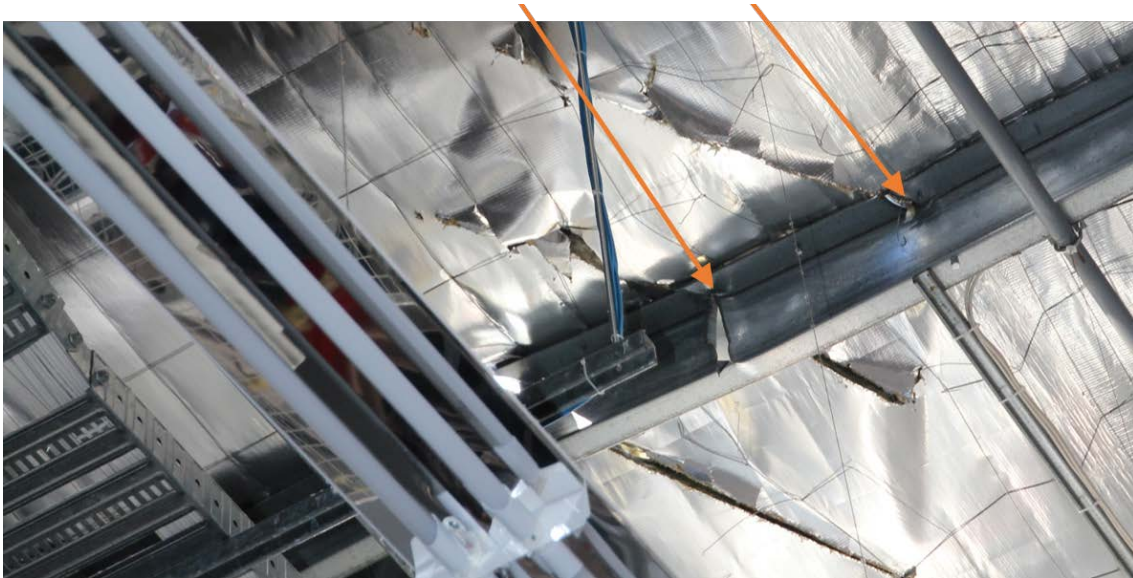
Figure 37: Left propeller cuts through roof structure

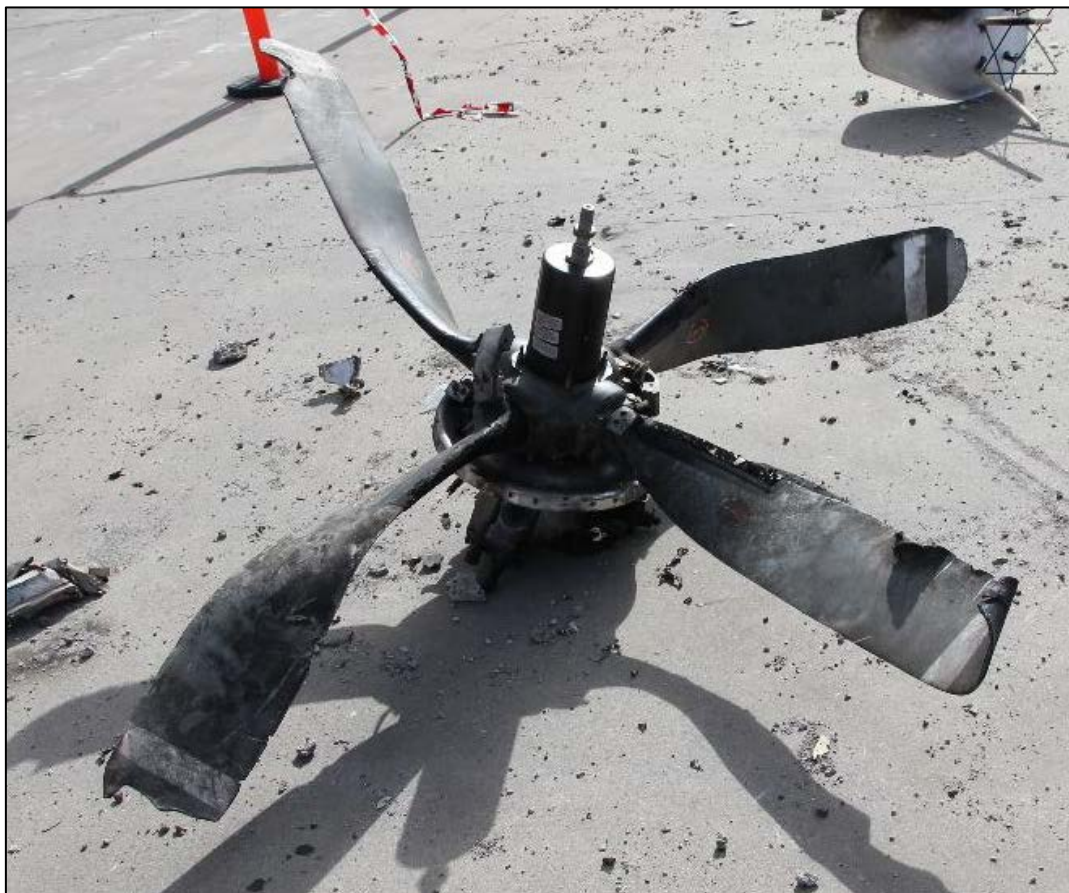
Figure 38: Front view of the right propeller showing bending, chordwise twisting, and leading edge gouging of the propeller blades

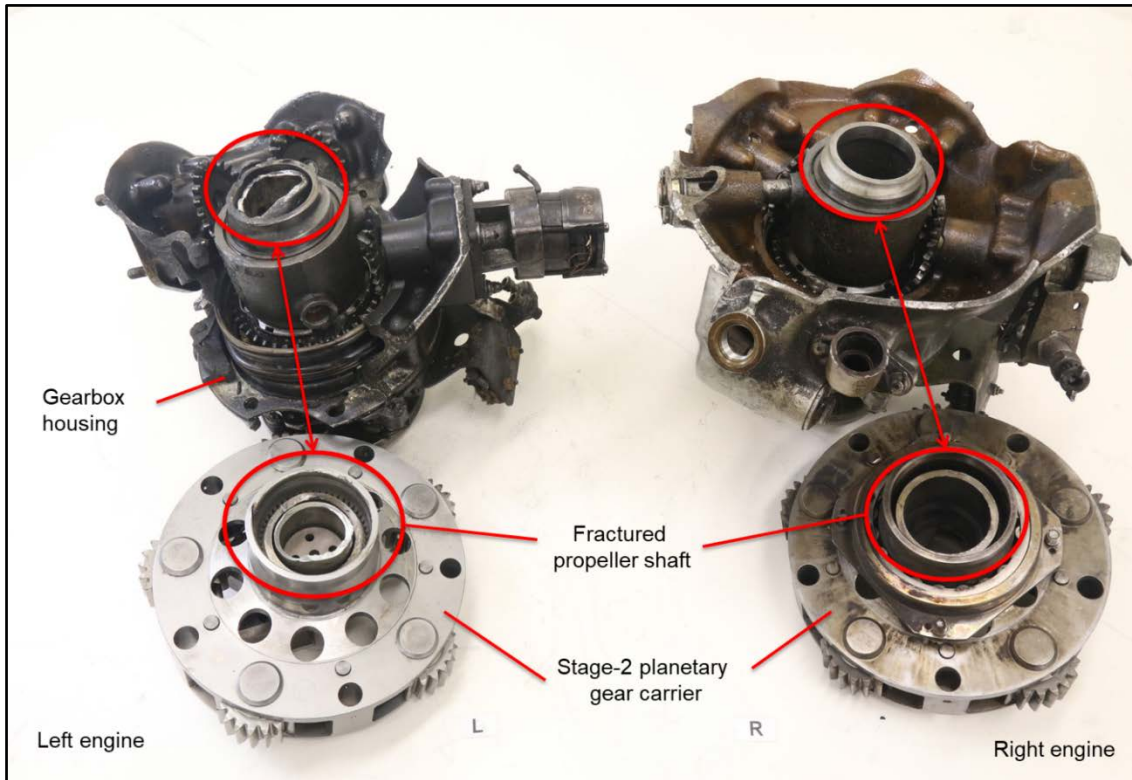
Figure 45: Left and right propeller shaft fractures

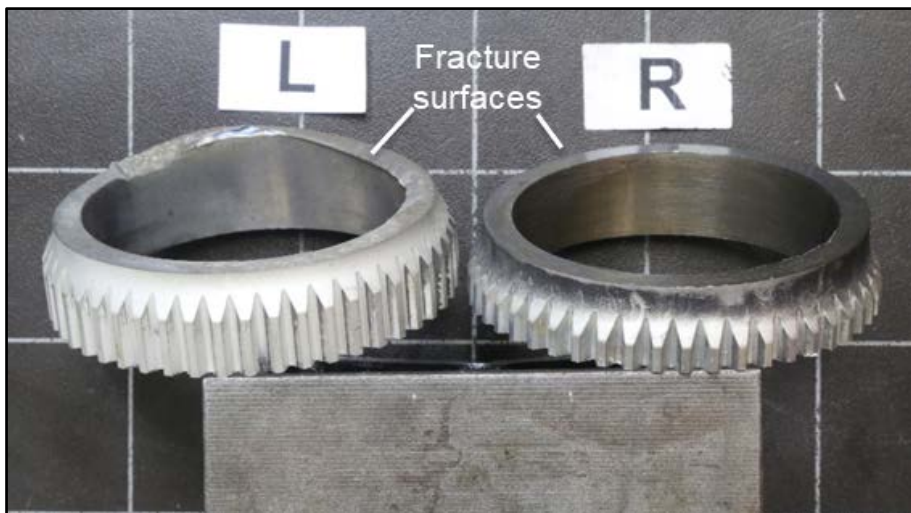
Figure 46: Fractured portion of the propeller shaft from the left and right engines

Note the almost identical planar fracture surfaces.
Source: ATSB

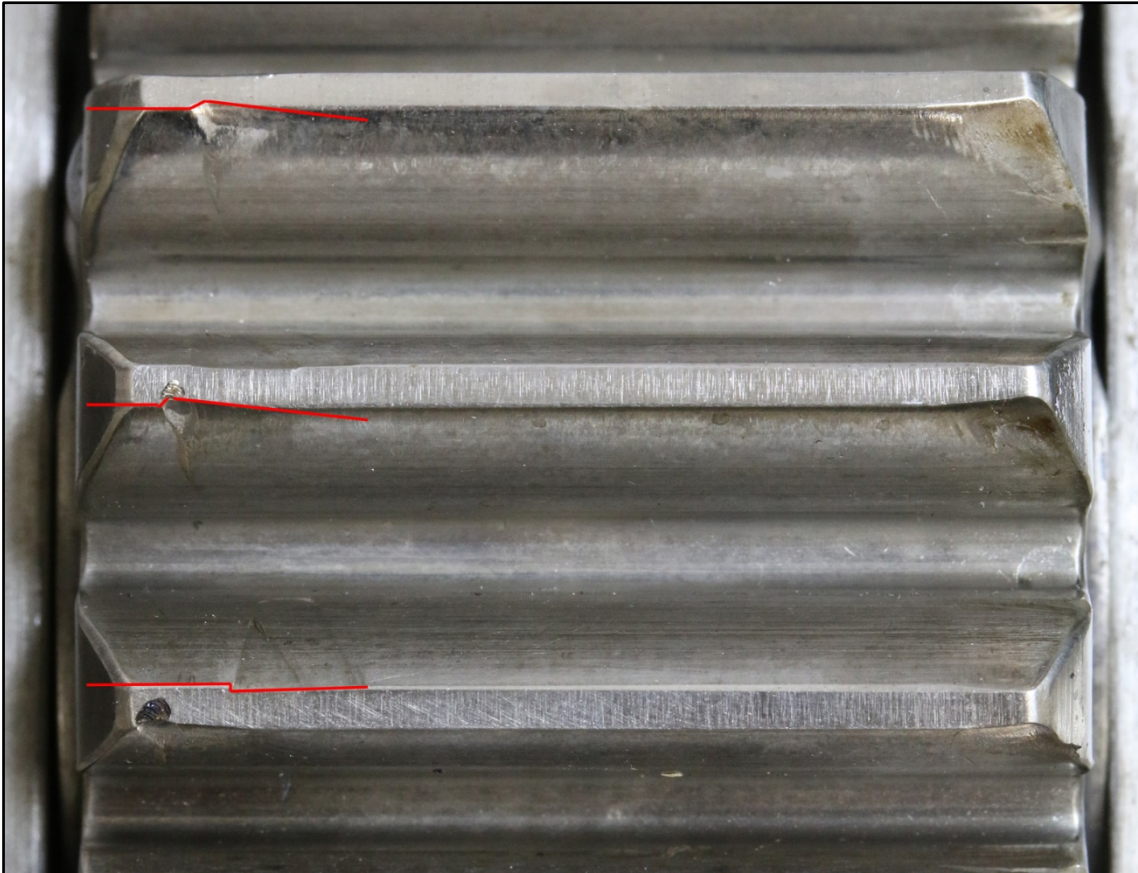
Figure 47: Left engine RGB stage-2 planetary tooth deformation

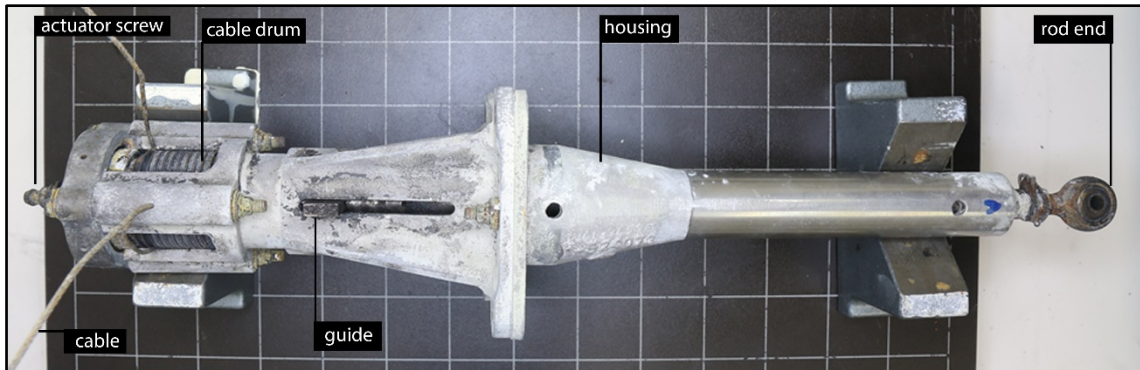
Figure 50: General view of the rudder trim actuator, as received from the accident site

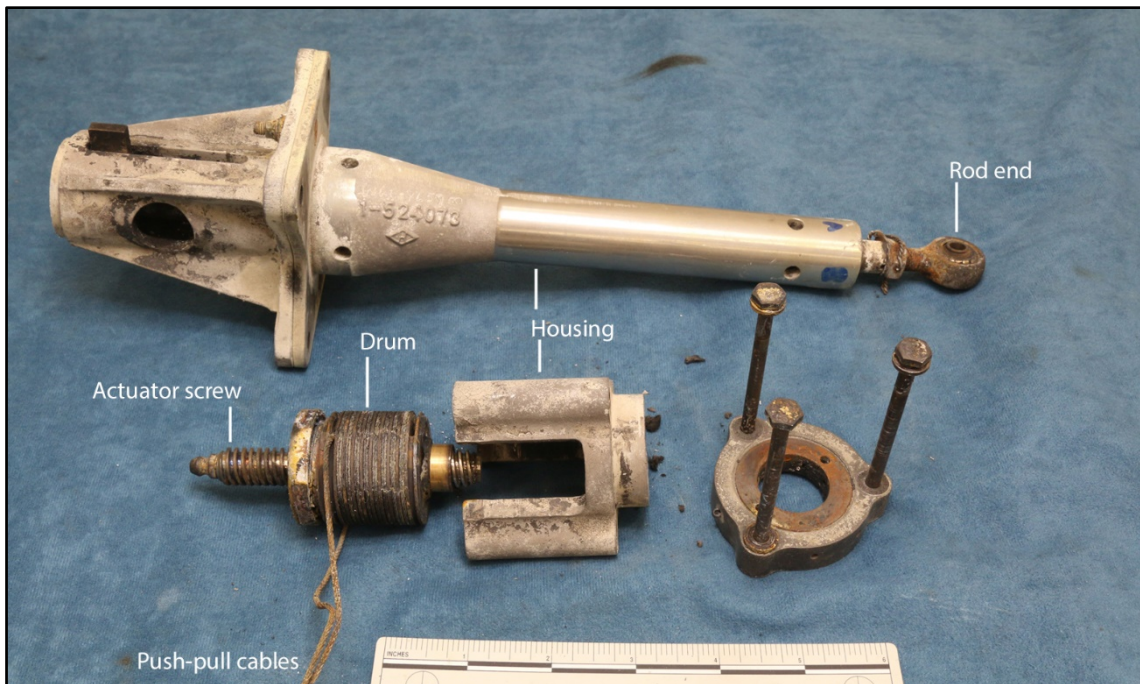
Figure 51: Disassembled and sectioned rudder trim actuator

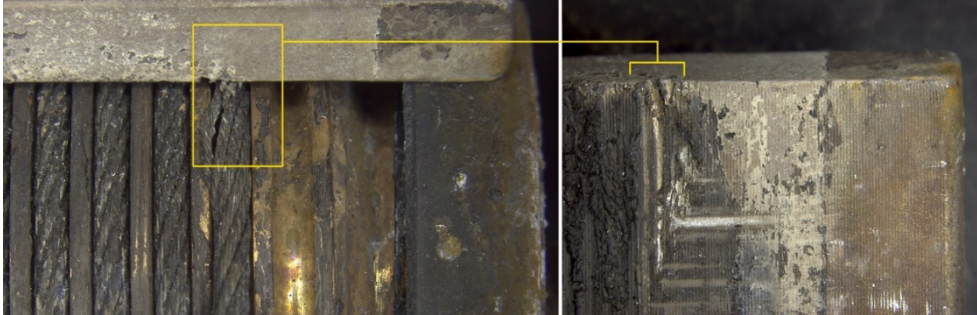
Figure 52: Actuator housing showing the location of the abrasion damage

Sliding contact from the right cable (left image) produced abrasion damage within the housing (right image).
Source: ATSB

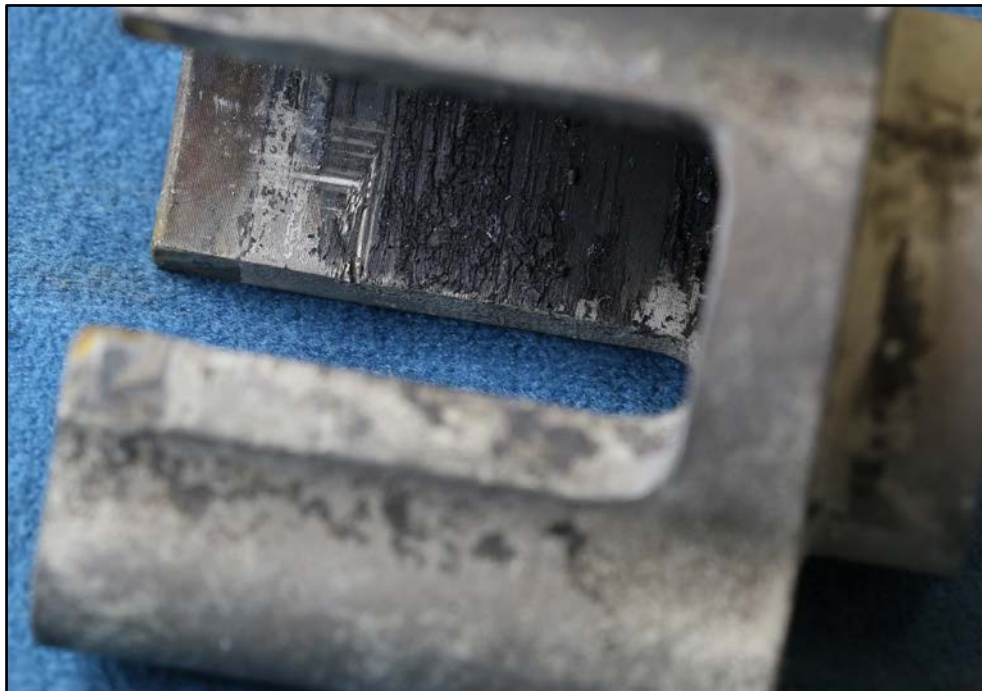
Figure 53: Abrasion damage to the housing attributed to sliding contact from the right cable

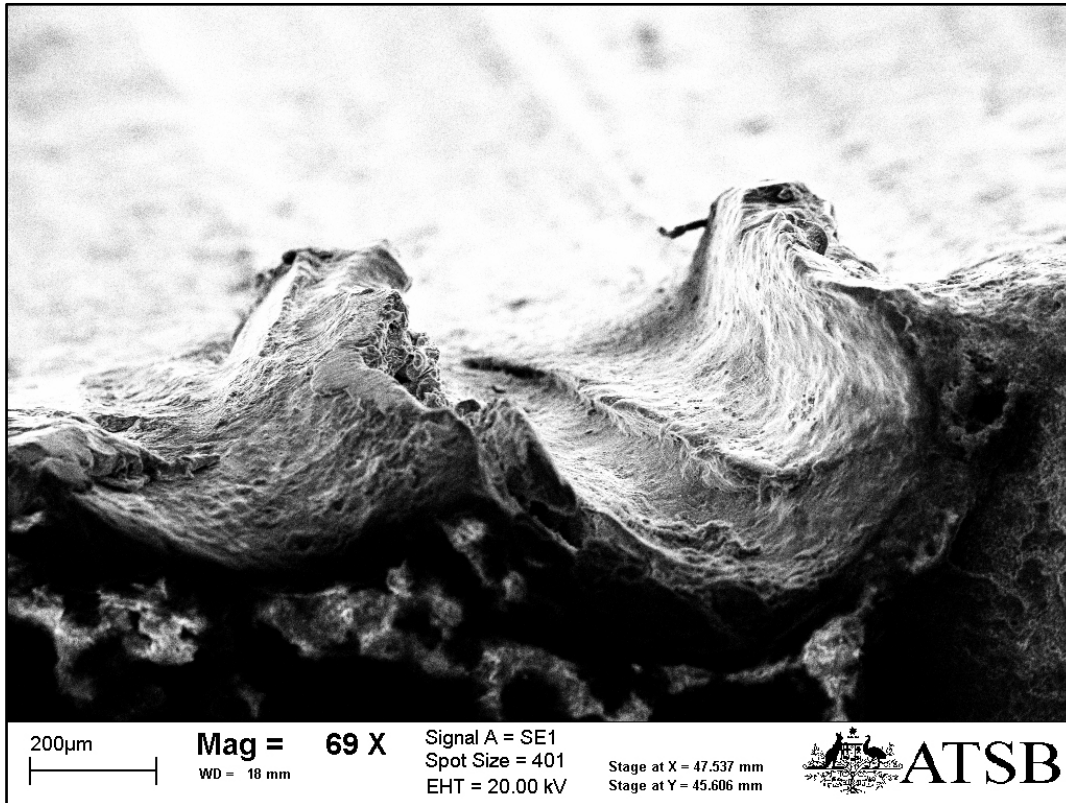
Figure 54: High magnification SEM image of the abrasion damage

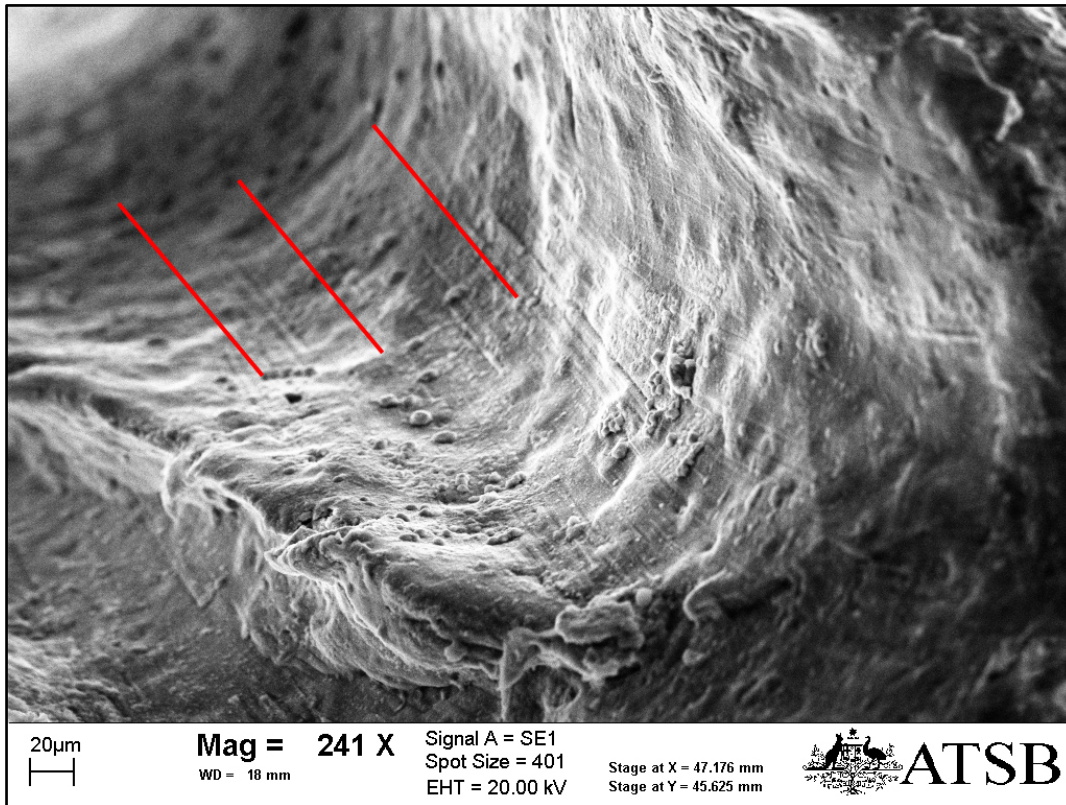
Figure 55: Higher magnification SEM image of the abrasion damage

The red lines highlight the abrasion and scoring resulting from sliding contact between the trim cable and the actuator housing.
Source: ATSB
