In-flight loss of propeller involving Saab 340B, VH-NRX

19 km (10 NM) SW of Sydney Airport, NSW | 17 March 2017

ATSB Transport Safety Report
Aviation Occurrence Investigation
AO-2017-032
Final – 10 October 2018

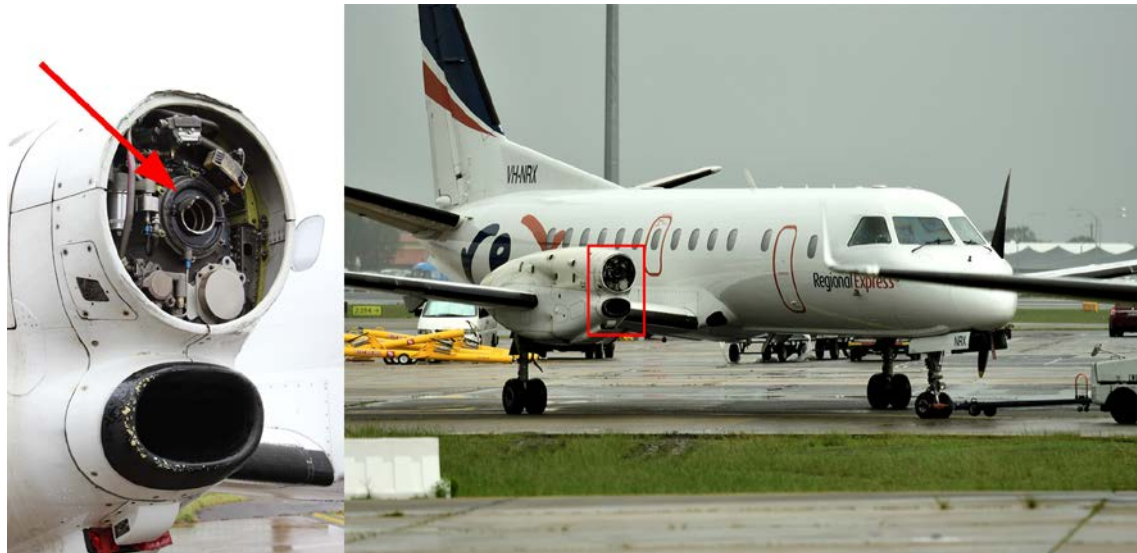
Figure 1: The aircraft, VH-NRX, at Sydney Airport after the incident showing the point of separation of the propeller in close-up

An inspection of the aircraft by the ATSB at Sydney Airport identified that the propeller shaft had fractured, leading to the separation of the propeller.

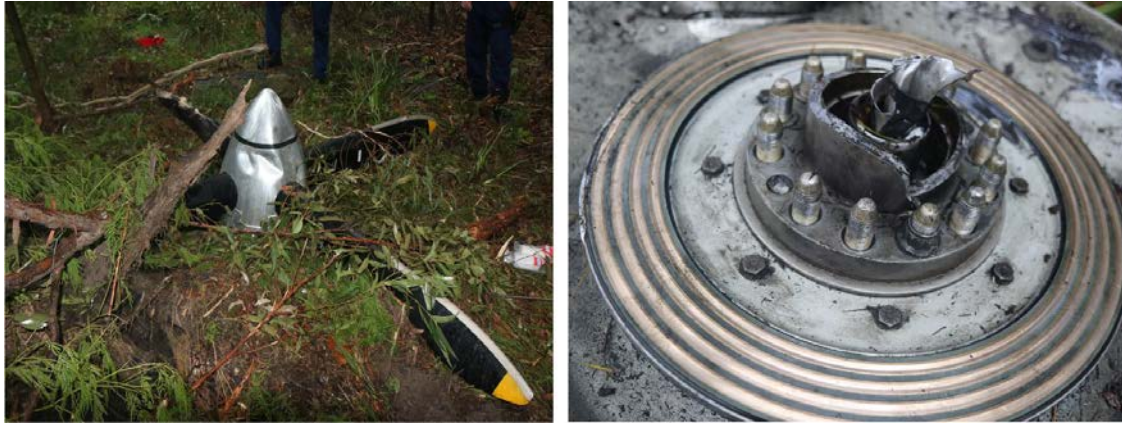
Figure 2: The separated propeller from VH-NRX

On 21 March 2017, the NSW Police Aviation Support Branch (PoAir) located the propeller in an area under dense forest about 19 km (10 NM) south-west of Sydney Airport. The propeller was found with the flange section of propeller shaft secured to the propeller assembly and a fracture through the propeller shaft (Figure 2).

The image on the left shows the propeller as found in bushland by PoAir about 10 NM south-west of Sydney airport. The image on the right shows the propeller flange still attached to the rear of the propeller. Note that the attachment nuts were in the process of being removed by ATSB investigators onsite, in order to release the flange. Source: ATSB

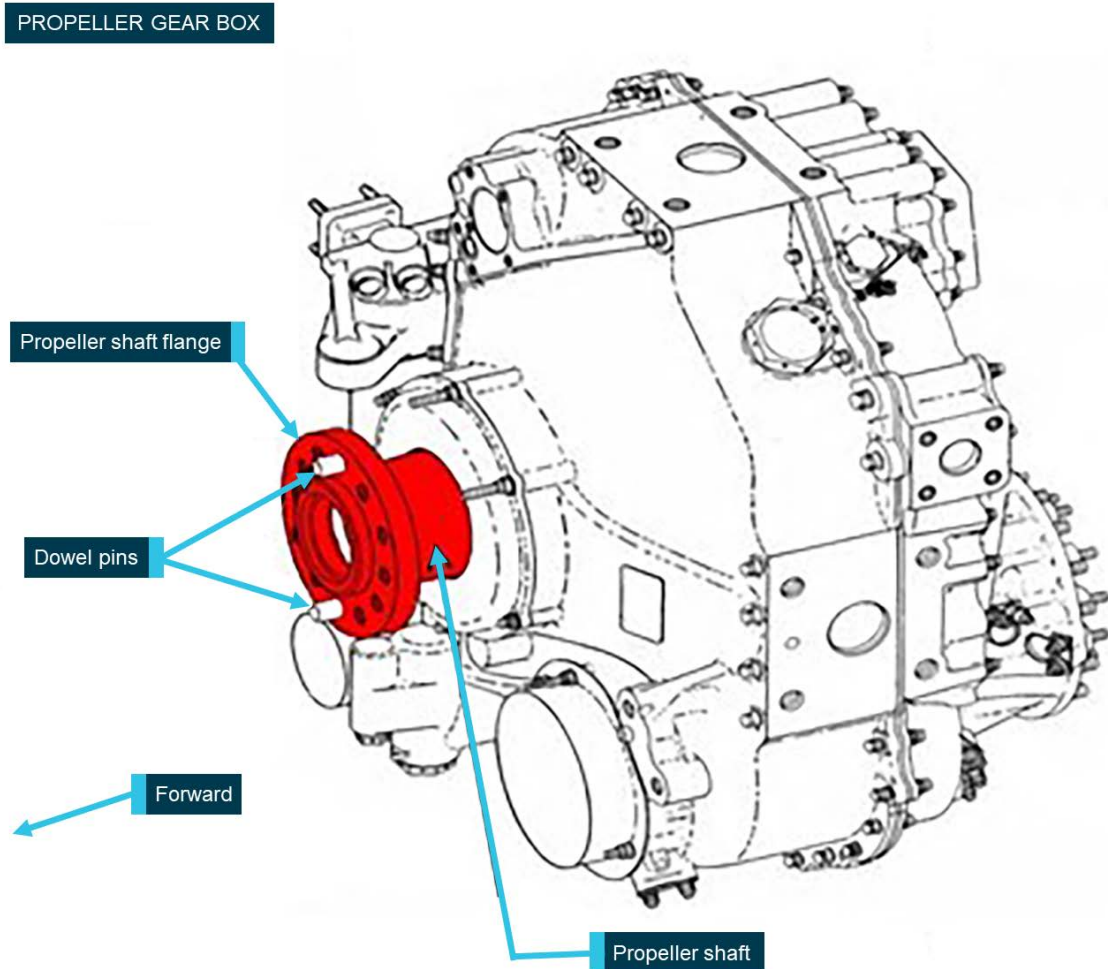
Figure 3: Propeller gearbox schematic highlighting the recovered section of the propeller shaft

The propeller separated due to cracking between the propeller main shaft and the flanged region (Figure 3) on the right side PGB.

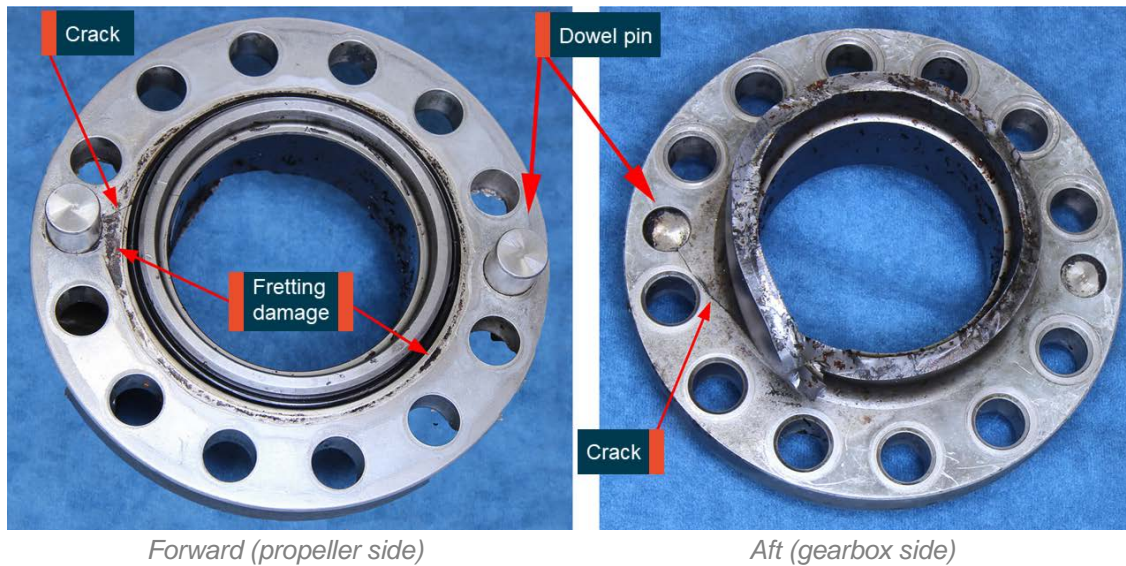
Figure 4: Separated shaft section in their as-received condition

Image shows that cracking was observed near one of the dowel pins and the fretting discolouration observed on the propeller side of the flange. Source: ATSB

Examination of the propeller flange section of the fractured shaft revealed cracking emanating from one of the dowel pin holes (Figure 4). The cracking had progressed through the flange thickness, transitioning into the shaft portion at an angle indicative of torsional loading, and ultimately resulted in shaft separation. The shaft fracture had deformed in a radial direction, which exposed some of the fracture face, and evidence of beachmarks typical of fatigue (cyclic) cracking were observed (Figure 5).

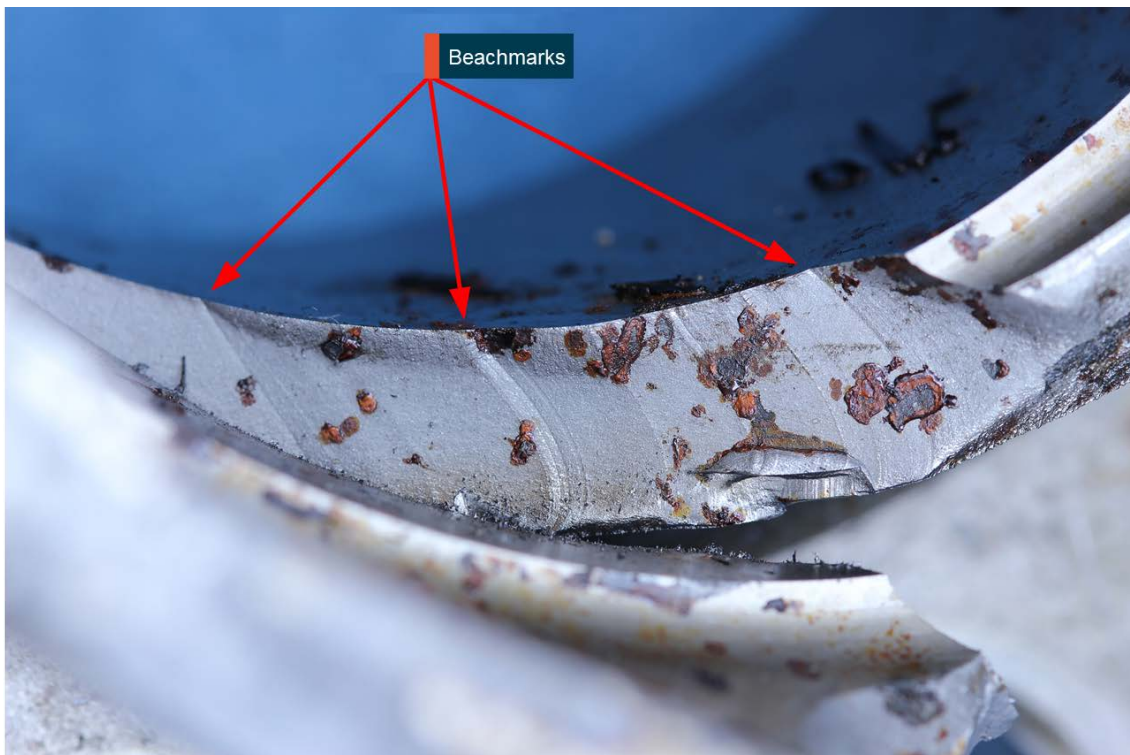
Figure 5: Section of the exposed propeller shaft showing beachmarks

Image shows the beachmarks on the fracture surface, which was indicative of a fatigue failure mechanism. Source: ATSB

The shaft failed as a result of a fatigue crack propagation that initiated at a dowel pin hole. The crack then propagated into the shaft in a torsional manner, before failing in overstress.

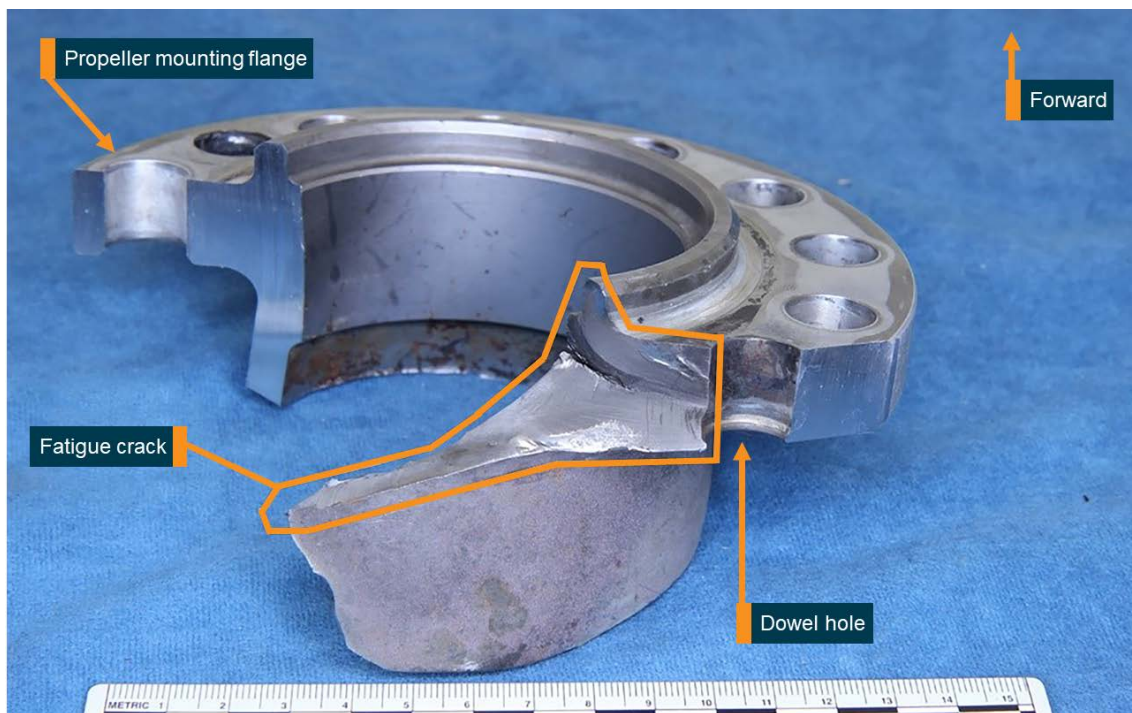
Figure 6: Section of the propeller shaft showing the fatigue crack progressing into the shaft

Following the initial visual examination, the sample was sectioned through the dowel pin holes in order to expose the fracture surface (Figure 6). Once opened, a discoloured initial fracture region consistent with fatigue was observed towards the forward flange face along with some discoloration of the dowel pin itself. The fatigue fracture itself had completely progressed through the flange thickness.

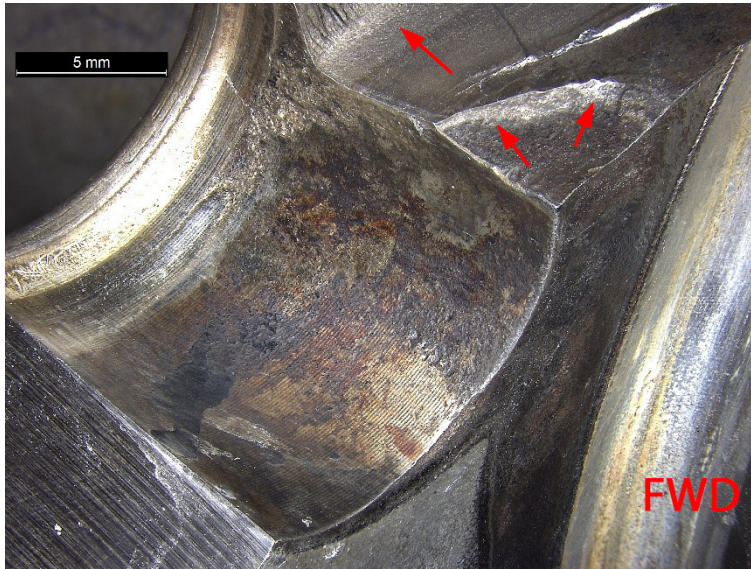
Figure 7: Corrosion observed within the bore of the dowel pin hole

The dowel pin bore was corroded in parts (shown in Figure 7), and corrosion pitting was found near the fracture. Cadmium (Cd) plating, normally present on the forward flange face, dowel pin hole surfaces and exposed propeller shaft, was missing within the dowel pin hole, with the exception of several streaks near the aft end of the hole.

Image show corrosion in bore, along with crack originating at the forward corner of the dowel pin hole (arrowed) Source: ATSB

Due to the corroded condition of the initial fracture surface, a definitive root cause for crack initiation could not be established, although corrosion within the dowel pin hole was believed to be a strong contributor to crack initiation. Analysis by General Electric indicated that the initiation of fatigue cracking of the flange may be associated with a combination of factors that include:

In September 2017, GE made changes to the maintenance manual, including the introduction of fluorescent penetrant inspection of the dowel pin areas, a clarification of the inspection criteria for corrosion, and the addition of photographs of the dowel pin area condition.

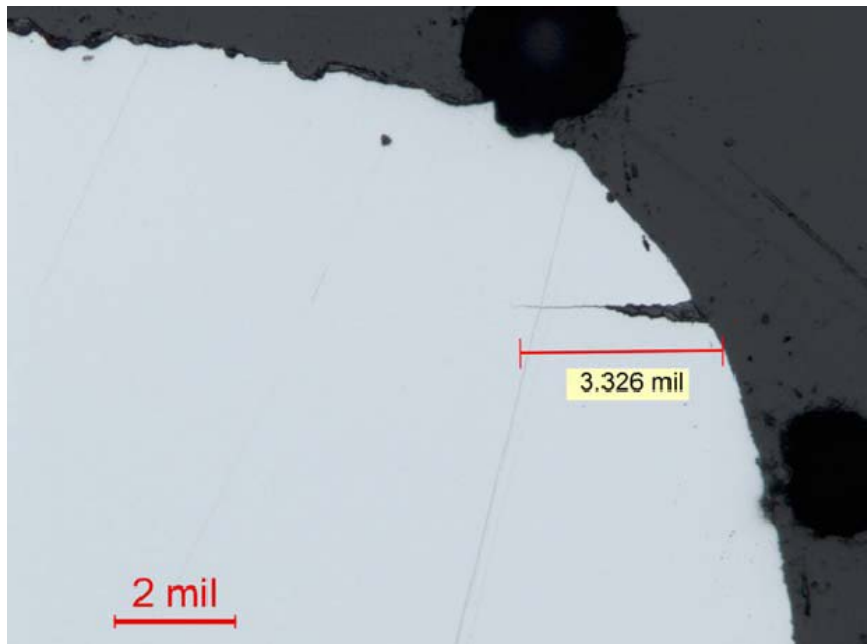
Figure 9: Metallographic cross section adjacent to the fracture surface showing secondary cracking

microstructure was tempered martensite, consistent with the material type in the correctly processed condition. However, the metallographic sections showed significant general surface corrosion, pitting corrosion and secondary cracking in the area adjacent to the primary fracture surface. Many of the shallow secondary cracks identified during a step polishing examination were filled with corrosion product (Figure 9). The presence of multiple shallow crack features supported crack initiation towards the forward dowel pin hole area.

The micrograph shows the secondary cracking extending from the dowel pin hole in the region adjacent to the primary fracture surface. Also, note the corroded initial fracture surface at the top of the image, and the rounded fracture edge. Note that 2 mil is approximately equal to 50 μm . The crack length in the image is approximately 84 μm in length. Source: GE

The presence of that significant secondary corrosion did, however, support either an initially slower moving crack or a crack that had arrested for some unquantifiable period allowing the corrosion to occur. The remaining, less damaged portion of the fracture surface was consistent with lower alternating stress, high cycle fatigue (HCF) mechanisms, ultimately leading to shaft separation.
