Collision with water involving Cessna 206 aircraft, VH-LHQ

Southport Broadwater, Queensland, 4 March 2018

ATSB Transport Safety Report
Aviation Occurrence Investigation
AO-2018-020
Final – 23 October 2018

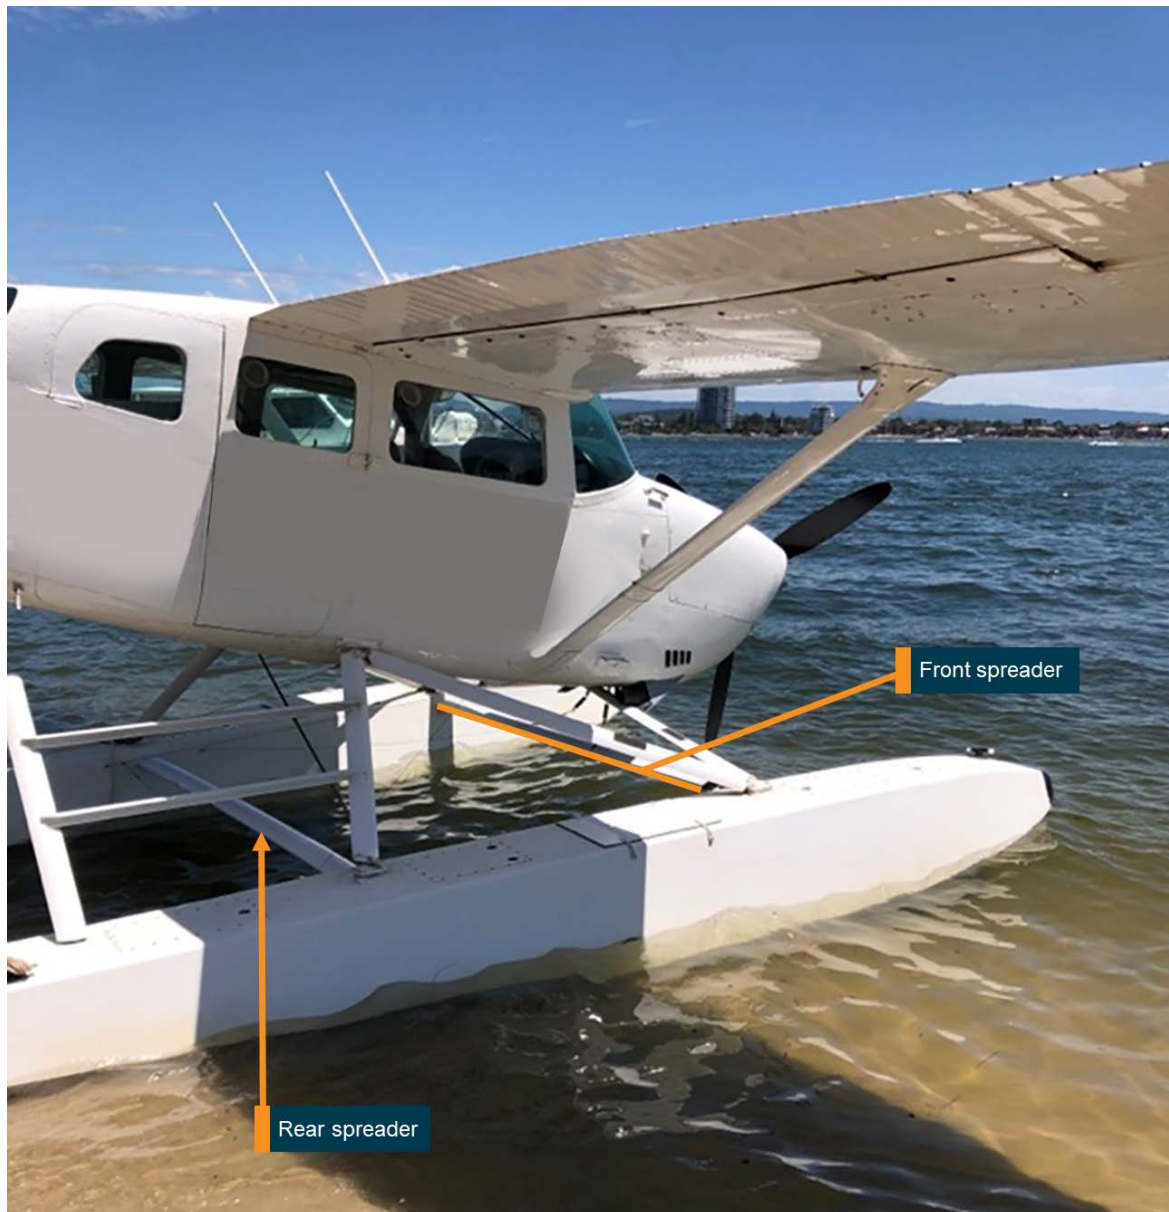
Figure 2: The damaged Cessna 206 aircraft

The aircraft came to a stop about 300 m from the shore. The pilot reminded the passengers of how to put on their life jackets, before he got out of the aircraft to assess the floats for damage. He found the front spreader bar of the floats had fractured but the floats were intact. As they were intact, he decided not to evacuate the passengers. No one had been injured.

After another couple of minutes, a voluntary marine rescue boat arrived at the scene, and arranged to tow the substantially damaged aircraft onto a nearby beach (Figure 2).

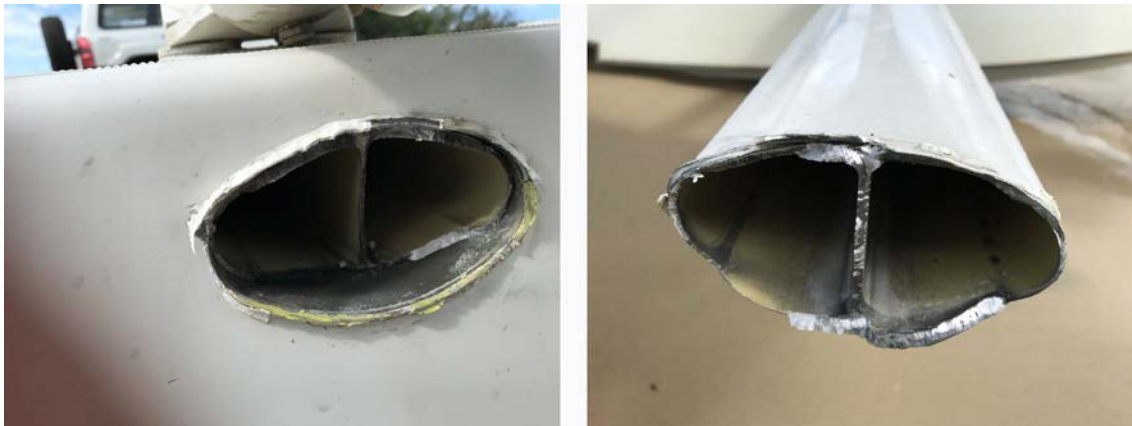
Figure 3: Front spreader bar fatigue failure located within the float

After the accident, the spreader bars were inspected and a fatigue crack was identified in the front spreader bar that had propagated to the point of failure. The failure was located about 3.5 cm inside the float so the fatigue crack was not visible (Figure 3). Cracks were also identified extending from the boltholes of the rear spreader bar. It could not be determined if these were a result of the accident or were pre-existing.

The spreader bars were returned to the manufacturer for further analysis. As a result of that analysis, the manufacturer reported that there was 'no apparent autogenous condition such as occlusions in the base material. It appears that repeated overloading of the float structure occurred leading to cracking in a difficult to detect location.'

The float system was designed and constructed with the spreader bar attached to a fitting within the float. This resulted in a section of the spreader bar that could not be visually inspected as it was also within the float. In this accident, the fatigue crack was located in that internal section of the spreader bar, which meant that it was not possible to visually identify it during normal operation and maintenance.

- During the take-off roll, the floatplane's front spreader bar fractured resulting in the floats separating and the aircraft pitching down sufficiently for the propeller to contact the water.
- The origin of the fracture was a fatigue crack in the spreader bar section located inside the float, which meant routine visual inspections could not have detected the crack.
- Frequent, short flights in an area of high water traffic exposed the floats and associated structure to high cyclic loading and stresses, increasing the likelihood of material fatigue.

- A borescope will be used to inspect spreader bars at intervals of 100 service hours.
- In addition to the 25 hourly inspection, the floats and hardware will be inspected while the floatplane is on the water. This will help to determine if there is any play in the fittings and hardware.
- Passenger loading has moved from Sea World Resort, to a location with a beach with less exposure to boat wake.
- Passengers and ropes will be used to keep the plane at a 90-degree angle to the water at all times when boat wakes are present. This will reduce uneven loading on the floats.

- A review of the take-off and landing areas and times will be carried out, to reduce rough and bouncy landings.
- The number of 5-minute scenic flights will be minimised to reduce the number of take-off and landing cycles.
- The end of day procedure will be modified to reduce stresses on the floats when loading the seaplane onto the storage trailer.
