Hard landing involving Kavanagh B-350 hot-air balloon, VH-EUA

6 km east-north-east of Yarra Glen, Victoria | 8 February 2018

ATSB Transport Safety Report

AO-2018-016

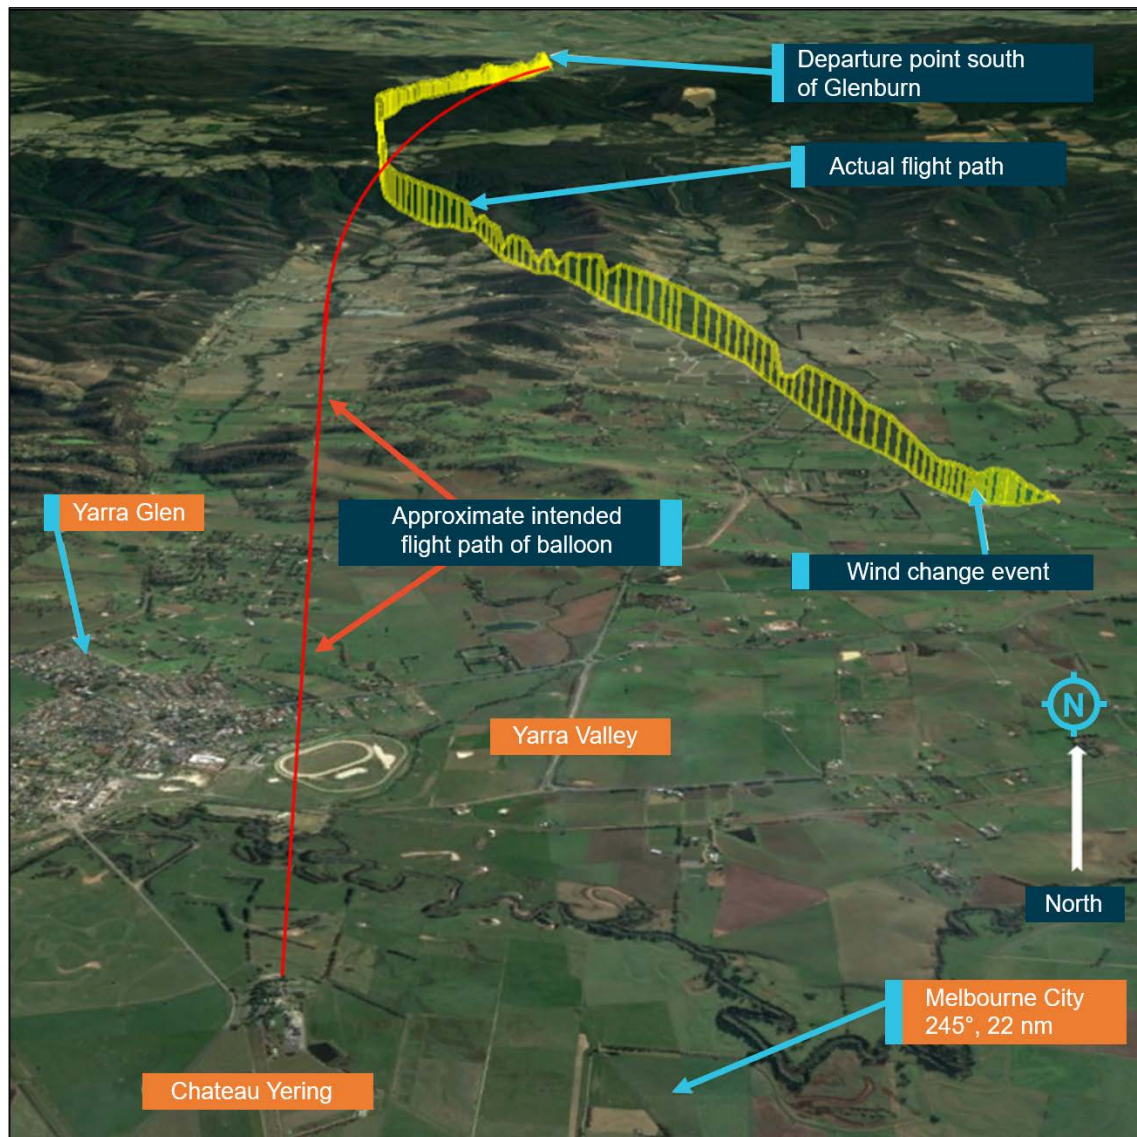
Figure 1: VH-EUA's approximate intended track (red) and actual flight path (yellow)

The pilot, ground crew and passengers met early at Chateau Yering Hotel, near Yarra Glen. The ground crew launched a pilot balloon (piball)¹ to measure surface and upper level winds. Based on the observations of the direction and speed of the piball, the pilot decided to take-off from a northerly launch site at Glenburn (Figure 1). Given the available forecasts and observations, the pilot's intention was to land back at Chateau Yering.

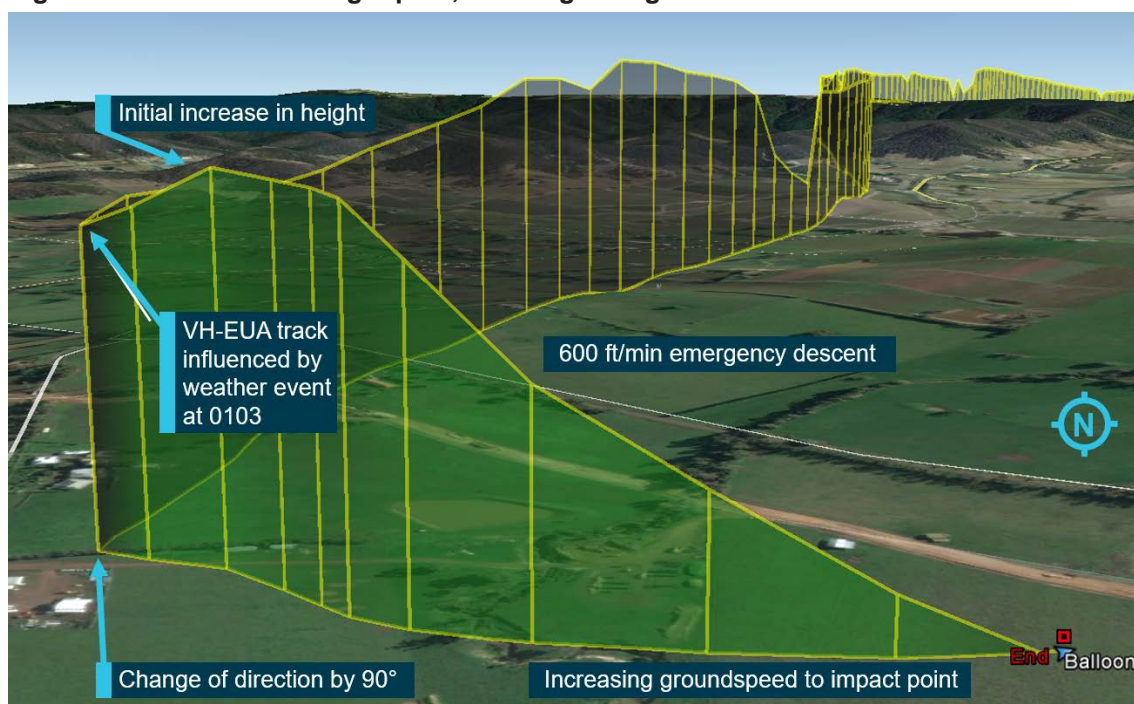
Figure 2: VH-EUA actual flight path, showing change in track due to wind

At 0703, when about 630 ft above ground level (AGL), the balloon encountered significant turbulence. There was also a significant change in the wind direction and speed, and the balloon started tracking about 90° to the left of its previous track (Figure 2).

Due to the turbulence associated with the wind change, the balloon initially increased altitude by 78 ft to 708 ft AGL (1,037 ft above mean sea level). Because of the turbulence, hot air inside the balloon canopy was forced out, reducing buoyancy and the balloon began to descend.

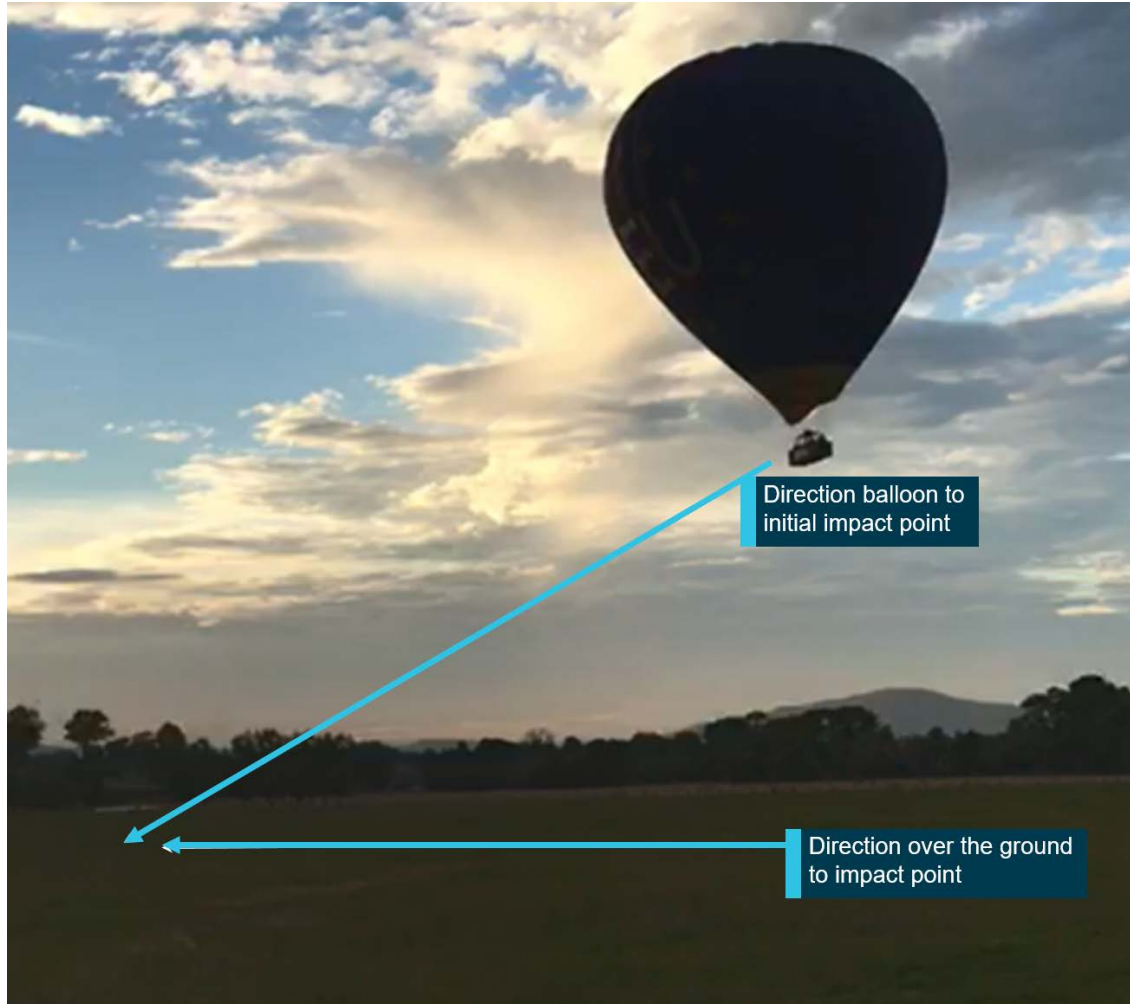
Figure 3: VH-EUA final descent profile

In the final stages of the flight (Figure 3), the balloon descended at about 600 ft/minute and accelerated to over a 16 kt⁴ groundspeed. Prior to impact, the pilot applied the burner, which reduced the descent rate to some extent. The pilot instructed the passengers to adopt the emergency landing position, but some passengers were initially confused about what to do.

On approaching the ground, the pilot turned the burners off and opened the vent at the top of the balloon to deflate the balloon envelope. The basket landed hard, and the deflating balloon envelope began to act like a sail. The basket then dragged for 48 m, and then became airborne for another 56 m. After a secondary hard landing, it tipped over and dragged for another 7 m before coming to rest on its side (Figure 4). The pilot isolated the gas and began to check on the passengers.

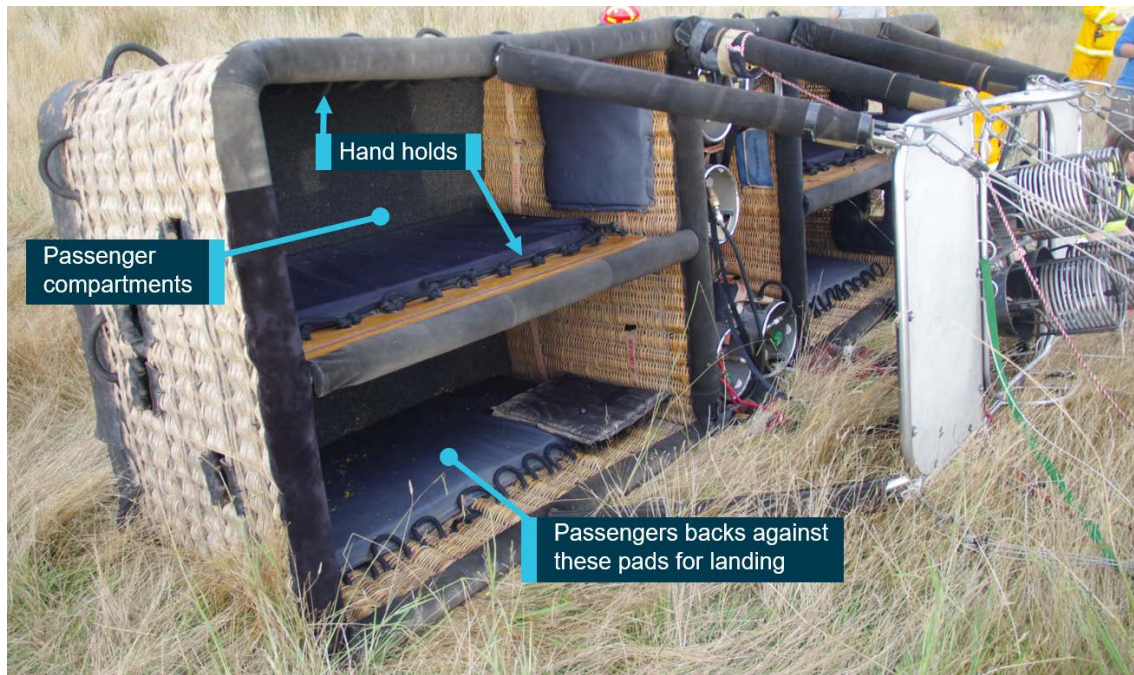
Figure 4: VH-EUA final resting position

Four passengers received serious injuries and seven received minor injuries. All of the serious injuries involved some form of spinal injury, three of which required hospitalisation. The balloon's basket sustained minor damage.

Some passengers reported that when instructed by the pilot to adopt the landing position, there was confusion about what position to adopt and the direction to face, with some passengers kneeling, sitting and/or facing the direction of travel. The non-English speaking passengers advised that they did not understand the pilot's instruction and copied the actions of other passengers. The pilot attempted to correct the passengers' landing positions, however, not all passengers were in the correct position on impact.
