# Tailstrike involving Boeing 737-800, VH-YIR

Auckland Airport, New Zealand, on 17 January 2018

**ATSB Transport Safety Report**  
Aviation Occurrence Investigation  
AO-2018-011  
Final – 8 November 2018

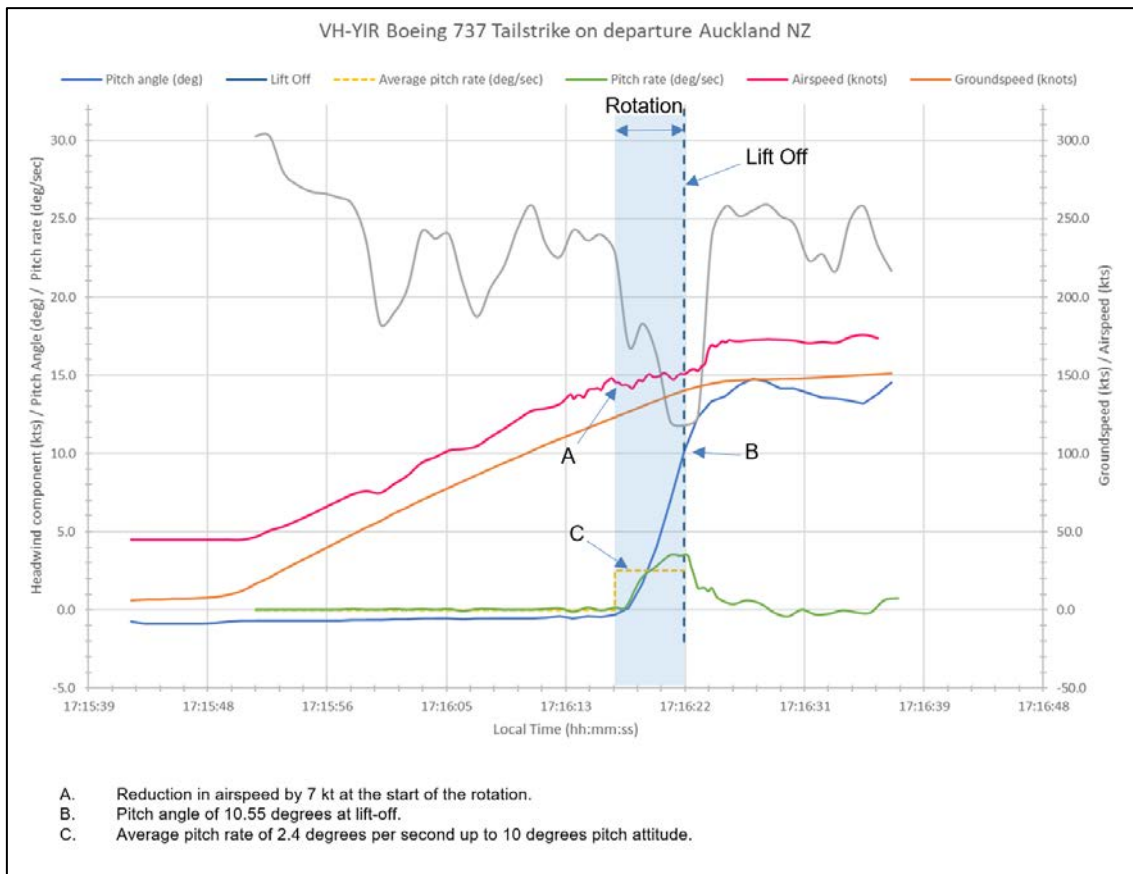
Figure 1: VH-YIR take-off data

Analysis of flight data from the aircraft's digital flight data recorder indicated the rotation occurred in gusty conditions with aircraft speed reducing during rotation. The data showed:

- a reduction in airspeed of 7 knots (Figure 1), followed by a stagnation in airspeed (the groundspeed continued to increase over this period, indicating the change in airspeed was a result of the variation in headwind component, which reduced by up to 11 knots during rotation)
- at lift-off, the pitch attitude of the aircraft was 10.55°
- maximum pitch rate during the rotation was 3.5° per second
- the average pitch rate during rotation was 2.4° per second
- the aircraft was slow to lift-off the runway (6 seconds from the point of initial rotation).

Analysis of the flight data determined that, during rotation, as the aircraft continued to accelerate, a reduction in headwind resulted in an initial drop and then stagnation in airspeed until just after lift-off. The airspeed variations were reportedly not identified and called out by the PM, as required in the flight crew training manual. Stagnation in airspeed at rotation had a similar effect to that of rotating too early: reduced lift and an extended the take-off roll, as confirmed by the flight data. The continued rotation with the main landing gear remaining on the runway then resulted in a reduced tail clearance.

- A decrease in the headwind component reduced the airspeed during rotation and extended the time required for VH-YIR to leave the runway, resulting in a reduced tail clearance and subsequent tailstrike.
