Collision with terrain involving Air Tractor AT-502, VH-LIK

50 km east of Walgett Airport, NSW | 5 November 2016

ATSB Transport Safety Report
Aviation Occurrence Investigation
AO-2016-146
Final – 20 November 2018

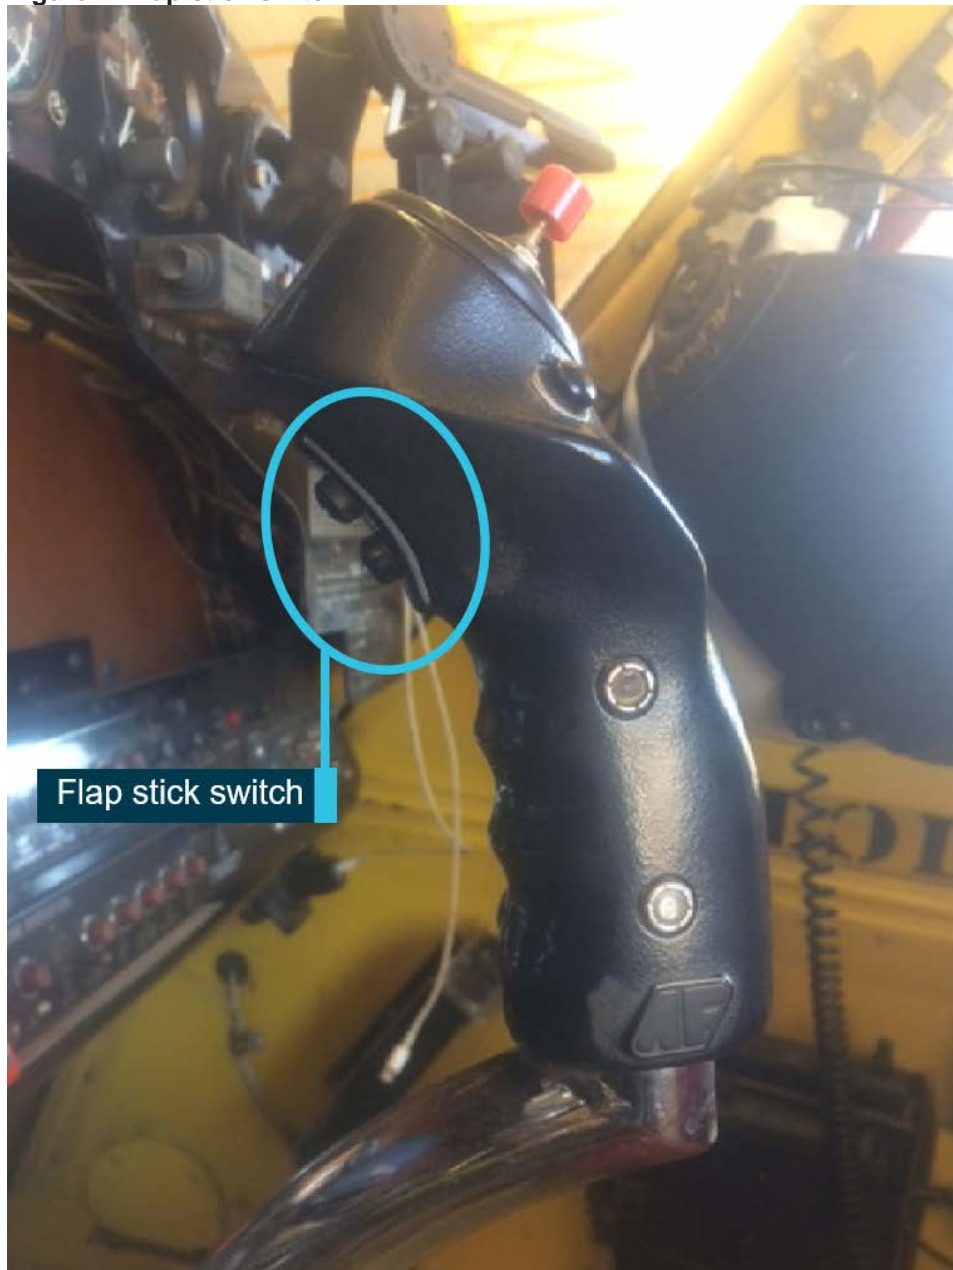
Figure 1: Flap stick switch

In Australia, it is common to fit an additional flap switch in accordance with an engineering order. The setup comprises either a rocker switch or, in the case of LIK, two buttons on the control stick (Figure 1). This allows the flaps to be operated with the pilot's right hand, leaving the left hand free to operate the throttle and/or dump lever.

The flaps may have been extended at the start of the take-off run but then retracted at some point during the flight. It was considered unlikely that the pilot would have deliberately retracted the flaps during the take-off, given his experience and knowledge of performance degradation that would have ensued. Previous occurrences have shown that it was possible to inadvertently retract the flaps using the flap stick switch however, there was insufficient evidence to determine if that occurred.

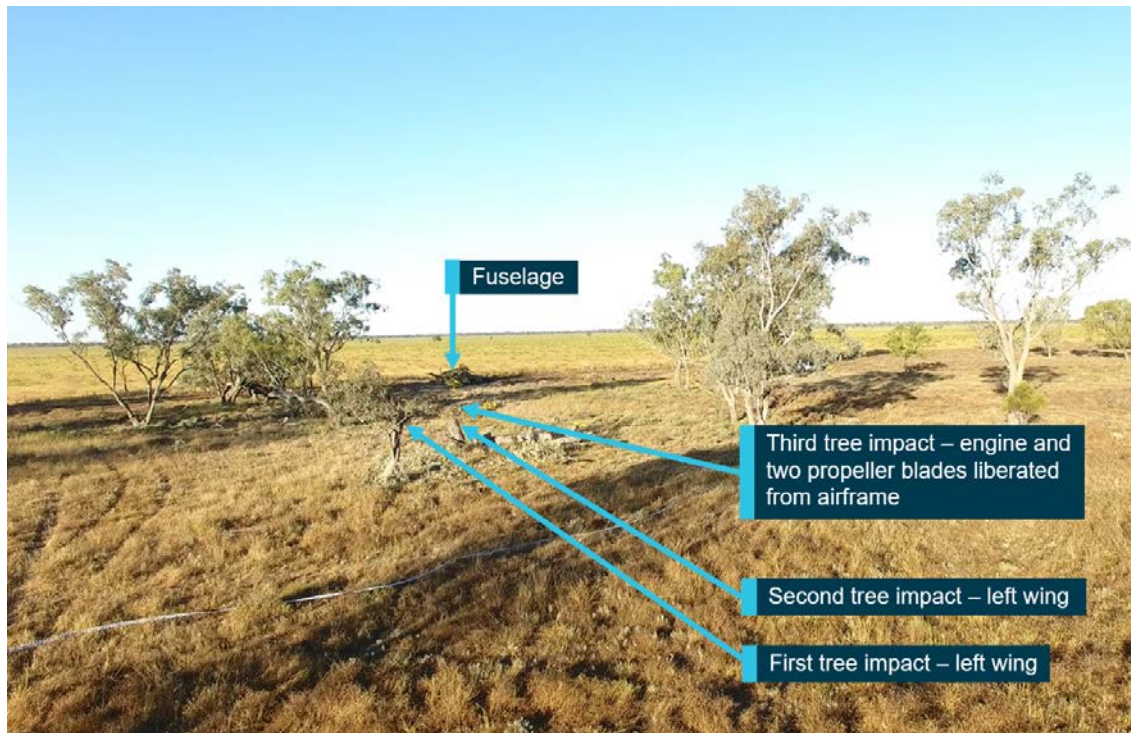
Figure 7: Accident site showing tree impacts

Having failed to gain any significant altitude, the aircraft clipped the top of a fence about 1,300 m beyond the start of the runway. The aircraft subsequently descended and collided with trees and the ground a further 700 m along the flightpath. Despite the impact and fire damage to the aircraft, there was no evidence of failure of the engine, or structural failure of the aircraft that may have contributed to the accident. The pilot was suitably qualified and experienced in low-level and agricultural operations and the investigation did not identify any preconditions with the pilot that may have contributed to the accident.

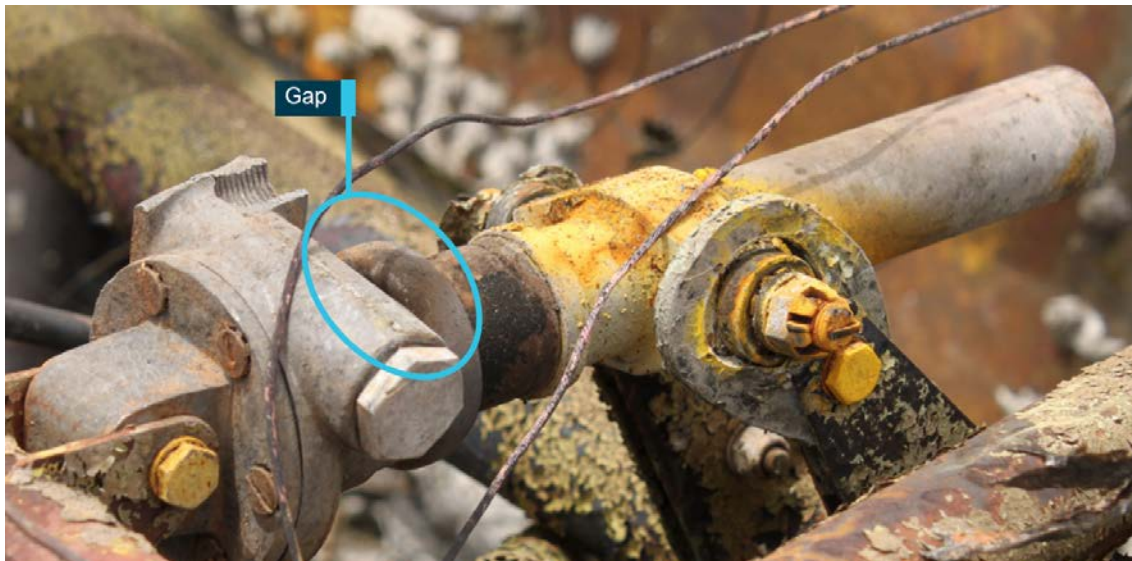
Figure 8: Flap actuator

The flap actuator was in the fully retracted position (Figure 8) and the flap actuator motor had broken free from the gearbox.

When fully retracted, the manufacturer specified that there should be a gap of 1/16" to 1/8" (1.6-3.2 mm) between the striker and the end of the up travel. If the flap micro-switch is not set correctly, and the gap is insufficient, the flap motor may stop the 'up' travel. If this occurs, it can jam the actuator and prevent the flaps from extending. An appropriate gap was identified on the occurrence actuator. The aircraft's maintenance records indicate that the aircraft had flown 150 hours without any related issues since the flap micro-switch was set.

There was one known means for the flaps to retract uncommanded. That is, if the rubber coupling in the flap actuator perished (as per Air Tractor Service Letter 260), which should be inspected for during scheduled maintenance. The condition of the coupling prior to the accident was unable to be assessed, however, based on previous occurrences, the likelihood of this occurring was considered low.

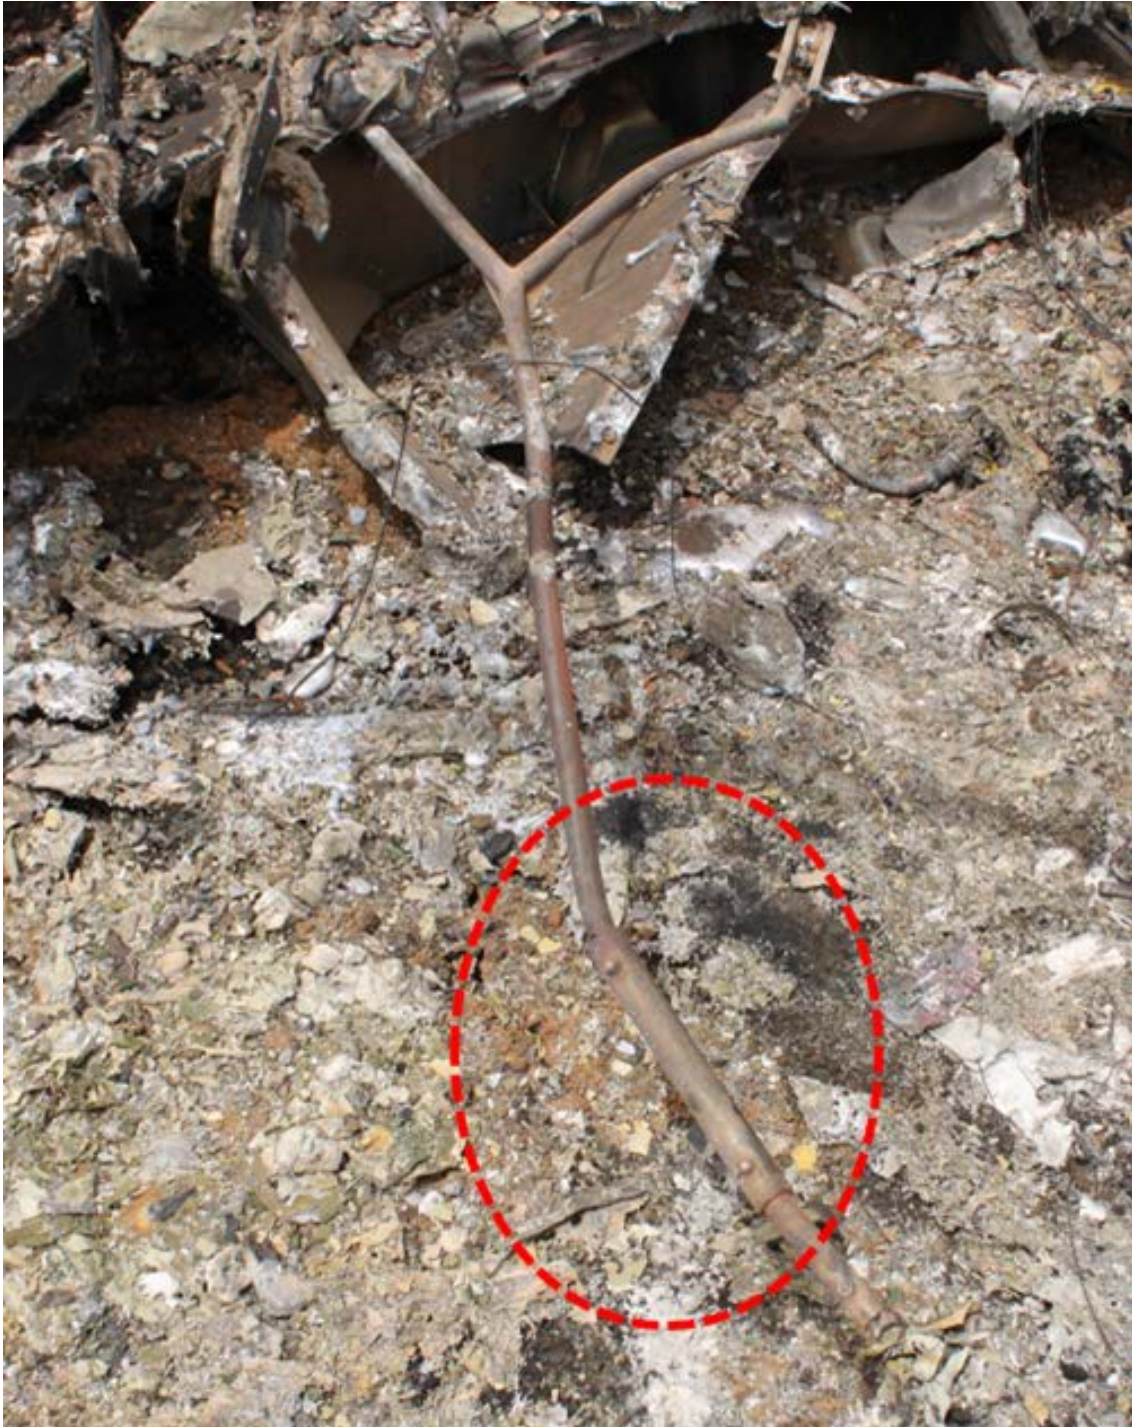
Figure 9: Gate box push rod showing modification

A modification, involving a sleeve bolted to the hopper gate box push rod, was identified during the wreckage examination (Figure 9). No documentation for the modification was available and therefore an assessment of its suitability could not be made. However, the operator advised that the modification had been made to extend the rod, and that the aircraft had flown over 10,000 hours since, without any issue relating to the dump mechanism. The push rod was bent at the sleeve modification but it had not fractured. It was likely that the damage was a result of the accident impact. The hopper gate mechanism had been used in this configuration during spreading operations and cleaning.

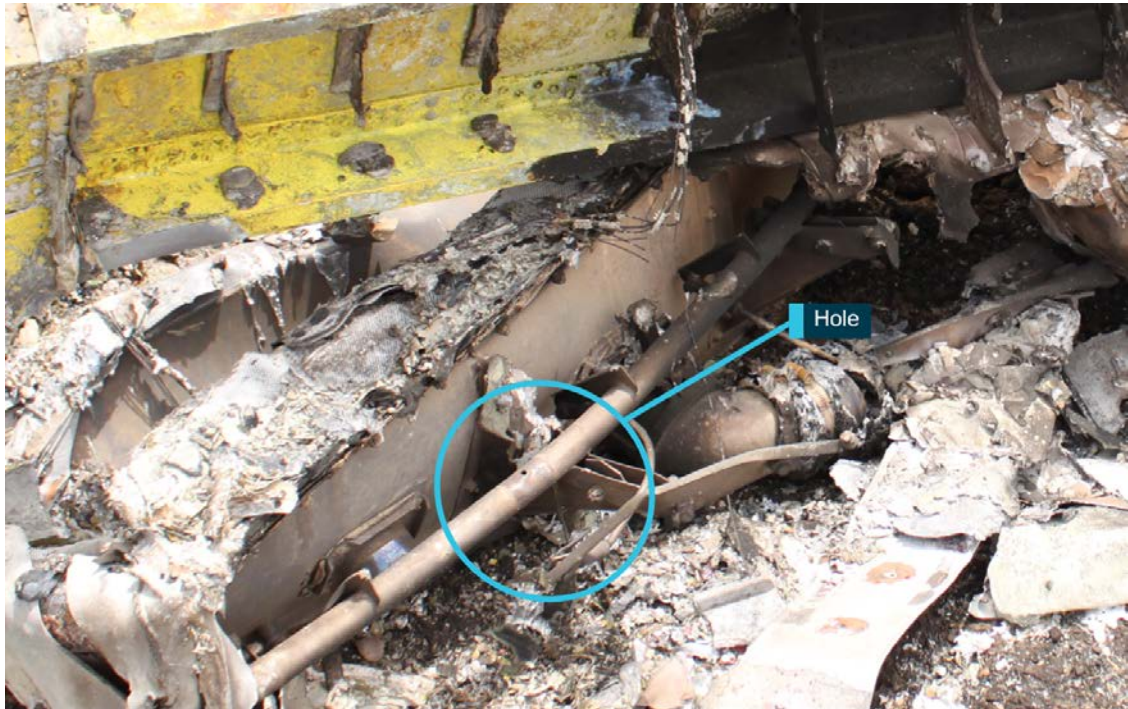
Figure 10: Gate box wreckage showing hole in gate box torque tube where bolt was missing

Examination also identified that a bolt was missing from one of two gate box push rod attachments (Figures 10 and 11). The bolt was not recovered and therefore the failure mode could not be assessed. The aircraft manufacturer advised that those bolts and clamps were known to separate from the torque tube during the majority of impact sequences. In any event, testing showed that failure or absence of one of the bolts would not prevent the transfer of sufficient force to open the hopper door, providing the associated clamp was tightened securely.

Check gatebox controls and emergency dump controls for proper function and adjustment. Check all components and hardware for condition, wear, and/or cracking.
