Wirestrike and collision with terrain involving Cessna 172RG, VH-LCZ

Parafield Airport, South Australia, 3 July 2018

ATSB Transport Safety Report
Aviation Occurrence Investigation
AO-2018-050
Final – 17 December 2018

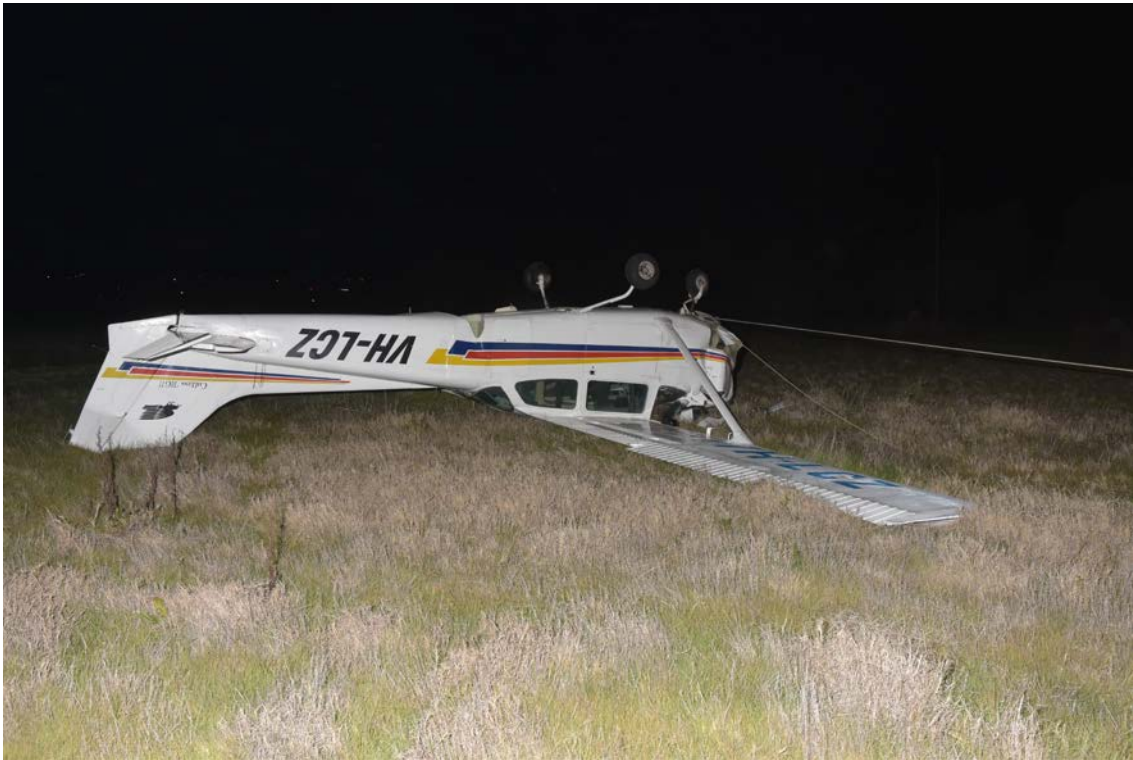
At about 1758, the pilot declared a PAN³ and informed ATC that he was unable to make the runway. The pilot recalled that he had sighted an unlit area ahead, which he assumed to be an open space. He turned the aircraft towards that area and pitched the nose down to achieve the airspeed associated with the maximum glide distance. The pilot reported that, as the aircraft approached the open space, he heard the fuselage hitting treetops. Seconds later, the aircraft stopped abruptly as the nose wheel struck a power line and it then collided with the ground (Figure 1).

Figure 1: Aircraft wreckage (note power line fouling the nose wheel)

- On final approach, the engine of VH-LCZ failed, likely due to carburettor icing.
- The engine failed at a position during the final approach that did not permit the aircraft to glide to the runway and afforded limited alternative landing area options.
- While descending during the forced landing at night, the aircraft struck a power line and then collided with terrain, resulting in minor injury to the pilot and substantial damage to the aircraft.

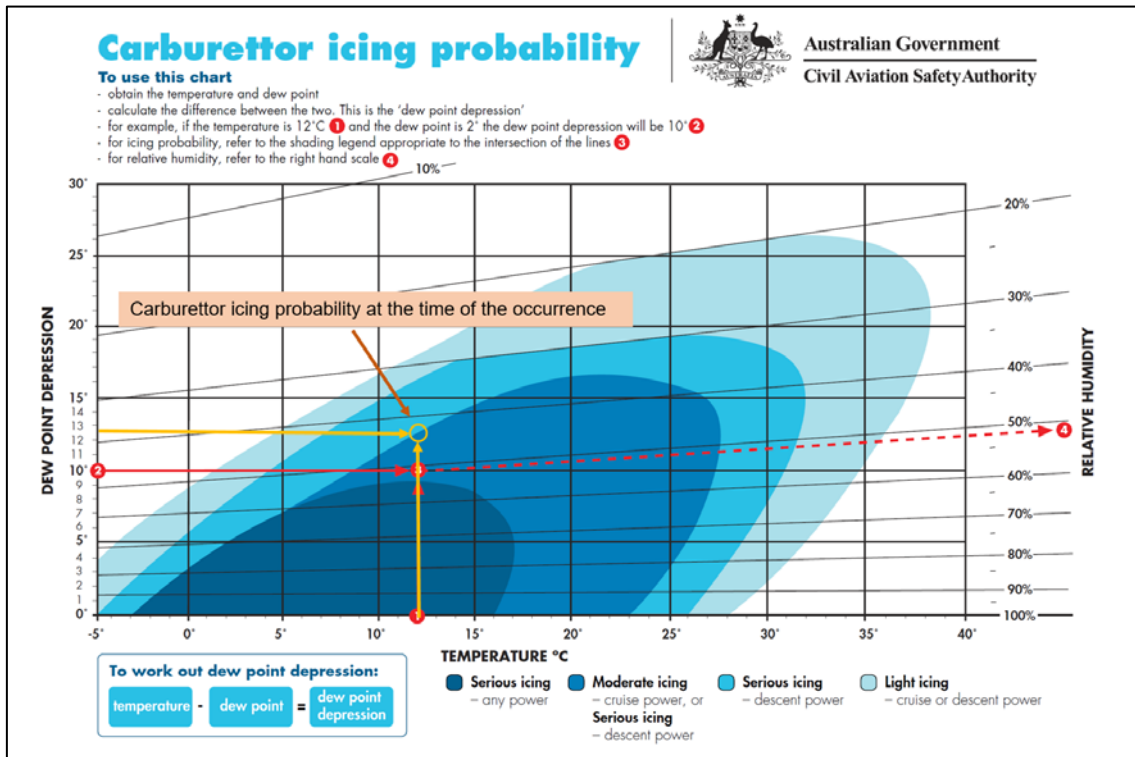
Weather observations recorded by the Bureau of Meteorology at Parafield Airport indicated a temperature of 12.2° C and a dew point⁴ of -0.6° C at the time of the accident. Figure 2 (see annotation in yellow) shows that these meteorological conditions presented a risk of moderate icing when using cruise power and serious icing when using descent power. At the time of the power loss, the engine was operating at descent power.

Figure 2: Carburettor icing probability

Contrary to the guidance in the POH, the pilot reported that he did not apply carburettor heat while descending to the runway during any of the circuits. This combined with weather conditions conducive to severe carburettor icing at descent power made it likely that the power loss was due to the accumulation of carburettor ice.

The routine application of carburettor heat during the period between the base turn point and late in the final approach will significantly reduce the potential for an ice-related power loss. More information regarding carburettor icing can be found in the ATSB report, [The ongoing danger of carburettor icing](#).
