Hard landing involving Robinson R44 II, VH-LGN

Channel Point, Northern Territory, 18 August 2017

ATSB Transport Safety Report
Aviation Occurrence Investigation
AO-2017-086
Final – 4 December 2018

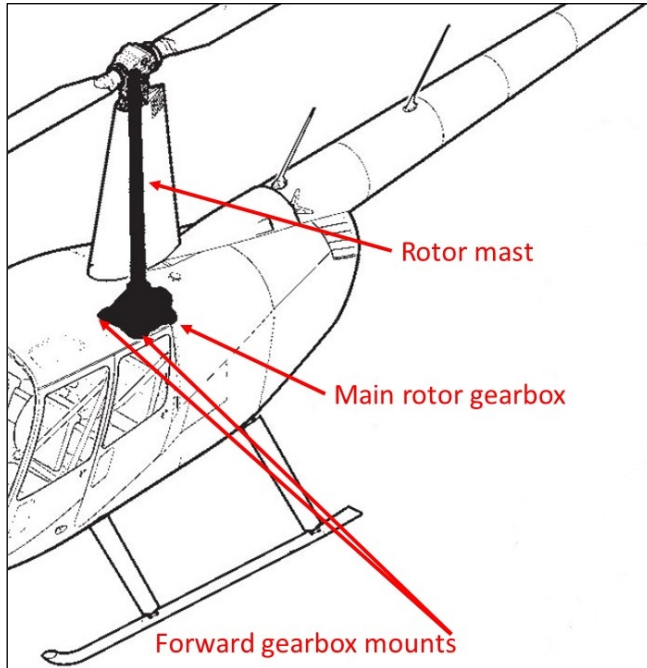
Based on information provided by Robinson Helicopters, the NTSB report indicated that the oscillation was associated with fore and aft movement of the rotor mast (Figure 1). The manufacturer had conducted flight tests related to the oscillations and determined that they 'may develop during operation at high gross weight, at about 90-100 kt airspeed'. Additionally, the tendency to develop oscillations was exacerbated by flying with a forward centre of gravity (although still within the approved envelope) and by entering a 30° left banked turn. A right banked turn could also exacerbate the oscillation, but it was more easily initiated in a left turn.

The mast oscillation was attributed to lack of firmness of newly-installed gearbox mounts and the manufacturer introduced stiffer mounts (part number A653-2) in June 2007 to counter the problem. The rubber in the mounts was found to harden with heat and compression during service and the issue was therefore more likely to affect low-hour helicopters. As such, there was only a requirement to change to the new, stiffer mounts during routine replacement of the original (A653-1) parts.

Figure 1: Location of the main rotor gearbox and forward gearbox mounts

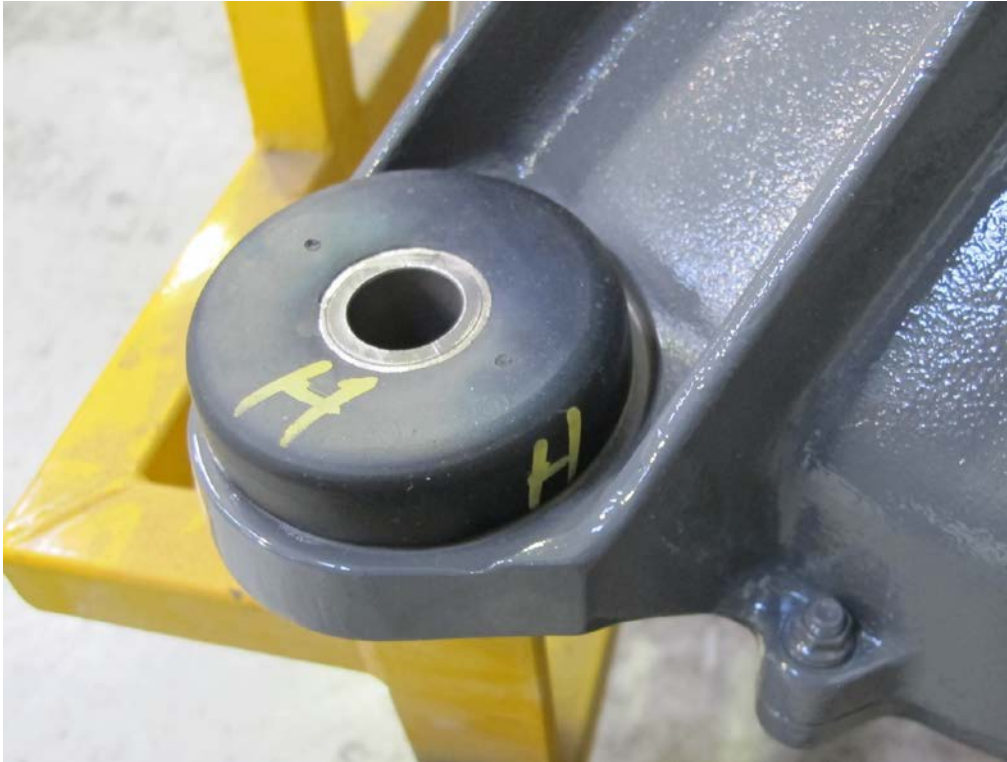
Review of maintenance documentation showed that VH-LGN had 1,609 hours total time in service and 45 hours since the last 100-hour inspection on 14 July 2017. The airframe logbook indicated that replacement of the main rotor gearbox transmission mounts was conducted at that service. The airframe logbook recorded that the forward main rotor gearbox transmission mounts were replaced with the incorrect (superseded) part number A653-1, instead of the required A653-2 parts.

The A653-1 and A653-2 parts were the same size and shape. They were distinguished by the -2 parts having a large, handwritten 'H' in yellow ink on the top and edge of the mount (Figure 2), in addition to the labelling on the parts' packaging. The availability of the -1 part was due to their continued installation on the smaller, Robinson R22 helicopters. The engineer who had changed the mounts had referenced the correct maintenance information at the time, but was unable to recall or reconcile the circumstances that resulted in him obtaining and fitting the incorrect part number mounts.

Figure 2: A653-2 gearbox mount installed

Incorrect forward main rotor gearbox mounts were installed in the R44 helicopter during recent maintenance. The manufacturer had previously found that these softer forward gearbox mounts increased the likelihood of the onset of oscillations associated with mast rocking in Robinson R44 helicopters. The onset of the airframe oscillations experienced by the pilot in this occurrence were therefore consistent with the manufacturer's findings.

The circumstances that resulted in the installation of the incorrect parts was not clear. However, this type of error highlights the importance of extra vigilance around visually and dimensionally-similar parts.
