Collision with water involving de Havilland Canada DHC-2 Mk 1 (Beaver), VH-NOO

Jerusalem Bay (Hawkesbury River), New South Wales, on 31 December 2017

ATSB Transport Safety Report
Aviation Occurrence Investigation
AO-2017-118
Interim – 20 December 2018

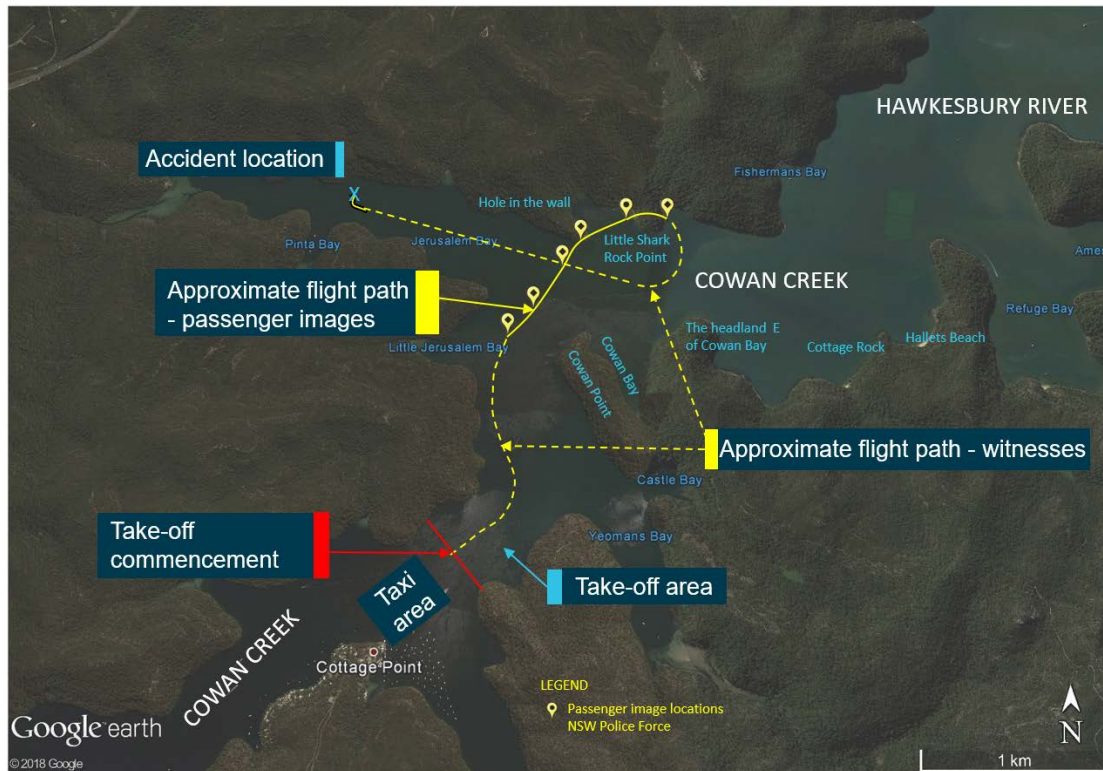
Figure 4: Cottage Point area, established flight path and accident location

Shortly after entering Jerusalem Bay, numerous witnesses reported seeing the aircraft suddenly enter a steep⁵ right turn and the aircraft's nose suddenly drop before the aircraft collided with the water in a near vertical position. The aircraft came to rest inverted and with the cabin submerged. Witnesses reported the entire tail section and parts of both floats were initially above the waterline. The aircraft took over 10 minutes to completely submerge. A number of witnesses who heard or observed the impact responded to render assistance. All six occupants received fatal injuries.

VH-NOO travelled about 1.75 km from the end of the right turn near Little Shark Point to the steep right turn in Jerusalem Bay.

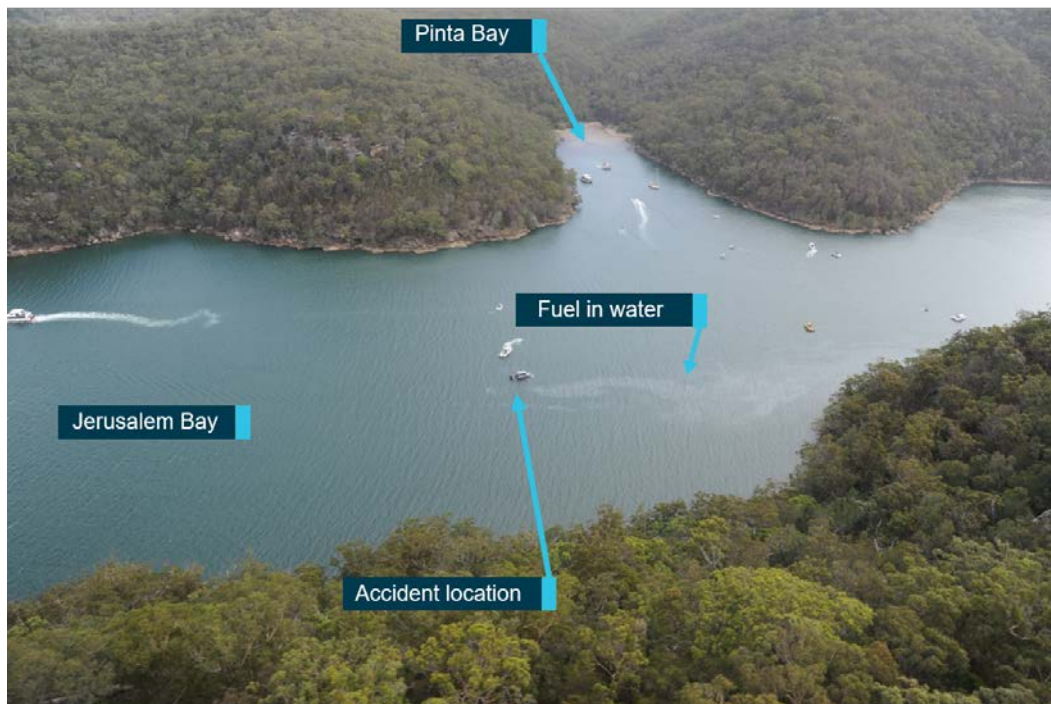
Figure 15: VH-NOO accident location in Jerusalem Bay

The aircraft came to rest upside down on the floor of Jerusalem Bay. The wreckage was located near the entrance to Pinta Bay (Figure 15) at a depth of about 14 m. A significant quantity of fuel leaked from the aircraft and was observed in the water. On 4 January 2018, the aircraft was recovered from the water, where it was established that both wings and floats had become separated from the fuselage with the left wing located about 75 m East of the main wreckage (fuselage, tail, engine, floats and right wing). The aircraft was retrieved during three 'secure and lift' operations undertaken by the NSW Police Diving Unit and a barge operated crane crew. These were:

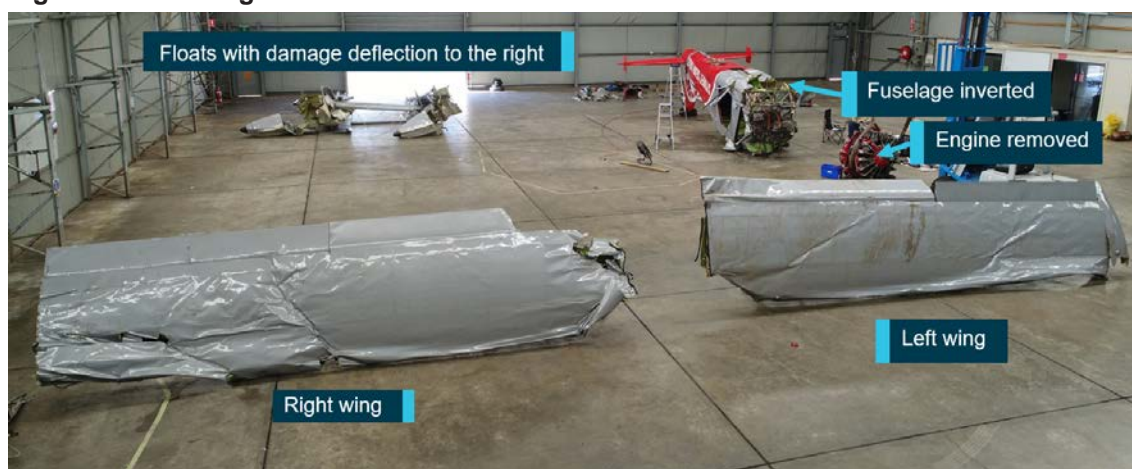
Figure 16: Wreckage examination

- there was no evidence of an in-flight break-up or pre-impact structural damage
- there was no evidence of a pre-existing aircraft defect
- the front of the aircraft and float tips had been significantly damaged

- both the wings and floats had separated from the fuselage during the impact sequence
- both wing front spars had fractured in overload
- damage was consistent with the aircraft being slightly right wing down when colliding with the water and the fuselage then likely cartwheeled span-wise, to the right

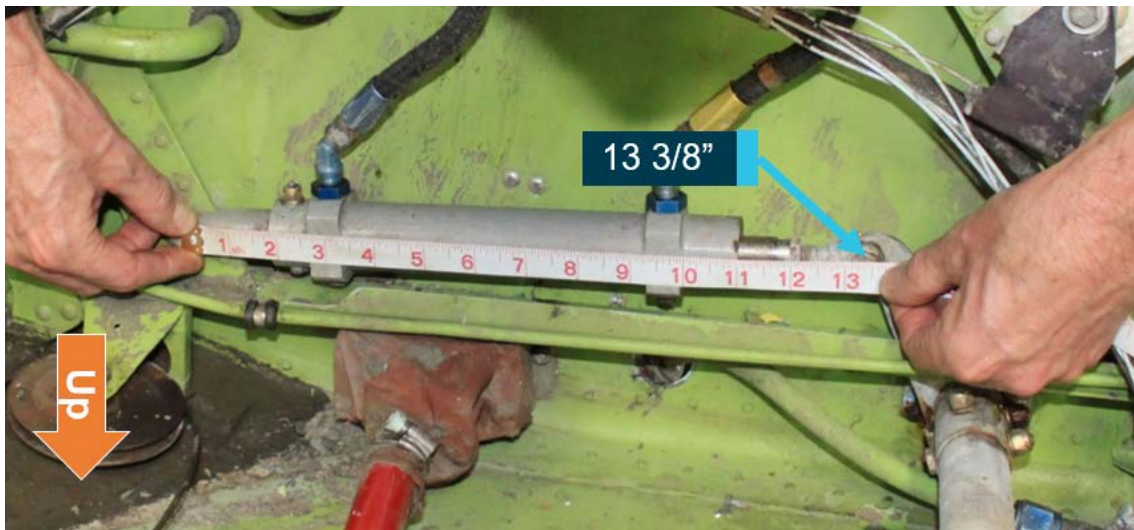
Figure 17: Flap actuator

The examination found that the flap actuator was extended to 13 3/8" (Figure 17), which according to the aircraft maintenance manual wing flap settings, was consistent with 'climb' flap of 15° being selected. The rudder trim was selected to the right, indicative of normal operations in this type of aircraft, and the elevator trim was neutral, consistent with normal operations for a 'full load'.

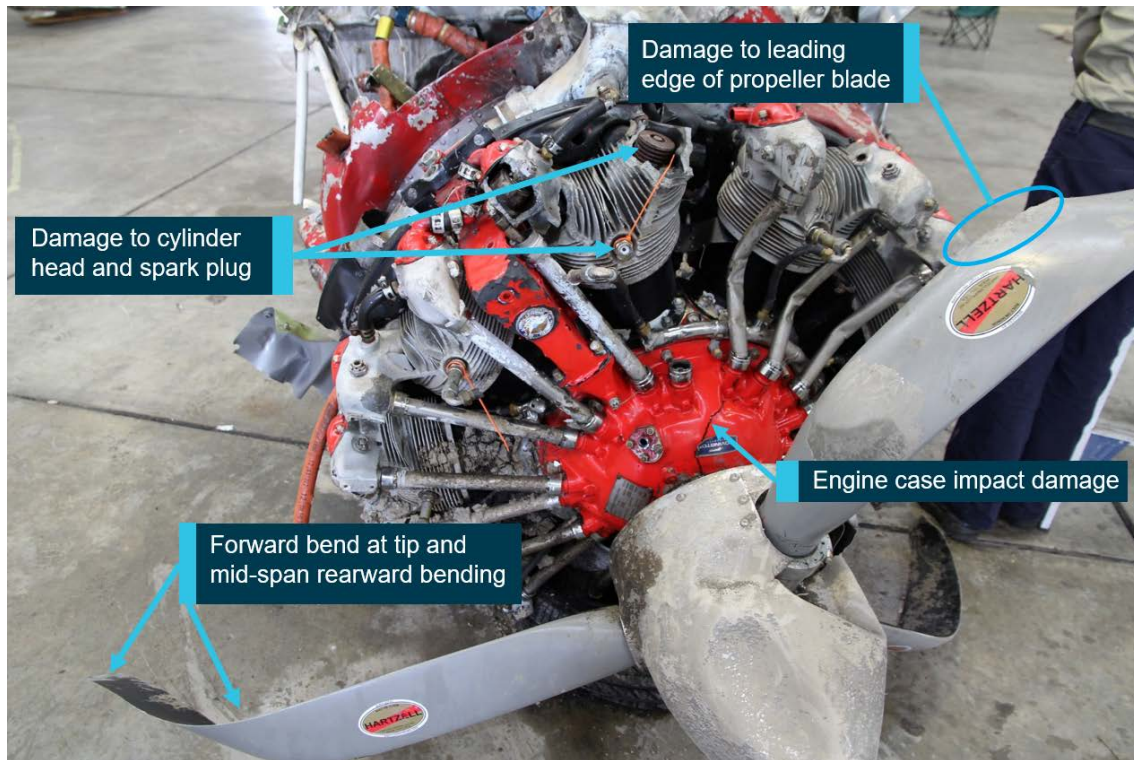
Figure 18: Damage to the engine and propeller, oriented upside down

The engine and propeller examinations were conducted at separate maintenance facilities under ATSB supervision. These examinations did not identify any pre-existing damage or conditions that may have contributed to the accident. Specifically, the examinations identified that (Figure 18):

- damage was consistent with the aircraft impacting the water in a steep nose-down attitude
- some of the supercharger section impeller intermediate drive gear teeth had sheared in overload, which was consistent with the engine producing power at the time of the collision with water
- one propeller blade had forward bending at the tip, then mid-span rearward bending, which was consistent with the engine driving the propeller at impact
- one propeller blade had damage that corresponded to impact damage on one of the engine cylinders, indicative of the propeller rotating as the impact forces bent it backward the propeller was rotating under power but likely at less than full power.
