Engine failure and forced landing of Beech Aircraft 76, VH-BDS

49 km NW of Cessnock Airport, NSW, 1 June 2018

ATSB Transport Safety Report
Aviation Occurrence Investigation
AO-2018-047
Final – 15 January 2019

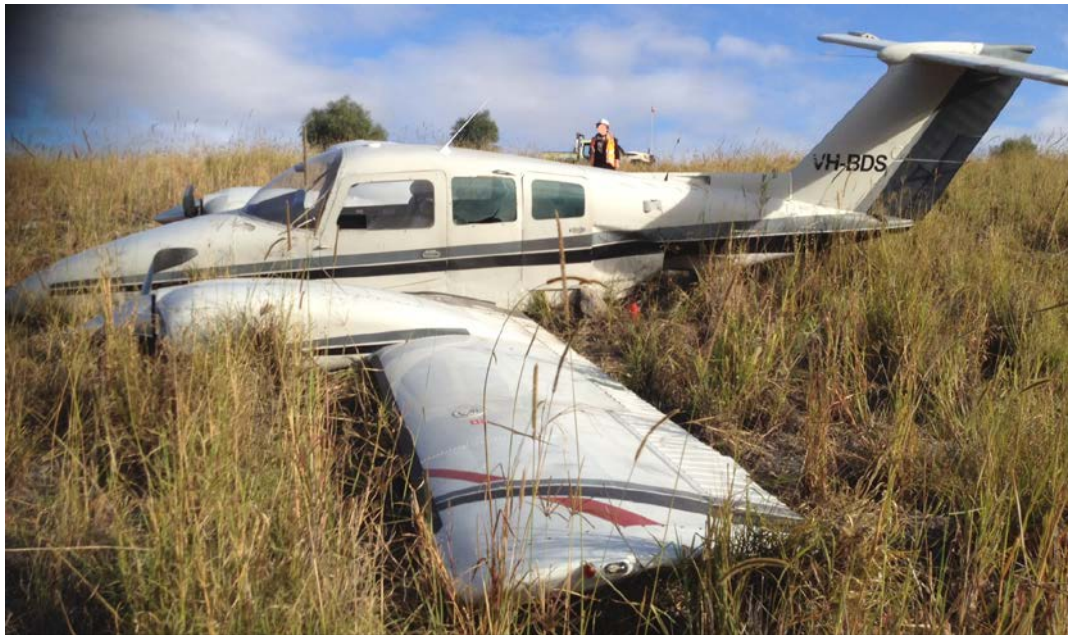
The aircraft touched down in a grassy field on the underside of the fuselage and slid over a slope. The pilot yawed the aircraft sideways in an attempt to slow down but it continued over the slope before coming to rest (Figure 1). The pilot and passengers then evacuated the aircraft using the left cabin door; they were not injured but the aircraft was substantially damaged.

Figure 1: VH-BDS at the accident site

As the aircraft descended, the pilot calculated that the aircraft would not safely clear high ground between its position and the airport. The pilot therefore elected to conduct a forced landing with the landing gear retracted. The forced landing resulted in substantial damage to the aircraft.

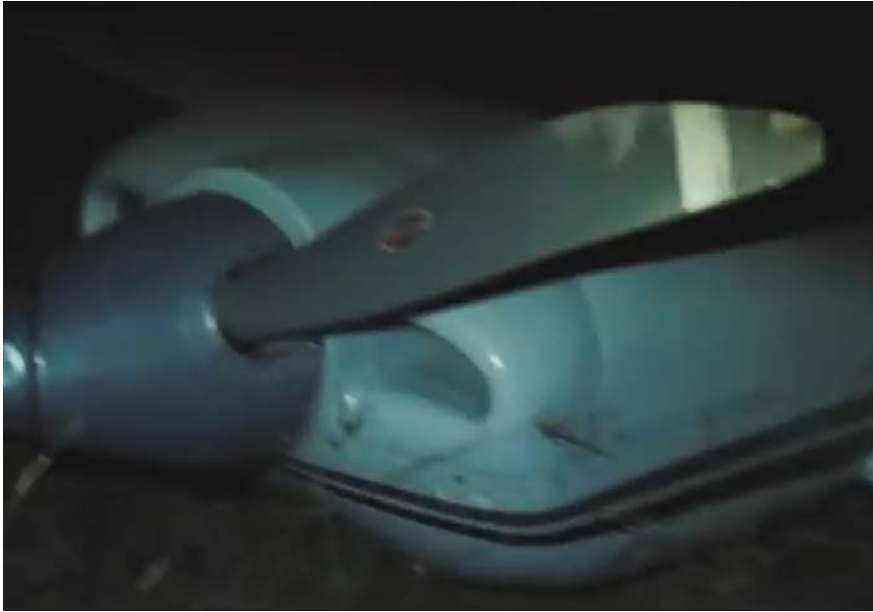
Photographs and video footage of the aircraft taken immediately after the accident showed the right propeller in the fine pitch position and not the expected feathered position (Figure 2). The engineer who recovered the aircraft reported that fuel was present in both fuel tanks and both engine carburettors.

Figure 2: Right engine after the accident showing the propeller

The pilot recalled that after the engine failure, he conducted the propeller feathering actions, but did not confirm that the propeller had feathered. He did not attempt to unfeather the propeller or restart the engine after this time. Post-accident photographs and video show that the propeller was not feathered at the time of the forced landing. Additionally, the inability of the aircraft to maintain altitude was considered to be due to the significant drag associated with the unfeathered propeller. As the aircraft and its systems were not examined, a fault that may have prevented selection of the feathered position could not be ruled out.

Additionally, this occurrence illustrates the importance of correctly configuring a multi-engine aircraft following an engine power loss. On this occasion, the increased drag associated with the unfeathered propeller resulted in a risky forced landing.

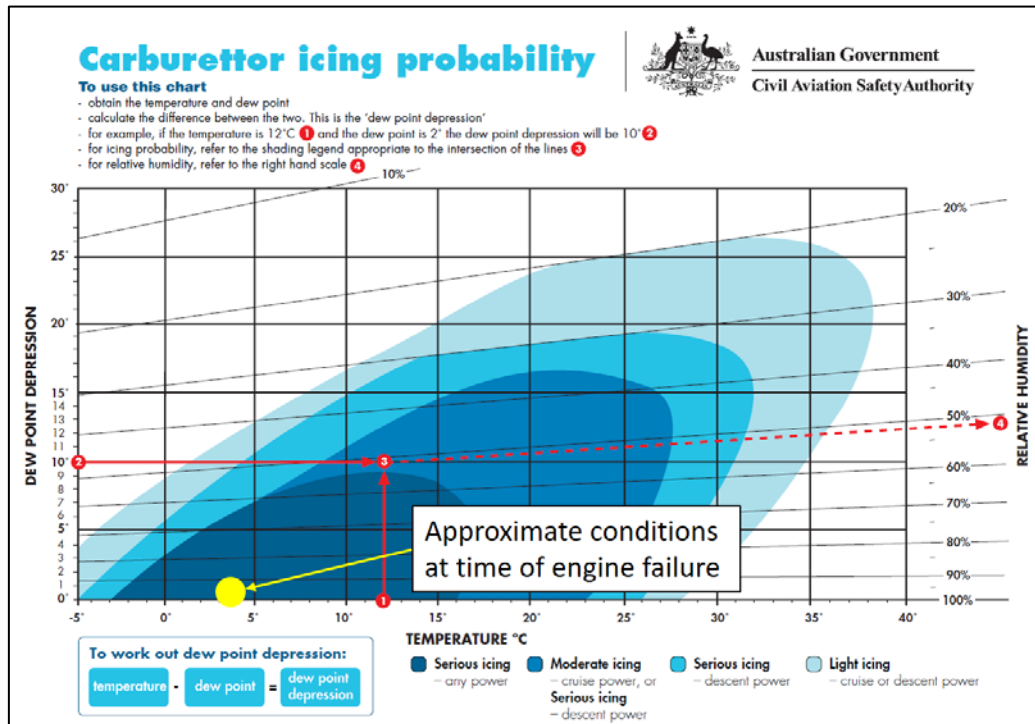
The carburettor icing probability chart shows that the aircraft was descending in conditions of serious carburettor icing at descent power (Figure 3).

Figure 3: Carburettor icing probability chart

At about 1820, the aircraft was descending in conditions that were conducive to serious carburettor icing at the selected engine power without carburettor heat applied. Those operating

This accident highlights the importance of ensuring carburettor heat is used to prevent carburettor ice accumulating and leading to engine failure. If carburettor icing is encountered, or suspected, carburettor heat must be applied fully, and for sufficient time, to melt any accumulated ice. While that occurs, the performance of the engine may temporarily deteriorate further. The Flight Safety Australia article [Ice Blocked](#) provides useful guidance for managing carburettor icing.
