Hard landing involving Kavanagh Balloon B-425, VH-OKX

4 km south of Greta, New South Wales, 13 January 2018

ATSB Transport Safety Report
Aviation Occurrence Investigation
AO-2018-004
Final – 23 January 2019

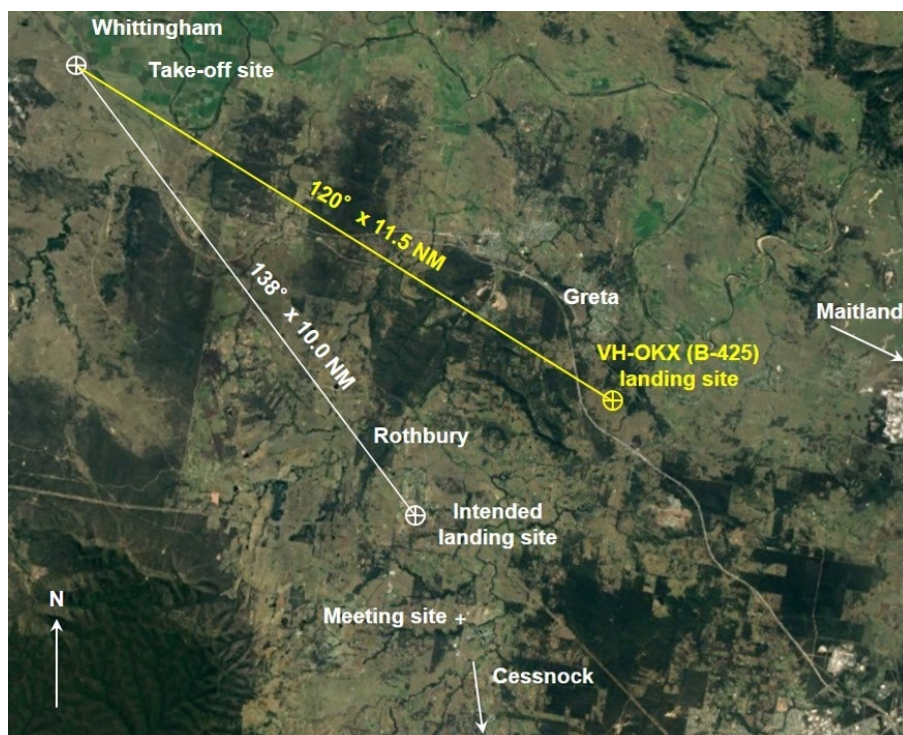
Figure 1: Take-off site, intended and actual flight paths and landing sites

The four pilots and the ground crew met at a location about 7 km north of Cessnock. They assessed the local conditions and decided on the take-off and landing site. The balloon ground crews launched a piball² at the meeting location and surface winds were assessed as being about 5 kt.³ As it ascended, the piball initially went in a northerly direction and then veered to steady on a heading of about 140° T. Based on the local assessment, the pilots decided to take off from the most northerly take-off site, at Whittingham, which was of a similar elevation to the meeting location. The intended landing site was in a paddock, 19 km to the south-east near Rothbury (Figure 1).

The balloon pilots communicated with each other regarding the wind speed and decided to land at the first suitable site. The predetermined landing areas were no longer available to them, as the wind change had taken them further east than they had planned. The area selected was a large open field that was not one of their normal landing areas.

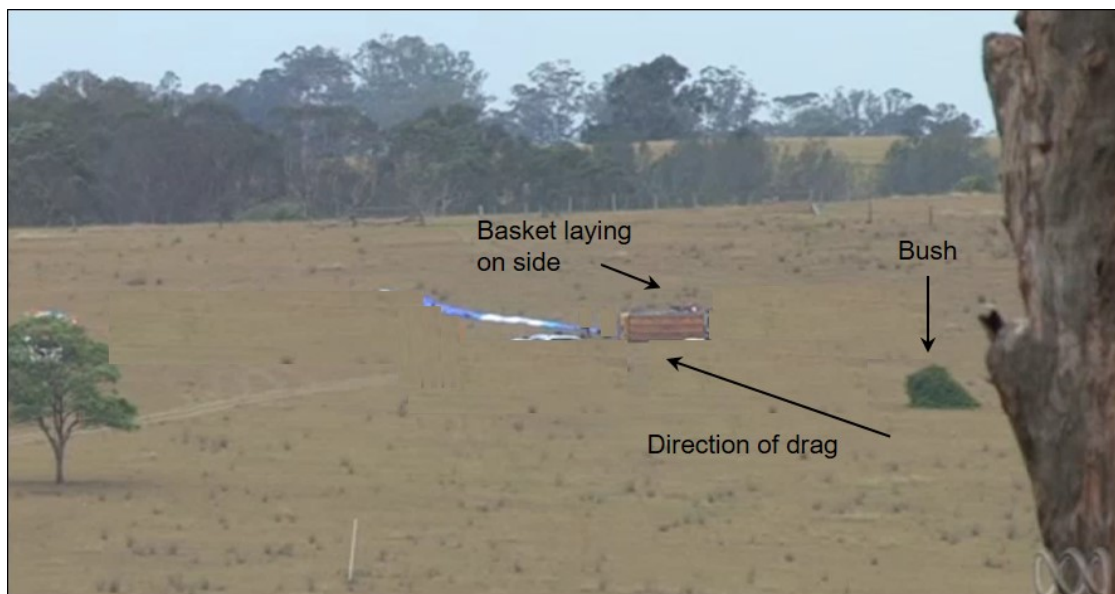
Figure 2: Landing site terrain with the deflated balloon, basket and the bush it contacted

The pilot stated that following the landing, the balloon changed direction slightly and was dragged about 40 m towards a large bush in the centre of the field. The basket subsequently contacted the bush, lifted up rapidly on its right side and landed back down heavily. It was then dragged a further 50-60 m before coming to rest (Figure 2). Due to the significant ground impact forces, one passenger was seriously injured and three others sustained minor injuries. All four passengers were taken to hospital for examination, with three being discharged on the same day.

As the basket landed, the balloon envelope started to drag the basket (on its side) across the terrain (Figure 2). Between the vent outlet and top of the balloon, a 5-6 m bubble of hot air remained, and the balloon envelope started to act like a sail, further dragging the basket. This also changed the direction of the basket and it was dragged towards a bush. The right hand side of the basket struck the bush, bouncing it forcefully back into the air. It subsequently came down on one corner and was dragged a further 50-60 m before coming to rest.

The landing site was largely cleared and the pilot had landed the balloon with clear ground in the direction of travel. However, the direction of drag changed, which resulted in the collision with the bush. When the basket collided with the bush and became airborne, the subsequent ground impact resulted in four injuries.

- Future flights at Whittingham will need another weather check to be carried out at a more elevated location to gain a better perspective of surface winds and temperature changes.
- Pressure dropping to 1,000 hPa and below is an indication of changing weather conditions and should be taken into strong consideration when making a decision to fly.
- The area south of Greta was the first large open area to land. Another very large landing area at a lower elevation has been identified for use should there be another weather event.

- Elderly passengers will be positioned in compartments with more people to restrict the potential for flail-type injuries.
