# Collision with terrain involving PZL Warszawa-Okecie M-18A Dromader aircraft, VH-WHR

9 km NW of Emerald Airport, Queensland, on 1 December 2017

**ATSB Transport Safety Report**  
Aviation Occurrence Investigation  
AO-2017-115  
Final – 5 February 2019

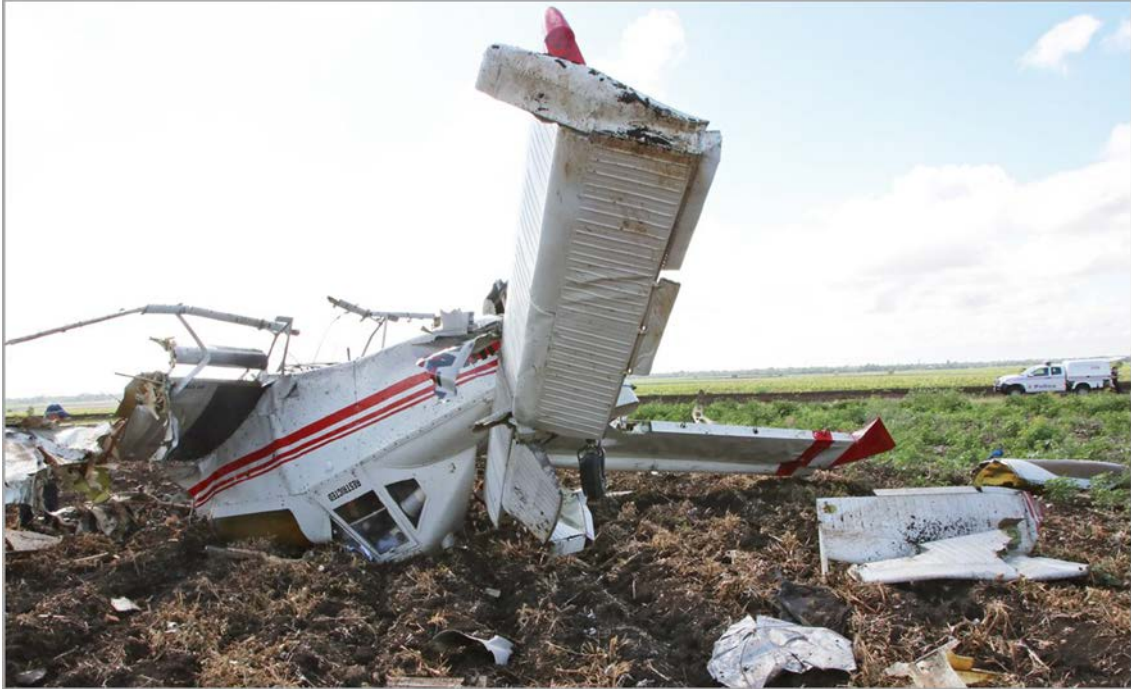
**Figure 2: Accident site**

run, the aircraft rapidly pitched down and the right wing collided with the ground. The aircraft subsequently flipped, and came to rest inverted and facing in the opposite direction to the flight path about 20-30 m from the initial contact point (Figure 2).

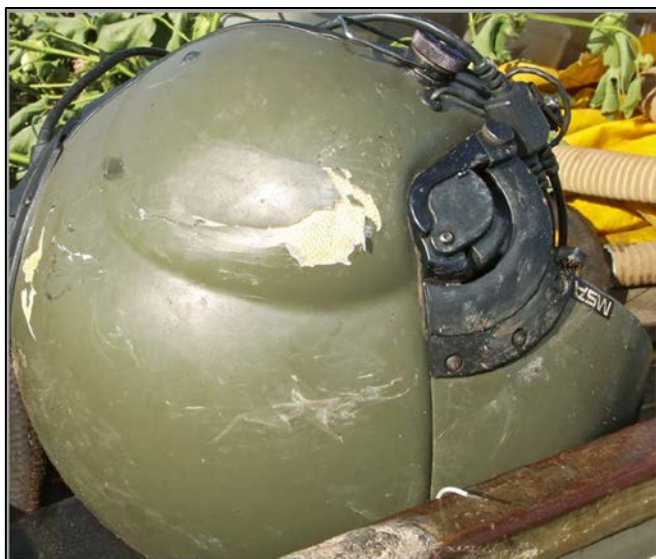
**Figure 3: Damage to the left side of the pilot's flight helmet**

Ambulance officers treated the pilot before transporting him to hospital. He was admitted to treat his injuries, which included a fractured left leg, three fractured left ribs, bruises, cuts to his left side, and concussion. The pilot was wearing a helmet at the time of the accident and it was damaged from impact with the aircraft structure (Figure 3). The pilot had no recollection of the accident and no mechanical issue was identified that may have contributed to the accident.

The pilot was wearing his own personal flight helmet at the time of the accident. During the accident, the left side of the helmet struck the internals of the cockpit. Based on the degree of damage to the helmet, it probably prevented the pilot receiving more serious head injuries.

The International Civil Aviation Organization circular 85-AN/71 [Safety in aerial work Part 1. Agricultural Operations](#) discusses the importance of reducing serious head injuries by wearing a correctly fitting flight helmet. Pilots operating aircraft in agricultural operations are particularly vulnerable to accidents involving major or fatal head injury. The circular also discusses the need to select a helmet which provides effective protection and that is part of the pilot's personal flying equipment as was the case in this accident.

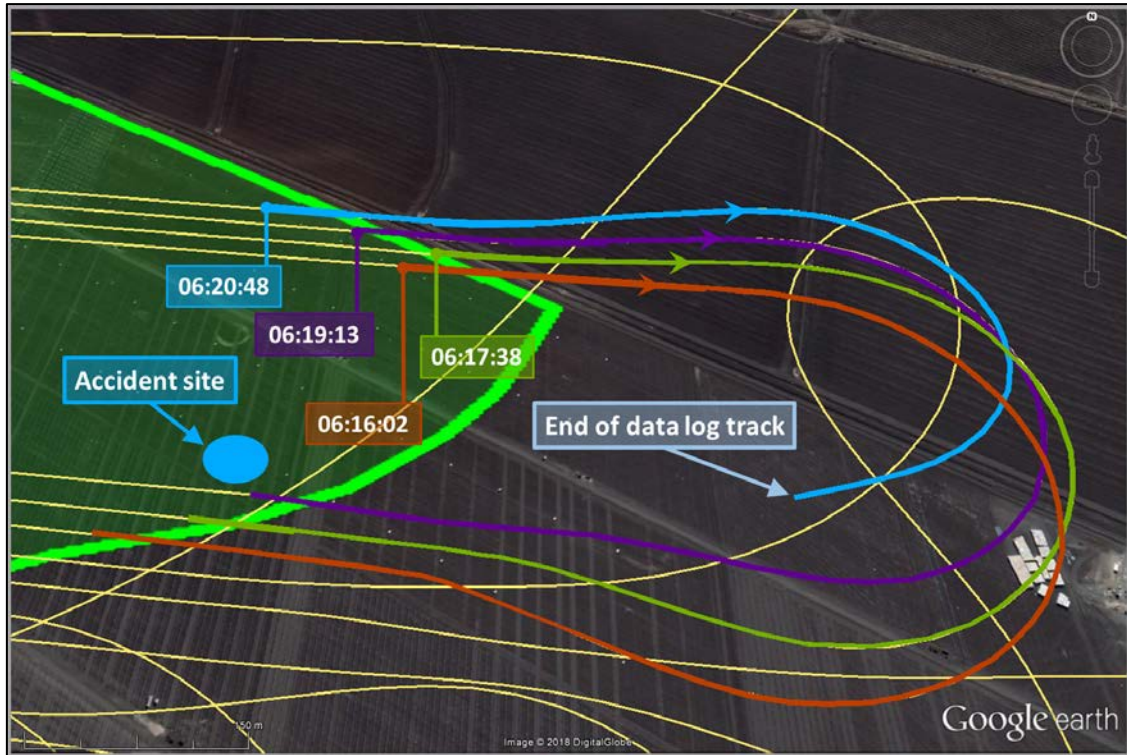
**Figure 4: Final four right turns from an easterly track (last shown in blue)**

While the track of the aircraft during the spray operation was recorded, other parameters such as airspeed, time, altitude, and aircraft attitude were not. Figure 4 shows the final four racetrack pattern turns back towards the west. The last inbound turn (shown in blue) was conducted at a smaller turn radius than the previous three turns in that direction. The track data finished about 460 m from the accident site.

About three quarters of the way through a turn, as the aircraft was lined up for the next racetrack pattern spray run, the aircraft was observed to rapidly pitch down and collide with the ground. Analysis of the limited available recorded data showed that the final turn was flown at a tighter radius than the previous racetrack pattern turns. In combination, this could indicate that the accident was the result of an aerodynamic stall. However, there was insufficient information to determine if that occurred.
