Contact with wharf by *Madang Coast*

Port of Townsville, Queensland, on 16 November 2015

ATSB Transport Safety Report
Marine Occurrence Investigation
323-MO-2015-007
Final – 19 February 2019

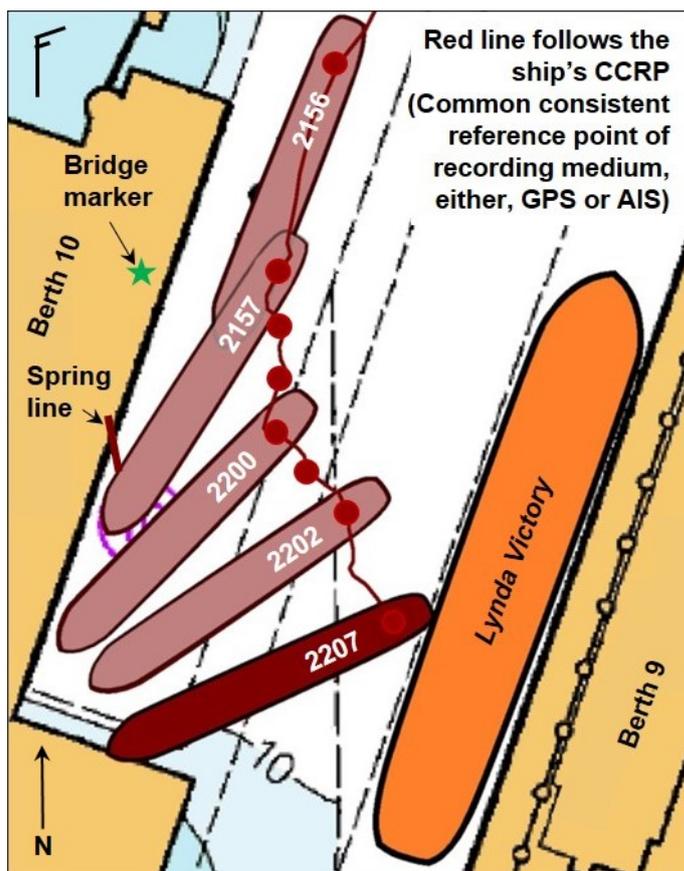
Figure 2: *Madang Coast*'s approach to Berth 10 showing times at each position

At 2146, *Madang Coast* entered the harbour basin at a speed of 5 kt.³ The pilot continued to reduce the speed as he manoeuvred the ship across the harbour to Berth 10. By 2149, with the speed at 3.6 kt, the pilot asked for stop and shortly after asked for dead slow astern. At 2151, with the ship just over two cables⁴ from the berth, the pilot asked for slow astern with the speed now 3.2 kt.

At 2156, the pilot asked for stop and the master set the ship's controllable pitch propeller (CPP) to zero pitch with about 100 m to run ahead (Figure 2 and Figure 3). *Madang Coast* was now parallel to, and about 15 m off the wharf, at a speed of 1.8 kt. Shortly after, when the bridge marker was about midships, the ship's stern started to slowly move away from the wharf.

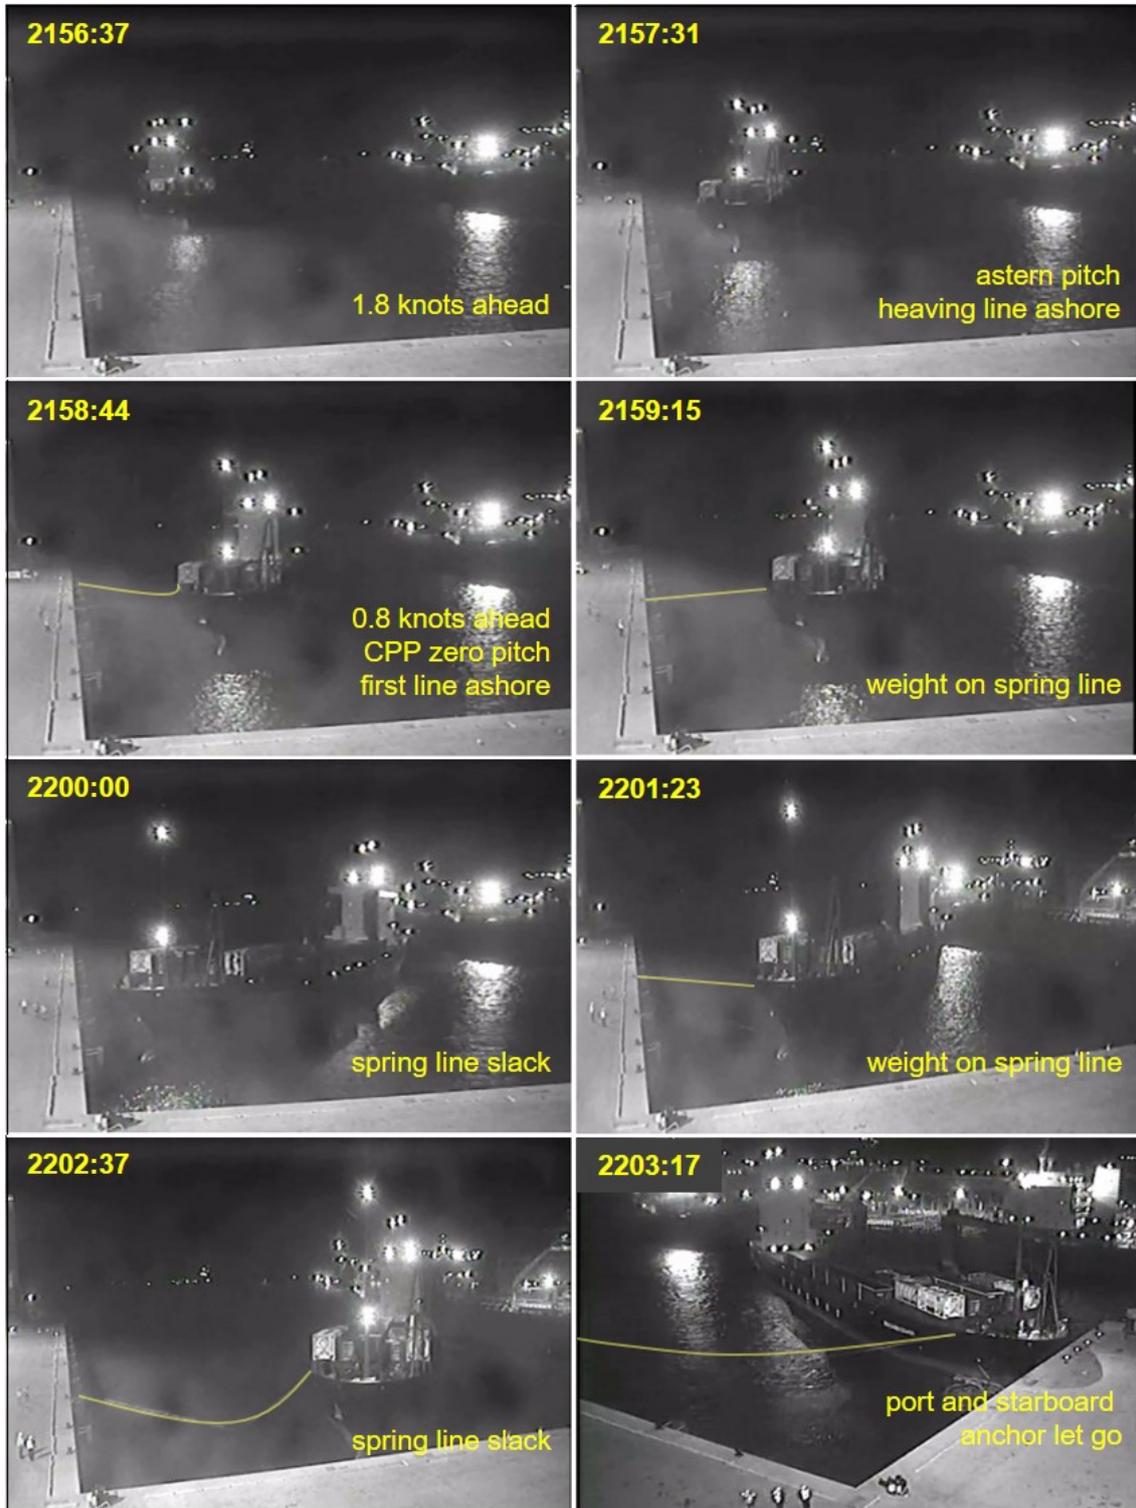
Figure 3: CCTV images of Madang Coast's attempted berthing at Berth 10

At 2157, with 25 m to run ahead, the pilot used astern pitch to further reduce the ship's speed. About 30 seconds later, the forward mooring party threw a heaving line⁵ ashore and started running out the forward spring line as the stevedores heaved it ashore.

Shortly after 2158, the line was ashore and was looped over a bollard on Berth 10. The CPP pitch was reduced to zero, with the ship's speed now at 0.8 kt ahead. The master then informed the second mate to hold on to the forward spring line. The second mate relayed this to the bosun and seaman and they made two turns around the first post of the bitts⁶ and manually held onto the working end of the line. At about 2159, as weight came on the forward spring line, the ship's bow began to pivot towards the wharf. Shortly after, the spring line slipped on the bitts and it fell slack. The bow continued to pivot towards the wharf and the stern continued to move away from it.

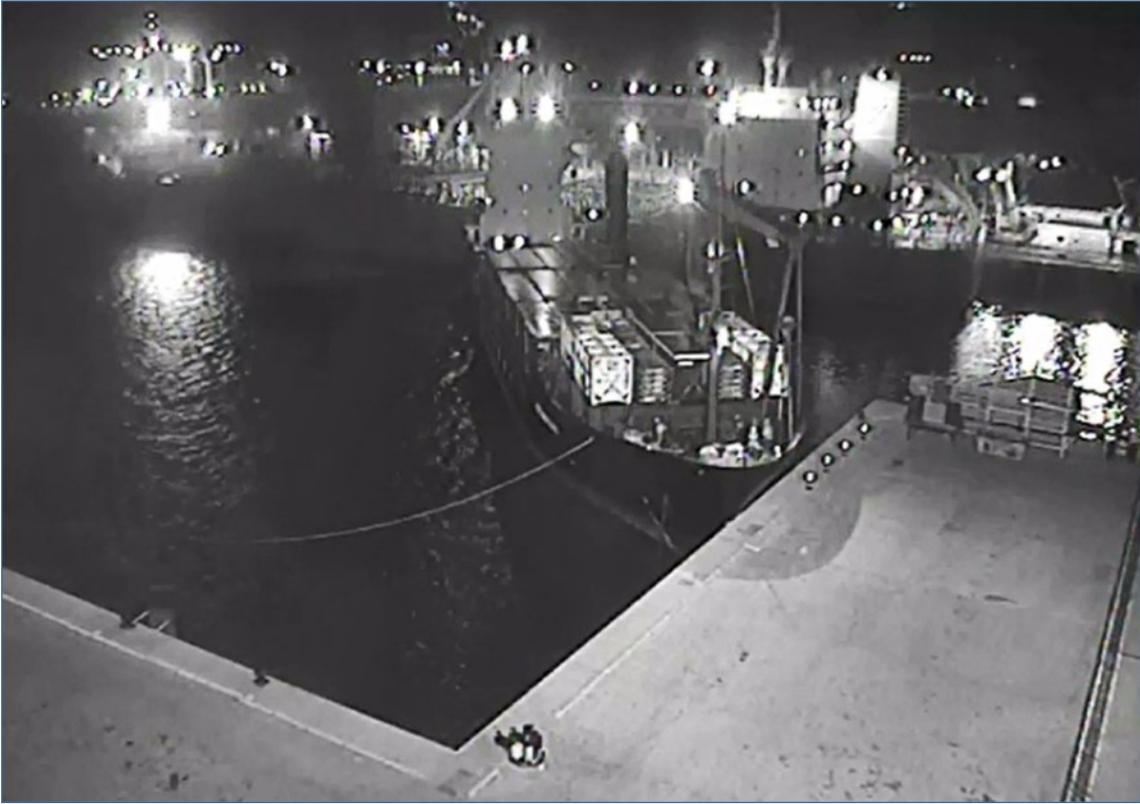
Figure 4: *Madang Coast* in contact with *Lynda Victory* and the wharf

At 2203, the port anchor was let go and held on the brake. Immediately thereafter, the crew also let go the starboard anchor. By 2205, *Madang Coast's* bow had made contact with the shore end of Berth 10 and its port quarter with *Lynda Victory*. The port quarter moved a short distance aft along *Lynda Victory's* hull, coming to rest at 2207 and remaining in this position awaiting the arrival of the tug (Figure 4).

Upon inspection, it was found that *Madang Coast* and *Lynda Victory* both received scrape marks and small indentations to the shell plating. Minor damage was also found along the edge of Berth 10 where *Madang Coast's* bow had made contact. On 17 November 2015, the ship's classification society surveyed *Madang Coast* and found minor indentations that did not affect its structural integrity. The ship subsequently sailed from Townsville on 18 November 2015.

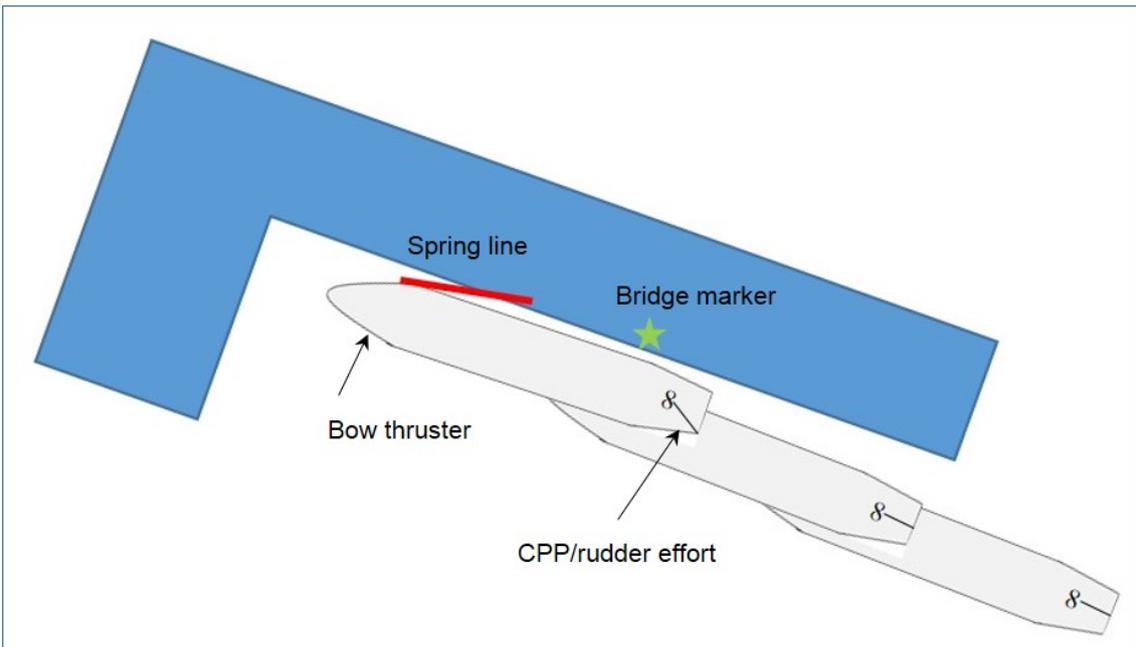
Figure 7: Planned berthing manoeuvre

As weight came onto the line, the forward movement of the ship would bring it slowly alongside. A short ahead movement of the ship’s propulsion and with the rudder hard-over to port would swing the ship’s stern in and the bow thruster could be used to maintain the bow’s position. Once alongside, the ship’s final position could be adjusted by using the head and stern mooring lines and/or main engine.

The berthing plan relied solely on the use of the forward spring line to manoeuvre the ship alongside. It had not been risk assessed nor had contingencies been considered. As a result, a single failure at such a late stage of the berthing meant that the incident could not be avoided.
