# Loss of control and collision with terrain involving de Havilland DH82A Tiger Moth, VH-UZB

Pimpama Airfield, Queensland | 28 December 2015

**ATSB Transport Safety Report**  
Aviation Occurrence Investigation  
AO-2015-150  
Final – 1 March 2019

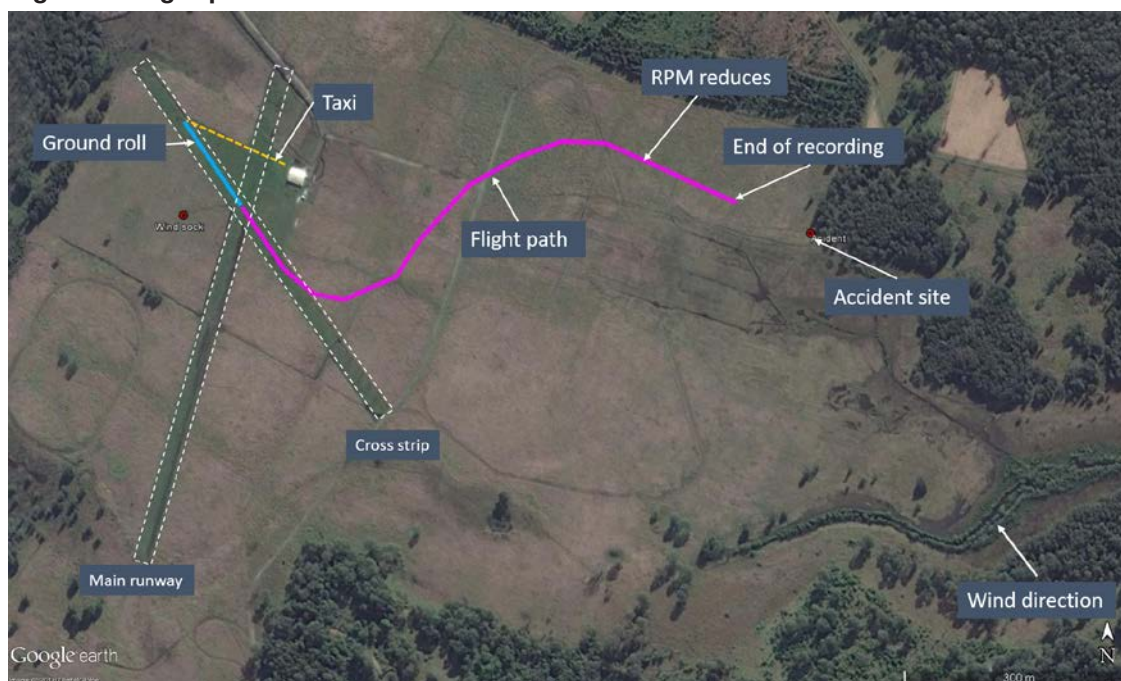
**Figure 1: Flight path of the aircraft**

The yellow dotted line indicates the aircraft's taxi, the blue line the ground roll and the pink the flight path, based on analysis of the on-board video recording (the recording stopped before the accident).

About 27 seconds after lift-off, when the aircraft was travelling approximately parallel to the take-off strip, the pilot observed a change in engine noise and a reduction in engine RPM.<sup>6</sup> He reported that he retarded and then fully advanced the throttle but the engine only returned to a similar lower power condition.

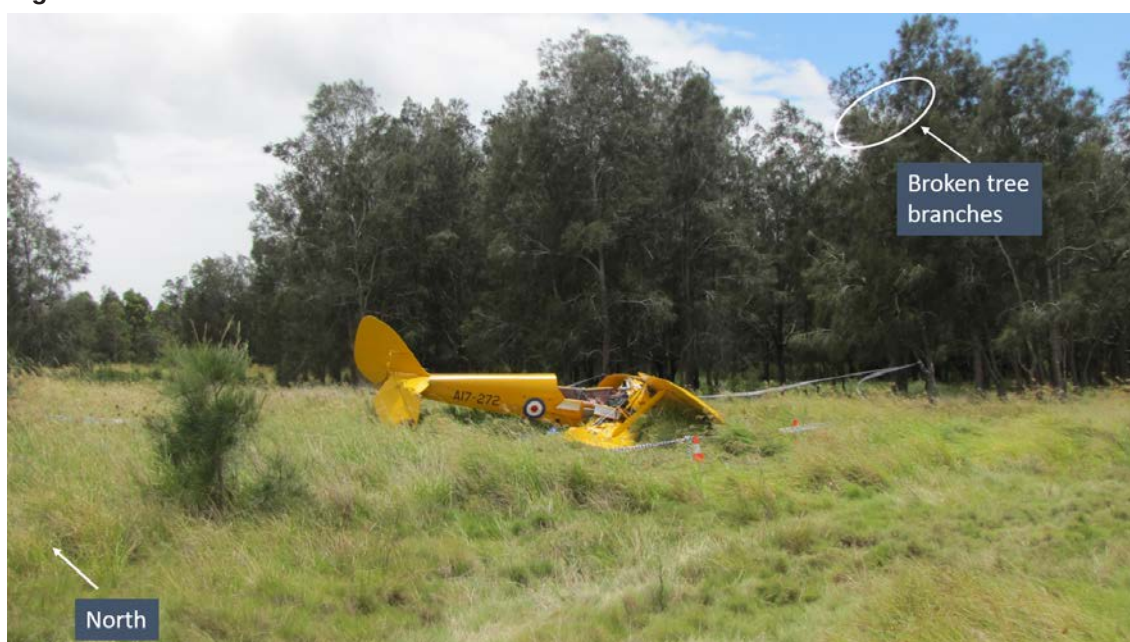
**Figure 3: Accident site**

- all parts of the aircraft were present at the accident site
- there were no observable pre-accident defects to the airframe
- propeller slash marks and the damage to the propellers indicative of the engine driving the propeller at the time of impact (Figure 5)
- the aircraft impacted the ground in a steep nose-down attitude with little forward velocity
- the damage to aircraft, the trees and location of the aircraft wreckage was consistent with a collision with terrain while spinning to the left.

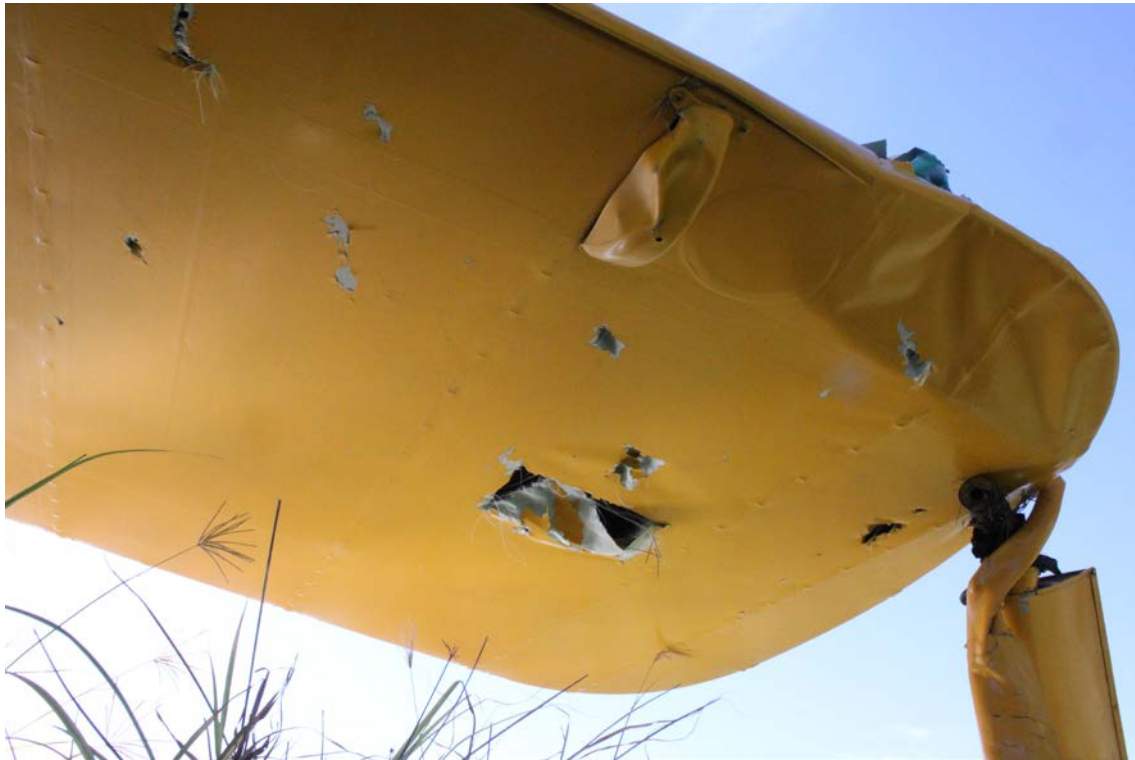
**Figure 4: Tree impact marks on underside of upper left wing**

Impact marks were identified on the underside of the upper left wing (Figure 4) and significant tree debris were located in the vicinity of the left wing. There was evidence of freshly broken branches in the trees to the east of the accident site. There was minimal damage to the right wing.

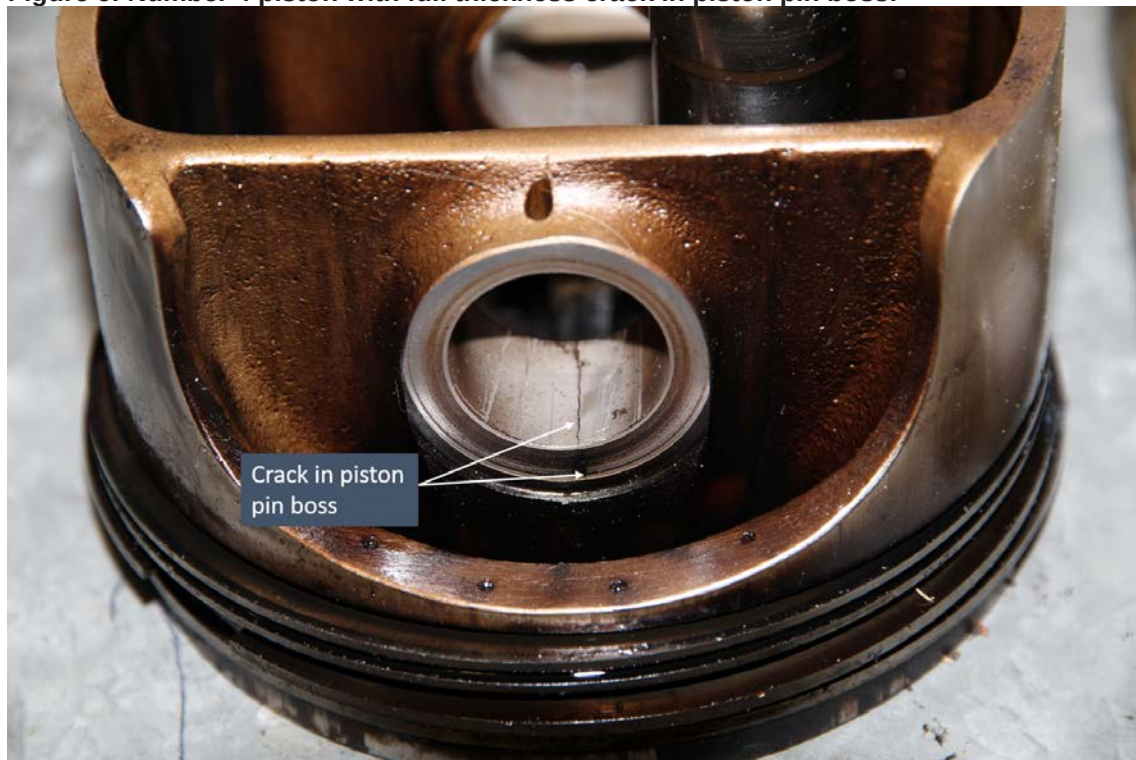
The engine was disassembled and examined at an engineering facility under the supervision of the ATSB. The examination found that there was no evidence of a catastrophic engine failure. In addition, the examination identified:

- impact damage to the rocker covers and exhaust system
- the number 1 cylinder exhaust valve was bent and stuck, most likely due to impact damage
- the engine rotated freely by hand with all cylinders (apart from number 1) having correct compression
- the number 4 piston had a full thickness crack through the piston pin boss (Figure 6). The crack may have been pre-existing or a result of the impact. As the crack had not propagated to the point of failure, it did not lead to the power loss.
- the spark plugs appeared normal
- the engine carburettor in line filter was clean
- the valve guide clearances were within the documented tolerance. The cylinder number 4 exhaust valve was stiff in comparison to the other valves, although still free to move.

There were no mechanical defects identified that would have led to a sudden reduction in engine power.

**Figure 6: Number 4 piston with full thickness crack in piston pin boss.**

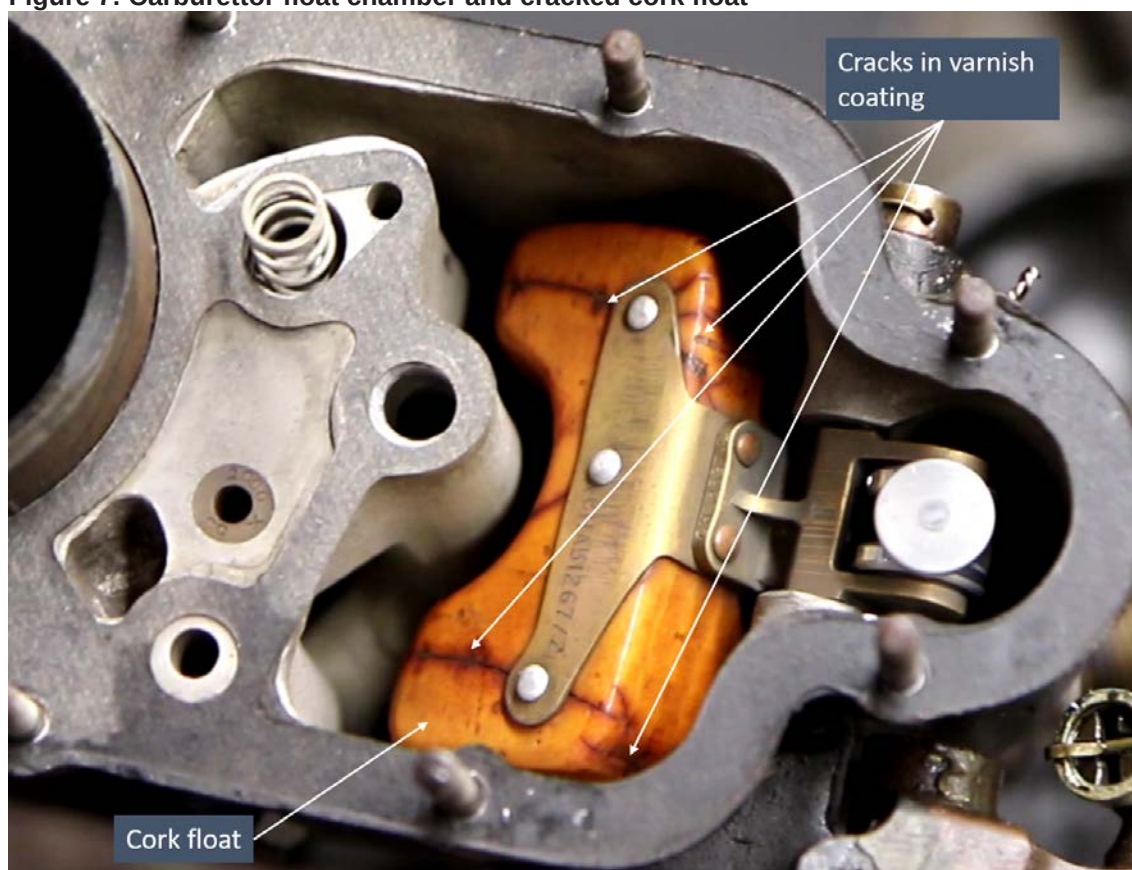
The carburettor was disassembled and inspected. The float chamber was refilled with fuel and the fuel level was measured and found to be within limits. The freedom of movement of the mechanism was also checked and found to be serviceable. Some cracks in the varnish of the cork float were identified (Figure 7). Such cracking can allow the ingress of fuel into the float and affect both the dimensions and buoyancy of the float within the carburettor. Fuel-affected cork floats have been found to be a contributing factor in a number of other engine malfunctions involving Gipsy Major engines.

Consequently, the ATSB conducted testing of the float to determine if the cracks allowed fuel to penetrate the float. The cork float dimensions and weight were measured and recorded. The float was then immersed in unleaded petrol for a total of 26 hours. There were minor changes in the float dimensions and a minor increase in weight, however, these changes were not considered significant enough to have resulted in the observed power loss.

Following review of the draft report, de Havilland Support Ltd (the aircraft type certificate holder, provided advice that it could take many months for the cork to become impregnated with fuel to a point where engine performance was affected. As a result of this new information, the ATSB has commenced additional testing on the float, in consultation with de Havilland Support, which will continue over the coming months. Once complete, the results of this testing will be published via an amended report.

**Figure 7: Carburettor float chamber and cracked cork float**

Observed cracking of the carburettor cork float varnish raised the possibility of the float being impregnated with fuel to the extent that the performance of the carburettor may have been affected. Testing of the carburettor mechanism and additional submersion testing of the float conducted during the investigation indicated that this was unlikely. However, following a submission from the type certificate holder, additional submersion testing of the float has commenced. The results of this testing, and any implication for the operation of the engine, will be detailed in an amended report.
