Contact with wharf by livestock carrier *Angus Express*

Berths 4 and 5, Broome, Western Australia, on 20 April 2018

ATSB Transport Safety Report
Marine Occurrence Investigation
343-MO-2018-006
Final – 20 March 2019

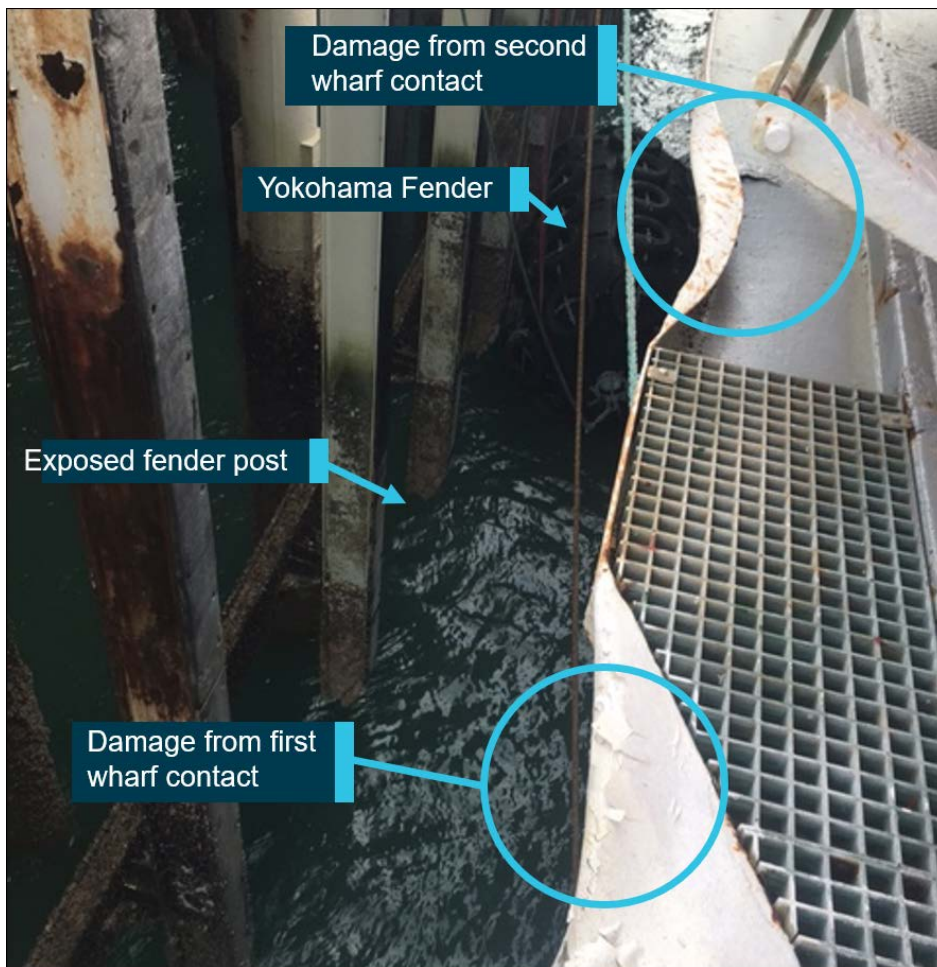
Figure 2: Damage to the *Angus Express*'s starboard scupper protrusion

At 0712, the weight of the ship against the forward Yokohama fender forced it to pass under the fender posts, which resulted in the ship's bow moving towards the wharf (Figure 2). Shortly after, an overhanging scupper⁵ protrusion made contact with the fender post (about 30 m from the ship's bow).

towards the wharf, and the scupper protrusion again made contact with the fender post (Figure 2). The pilot instructed the tug to stop, and the ship came away from the vertical fender posts.

The pilot reported the incident to the harbour master who subsequently attended the ship and found minor damage to the ship's superstructure.

The height of tide at the time of the incident was 1.62 m, which was low enough to expose the base of the fender posts (Figure 3). When the pilot attempted to manoeuvre *Angus Express* forward using the tug, the force exerted on the Yokohama fender by the ship, allowed it squish and roll under the fender post. Consequently, the ship moved closer to the wharf and the scupper protrusion contacted the post.

- The height of tide when *Angus Express* was berthing was low enough to expose the base of the wharf's fender posts. Consequently, when the tug pushed to move the ship, the forward Yokohama fender was forced under the post, which allowed the ship's starboard scupper protrusion to contact the post with resulting damage.
- The harbour master and pilot were unaware of any height of tide limitations associated with berthing ships alongside Yokohama fenders at berths 4 and 5. Therefore, the risk assessment did not include any mitigating factors for berthing alongside at a height of tide less than 2.5 m.

Guidelines for berthing and being alongside when using Yokohama style fenders have been implemented for times of limiting low water levels. Also, the risk evaluation process between harbour master and pilot has been extended to include focussed quick risk assessment for circumstances such as tug shortages, vessel manoeuvring issues and tidal levels.

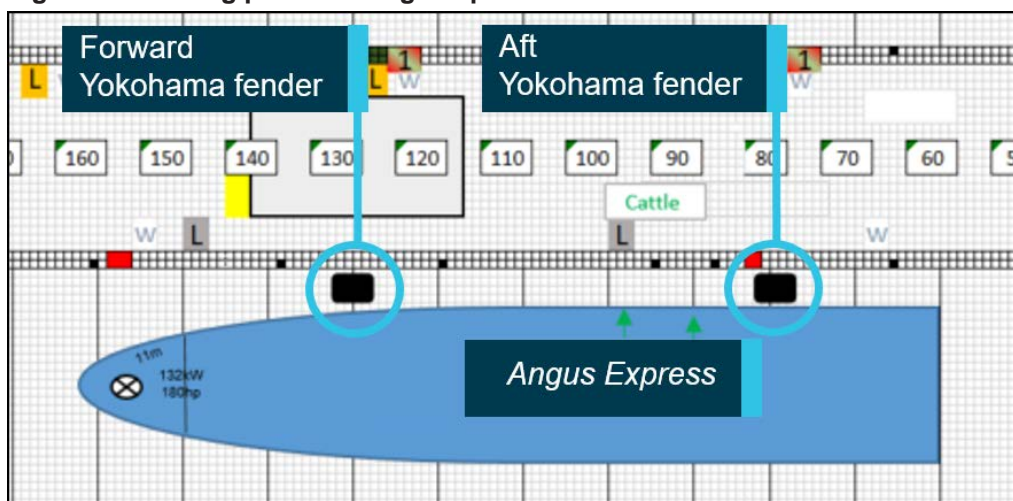
Figure 3: Berthing plan showing the position of the Yokohama fenders at berth 4 & 5

The Yokohama fender system in the Port of Broome consisted of large floating cylindrical rubber fenders, secured to vertical fender posts, which allowed vertical movement as the tide changed. The tyres fitted with chain to the outside of the fenders for protection also increased their width. The use of fenders kept the ship's side clear of the wharf, protecting both, and allowed longer loading windows (Figure 3). The added clearance from the wharf also reduced the steepness of the gangway in the large tidal range at Broome.

After the incident, inquiries by *Angus Express*'s pilot resulted in a pilot who had worked in the port until 2015 providing relevant information about the Yokohama fender system. That pilot's personal pilotage log indicated that a height of tide of less than 2.5 m was considered a significant factor with respect to the fenders at berth 5. When the water level fell below this height, the fenders could be forced under the vertical fender posts by a ship.

Post-incident investigations by Kimberley Ports Authority (KPA) and the pilotage provider, West Coast Pilots (WCP) confirmed that the fender posts at berths 4 and 5 were shorter than at others. No evidence was found to indicate that these shorter posts or the potential for fenders to be forced under them when water levels fell had been documented or otherwise promulgated to pilots through training or instruction.
