# VFR into IMC and loss of control involving Cessna 172, VH-FYN

13 km NNW of Ballina, New South Wales | 16 June 2017

**ATSB Transport Safety Report**  
Aviation Occurrence Investigation  
AO-2017-061  
Final – 14 March 2019

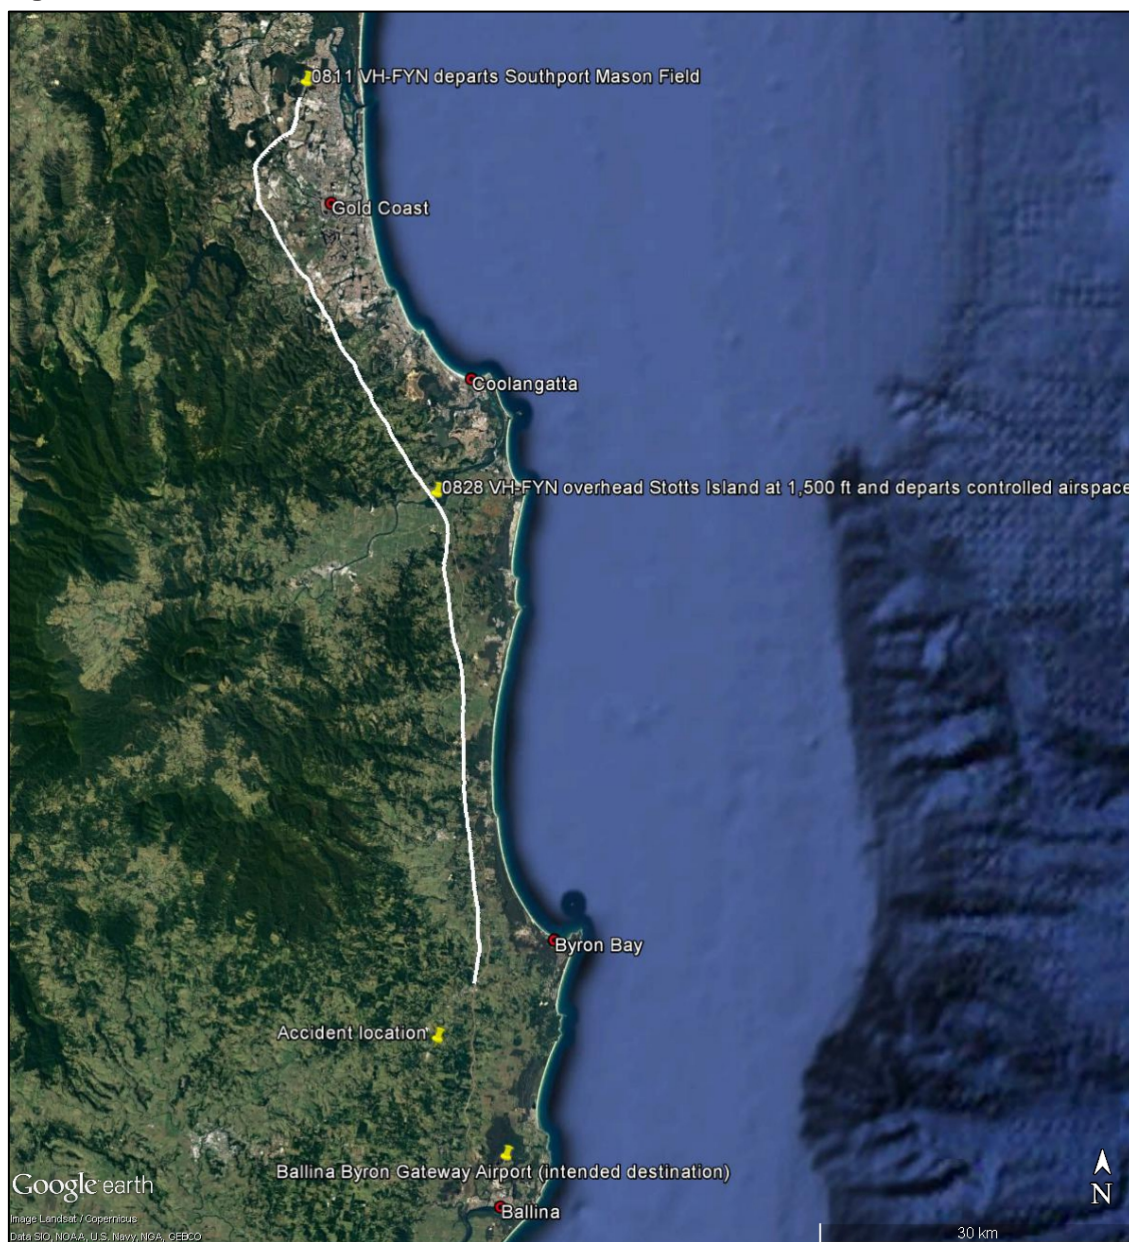
**Figure 1: Radar track of VH-FYN on 16 June 2017**

Radar track sourced from Airservices Australia overlaid on a Google Earth image showing the track of VH-FYN on 16 June 2017. The radar data show the aircraft take-off from Southport Masson Field and head south-east along the western VFR route to Stotts Island before tuning south towards Ballina. Also shown is the accident location approximately 13 km north-north-west of Ballina.

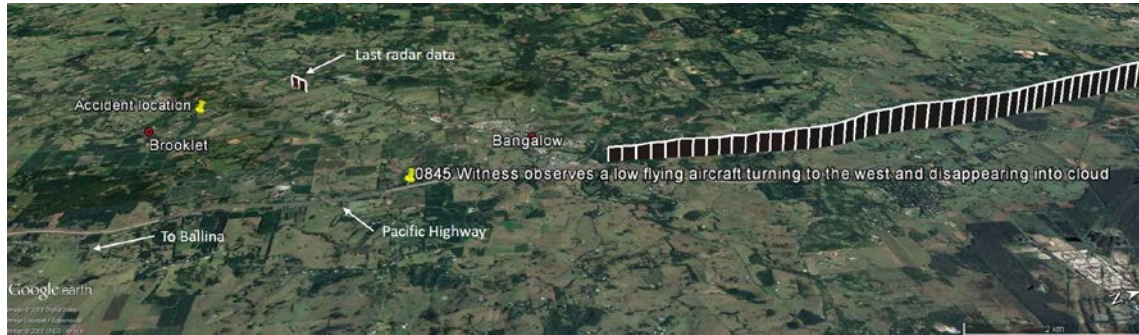
**Figure 2: Radar track of VH-FYN near Bangalow, NSW**

The flight from Stotts Island onwards took place between about 1,500 and 2,000 ft, tracking alongside the Pacific Highway. At 0842, when the aircraft was about 6 km north of Bangalow, a steady descent was commenced (see Figure 2).

Radar track sourced from Airservices Australia overlayed on a Google Earth image showing the track of VH-FYN on 16 June 2017. The radar data show the aircraft descended from 1,500 to 800 ft just north of Bangalow before radar identification was lost. Also shown further to the west are the last radar data obtained from VH-FYN as well as the position of the last known eyewitness of the aircraft and the location of the accident site. Source: Google Earth, modified by the ATSB

By the time the aircraft was about 1 km north of Bangalow, at 0844, it had descended to 800 ft, at which point radar identification was lost. A short time later, at approximately 0845, and about 3 km further south, a witness driving south on the Pacific Highway reported seeing an aircraft overhead in front of her vehicle. The witness noted that the aircraft was flying lower than she would normally have expected. The witness then saw the aircraft turning gradually to the right (west) and disappear into cloud. The witness reported low patchy clouds, fog and drizzle in the area at the time.

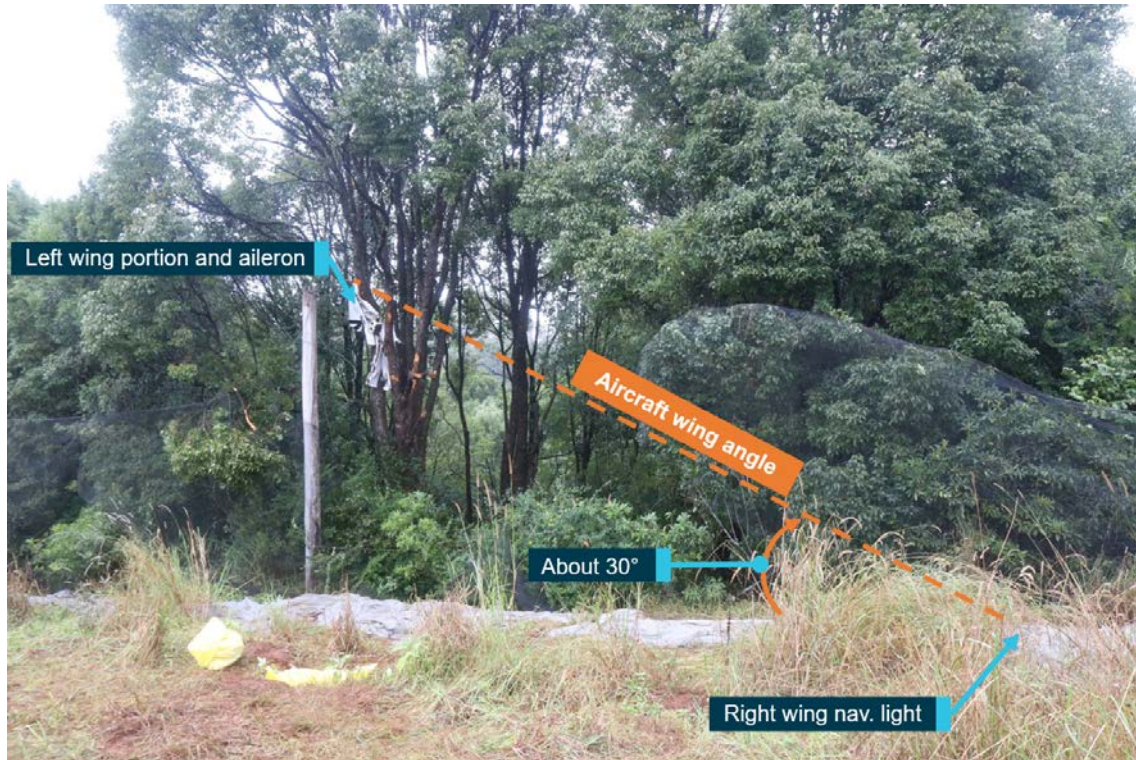
**Figure 4: Initial collision with terrain at Brooklet, New South Wales**

On-site examination of the wreckage found that the aircraft collided with terrain with the right wing down at an angle of about 30° (Figure 4). The outboard section of the left wing, with the left aileron and aileron bell crank was situated in a tree about six to eight meters above the ground at the beginning of the wreckage trail. The right navigation light assembly was captured on a wire that

was strung along the bottom of a net at ground level. Associated with the navigation light was a ground scar consistent with the wing tip colliding with the ground. The outer points of the wings were consistent with the Cessna 172M wingspan. Measurements of tree scars at the site indicated that the wreckage trail was at about a 50° downwards trajectory, indicating that the aircraft was in a significant nose-down attitude at the time of impact.

Image shows the initial impact points of VH-FYN. The left wing impacted trees while the right wing impacted the ground, indicating an angle of bank at the time of impact of about 30° to the right.  
Source: ATSB

Examination of the accident site found that at the time of impact, the aircraft was in a 30° right wing down and significant nose down attitude. This attitude is not consistent with normal operations of a C172, and is indicative of a loss of control. It is therefore likely that within five minutes of flying into conditions of reduced visibility, without adequate visual reference to the horizon, the pilot of FYN became spatially disorientated leading to a loss of control and collision with terrain.

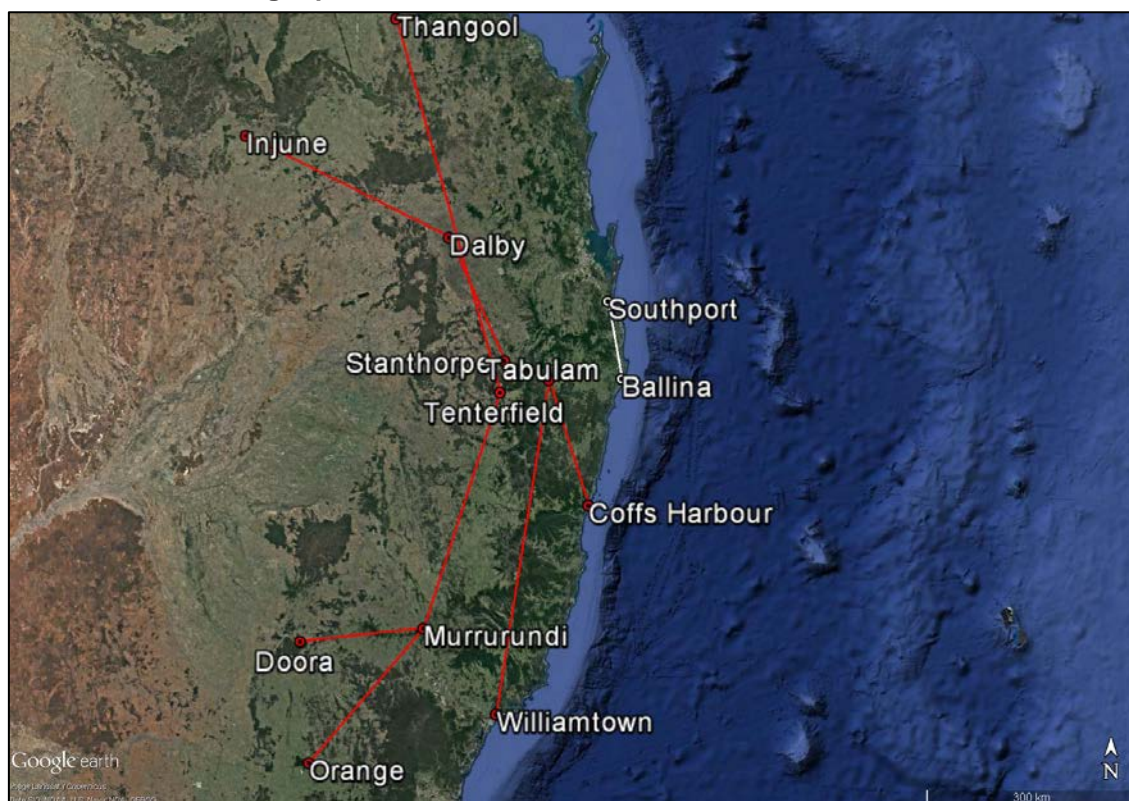
**Figure 5: Figure showing the accident flight in relation to waypoint references given in the Area 20 and 40 forecasts. Boundaries given by the Area forecast are shown in red; the location of the flight path is shown in white.**

- Areas of broken low cloud east of Thangool - Tenterfield until 1100 (see Figure 5).
- Broken stratus clouds between 500 and 2,500 ft near precipitation
- Scattered cumulus and stratus clouds between 2,500 and 8,000 ft east of Injune – Dalby - Stanthorpe
- Significant weather in Area 40 was forecast as being fog, mist, showers of rain and smoke. Visibility was forecast to be 500 m in fog, 2,000 m in mist and thick smoke, 3,000 m in showers of rain and 8 km in smoke haze. The freezing level was above 10,000 ft and icing was forecast to be moderate in cloud above the freezing level. Turbulence was forecast to be moderate in cumulus clouds.

Google Earth image showing waypoint locations given on the Area 20 and Area 40 forecasts in relation to the accident flight  
Source: Google Earth, modified by the ATSB
