In-flight breakup involving Cessna 210, VH-HWY

22 km east of Darwin Airport, Northern Territory | 23 October 2017

ATSB Transport Safety Report
Aviation Occurrence Investigation
AO-2017-102
Final – 9 April 2019

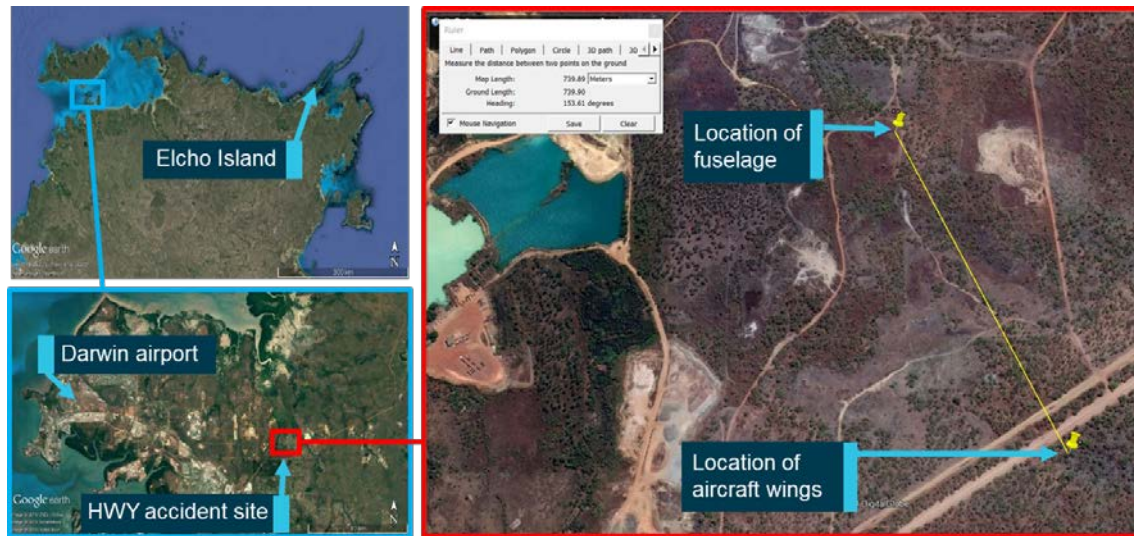
Figure 6: The accident site and location of fuselage and wings

Emergency services started arriving within 10 minutes of the impact. The main fuselage was located less than 1 NM from the aircraft's last recorded radar position. Both of its wings were found about 700 m south-east of the fuselage.

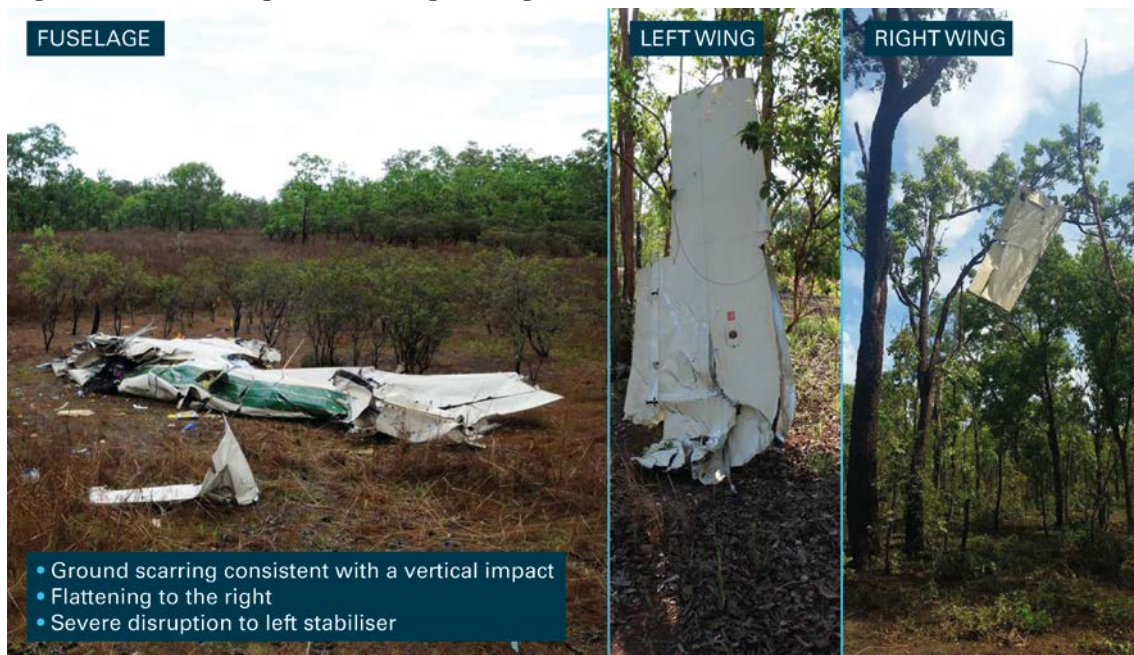
Figure 7: The fuselage, left and right wings

On-site examination of the severely impact-damaged fuselage (Figure 7), engine and propeller identified no pre-existing faults or anomalies that could have contributed to the accident. Examination of the wreckage indicated that the aircraft impacted terrain from a vertical descent, right side slightly down, in an almost level attitude.

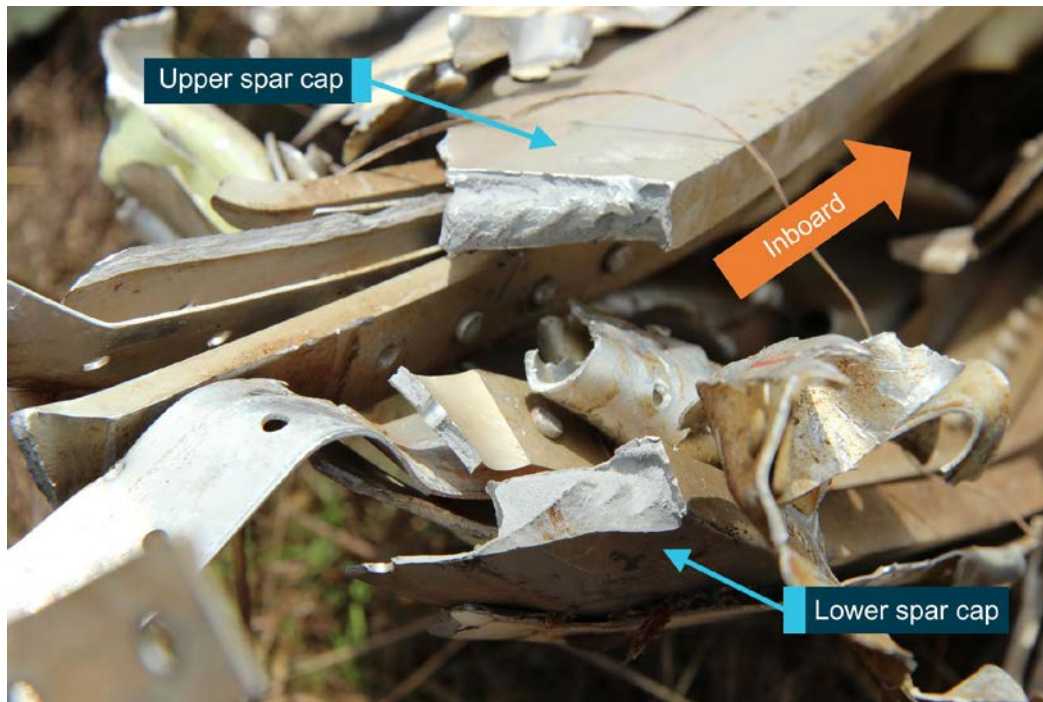
Figure 8: Fractured main spar caps from the right wing

Both wings had separated between 0.5 and 1.5 m outboard from the wing-to-fuselage attachment. Morphology of all fractures within the wing spars indicated that they failed due to overstress, and exhibited bending deformation consistent with forces acting upwards and rearwards on the wings. Examination of the wings showed no evidence of pre-existing defects.

The lower spar cap shows significant local deformation in an upwards and rearwards direction. The upper main spar caps had fractured at two points along their length. The left upper spar cap failed at the location shown in Figure 8. Further inboard, the same spar cap had sheared from the webbing that secured it to the rest of the wing spar. The deformation observed was consistent with buckling due to compressive loads, as the wings were bent upwards with forces in excess of the ultimate positive flight load (Figure 9). In short, the left upper main spar cap deformed enough to damage the wing skin, consistent with buckling due to compressive loads.

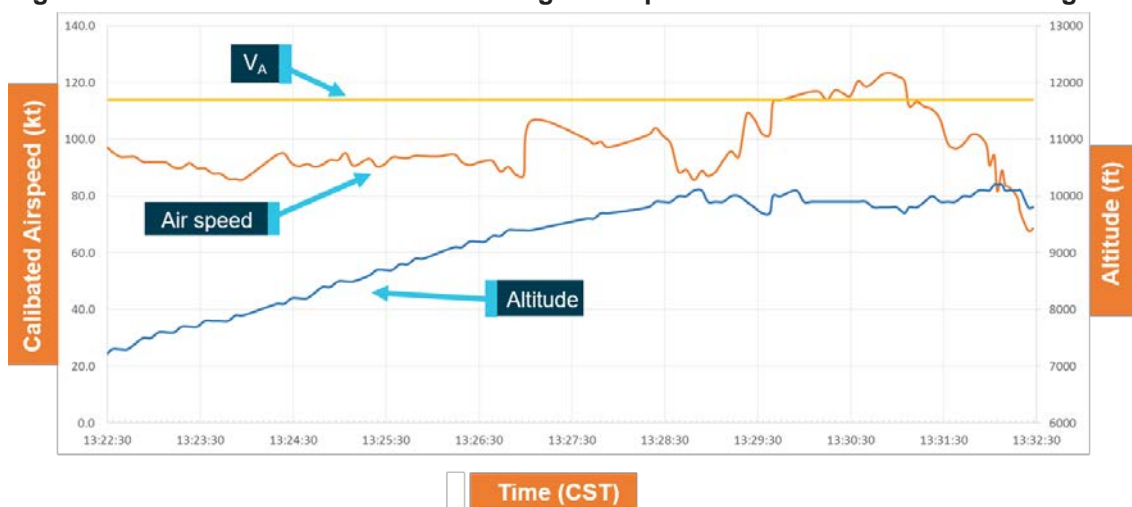
Figure 10: VH-HWY recorded altitude and groundspeed for the last 10 minutes of flight

At airspeeds above the manoeuvring speed, full or abrupt control inputs or turbulence may produce wing loading that can damage the aircraft's structure. At airspeeds above about 145 kt, this loading can result in failure of the aircraft structure.

The following graph depicts the calibrated airspeed with wind corrections based on the forecast, noting that actual wind conditions were unavailable, and may be significantly different due to the proximity to a rapidly developing cell.
