# Hydraulic system failure involving Boeing 757, VH-TCA

Auckland International Airport, New Zealand | 5 February 2018

## ATSB Transport Safety Report

AO-2018-014

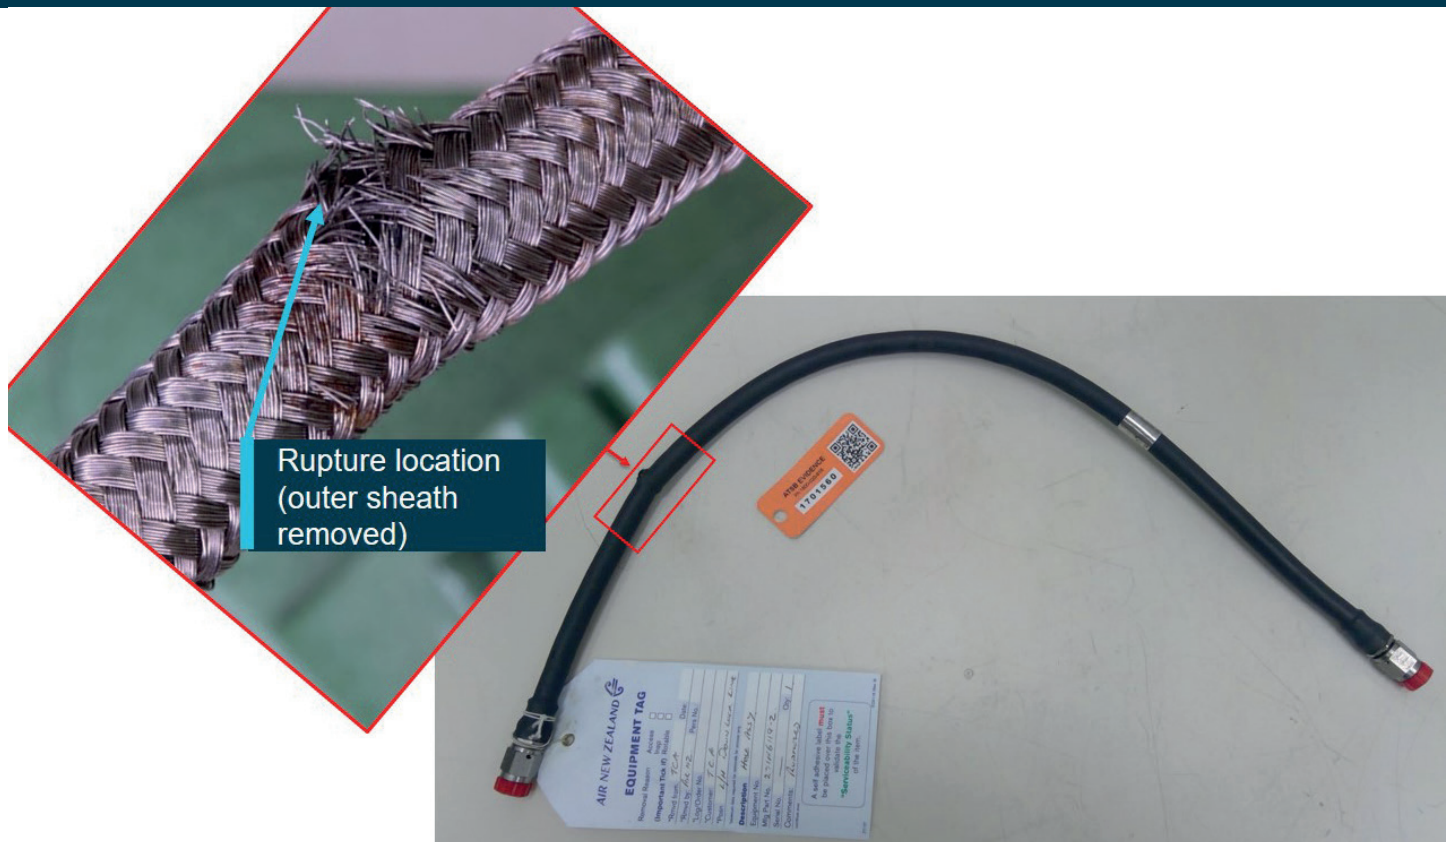
Rupture location  
(outer sheath removed)

The ATSB identified that the dual hydraulic failure was the result of a number of sequential failures in the hydraulic system. The initial failure was a ruptured left main landing gear flex hose, which resulted in a loss of the left hydraulic system pressure. Subsequently, the power transfer unit (PTU) pressure switch did not operate as intended, following depletion of the hydraulic fluid from the left system. This resulted in overheating and failure of the right hydraulic system. The pressure switch was the subject of a 2010 non-mandatory service bulletin which, if implemented, would likely have prevented the failure of the right system.

Following the occurrence, the operator conducted preventative maintenance on the aircraft, replacing all of the main landing gear flex hoses as well as updating the PTU pressure switch to conform to the published service bulletin. In addition, the operator revised the aircraft maintenance plan to introduce improved inspections and a time-limited life on the flex hoses.

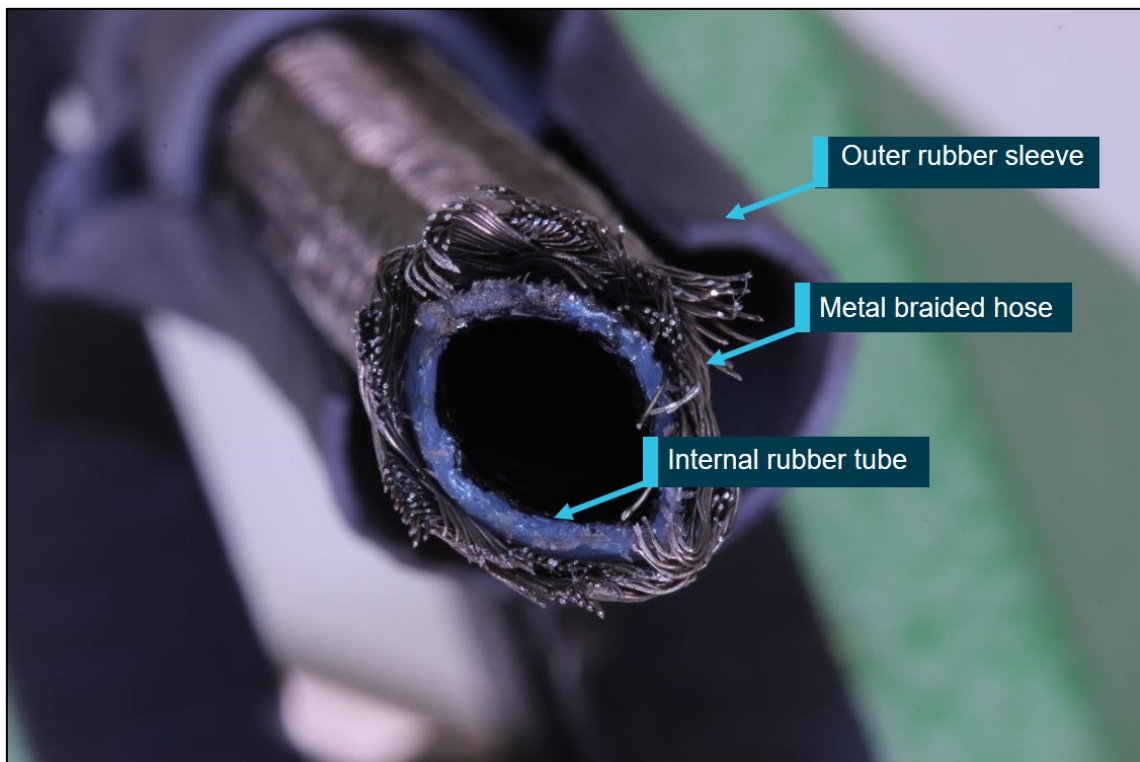
**Figure 3: Hydraulic flex hose construction**

The construction of the hydraulic flex hose consists of three layers; an internal rubber tube, housed in a braided metal hose<sup>3</sup> and covered with a rubber sleeve (Figure 3).

- the chemical composition of the braid material fell within the required specifications
- the direction of the failed wires indicated that the braided hose failed under burst pressure
- the location of the rupture was not coincident with the maximum bend location on the hose, indicating the failure was not due to bending fatigue
- corrosion was limited to the rupture location, indicating that it was likely the wires corroded after the rupture (Figure 4)
- there was some evidence of ductile overstress on the individual wire filaments, but significant corrosion on the fracture surfaces made determination of the failure mode impossible
- no wear, cuts, abrasion or pinching on any of the layers of the hose was evident
- there was no evidence of manufacturing anomalies or kinking/twisting of the hose to indicate improper installation.

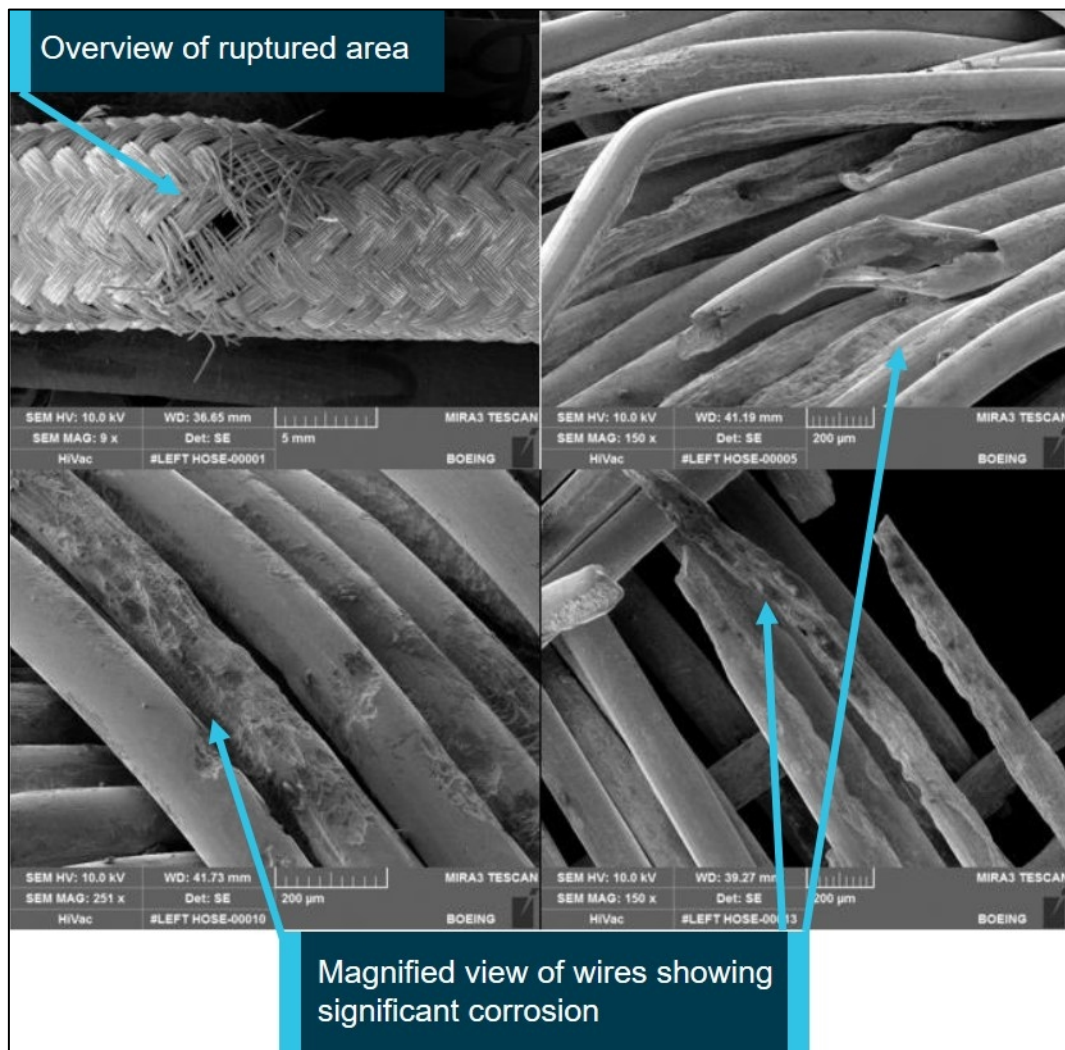
**Figure 4: Scanning electron microscope images of the ruptured area on the left hose**

The sequence of events leading to the dual hydraulic system failure commenced with rupture of the left main landing gear downlock actuator retract flex hose under pressure (during landing gear retraction). This resulted in the depletion of the hydraulic fluid in the left side and, subsequently, low pressure in the left system. The exact mechanism of the rupture could not be determined due to extensive corrosion on the fracture surfaces. However the hose did not exhibit any physical damage that would have made the hose more susceptible to failure.

- During initial climb, the left main landing gear downlock actuator retract hose ruptured, resulting in the failure of the left hydraulic system. The cause of the rupture could not be determined.
- After the loss of the left hydraulic system, corrosion inside the power transfer unit (PTU) pressure switch resulted in an overrun of the PTU system and subsequent overheat failure of the right hydraulic system.

- A 6-year soft life on all main landing gear flex hoses (replacement of hoses after 6 years rather than just on condition replacement) was introduced.

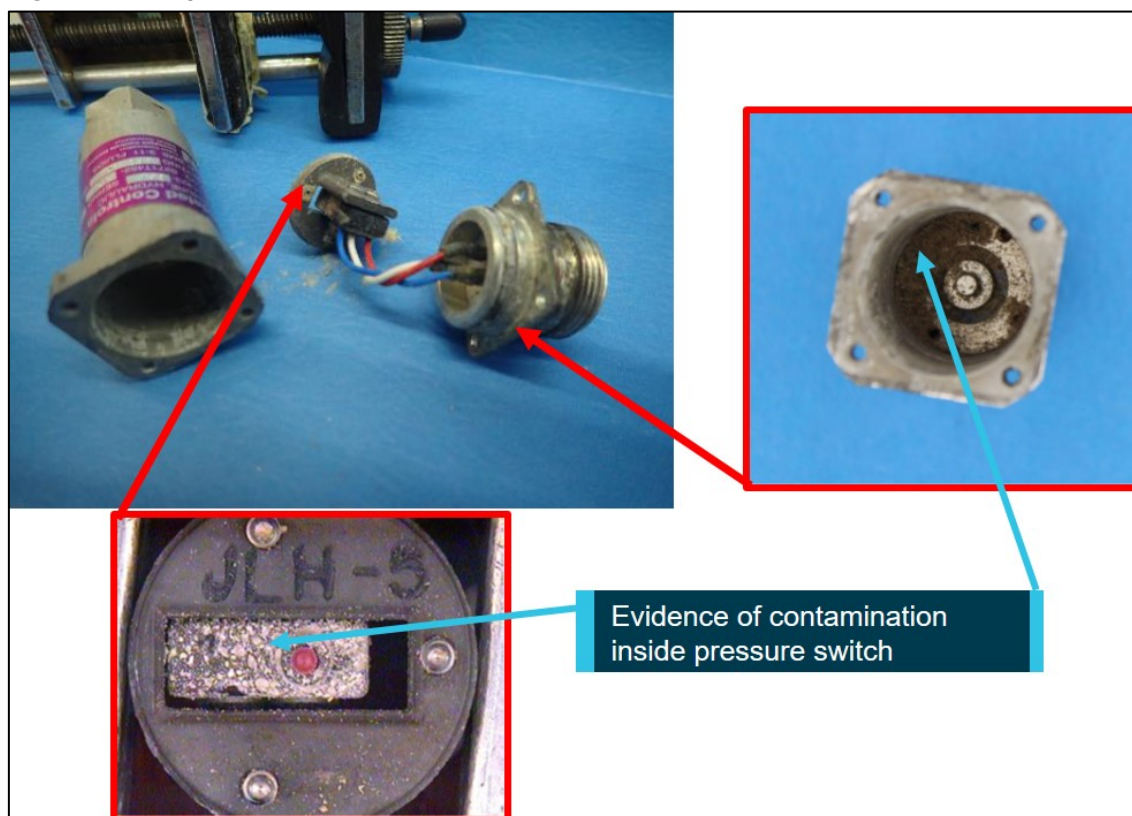
**Figure 5: PTU pressure switch installed on VH-TCA**

The examination of the PTU pressure switch revealed that the electrical switch contacts were stuck in the 'normally open' state due to an excessive amount of contamination on and around the electrical switch button. The contamination prevented the switch from returning to the 'normally closed' (unpressurised) condition. The visual appearance of the contamination was consistent with corrosion, as identified in the 2010 SB (SB 29-09-05-02).

Visual examination revealed a large amount foreign object debris (FOD) throughout the entire unit. Indications were that the FOD entered the unit past the O-ring seal between the receptacle and the unit housing (Figure 5).

After the crew shut down the left system, the right hydraulic system overheated due to the power transfer unit (PTU) pressure switch being stuck in the open position and the associated pump running continuously without hydraulic fluid in the left hydraulic system. These events were consistent with the failure sequence reported in the 2001 and 2010 service bulletins. The non-mandatory 2010 service bulletin to modify the susceptible PTU switch had not been actioned, which probably resulted in the failure of the pressure switch due to contamination/corrosion.

- Nose landing gear and main landing gear hydraulic flex hoses were all replaced.
- The 2010 SB for the power transfer unit pressure switch was incorporated.
