Near grounding of *Aquadiva*

Newcastle Harbour, NSW | 12 February 2017

ATSB Transport Safety Report
Marine Occurrence Investigation
330-MO-2017-002
Final – 4 September 2018

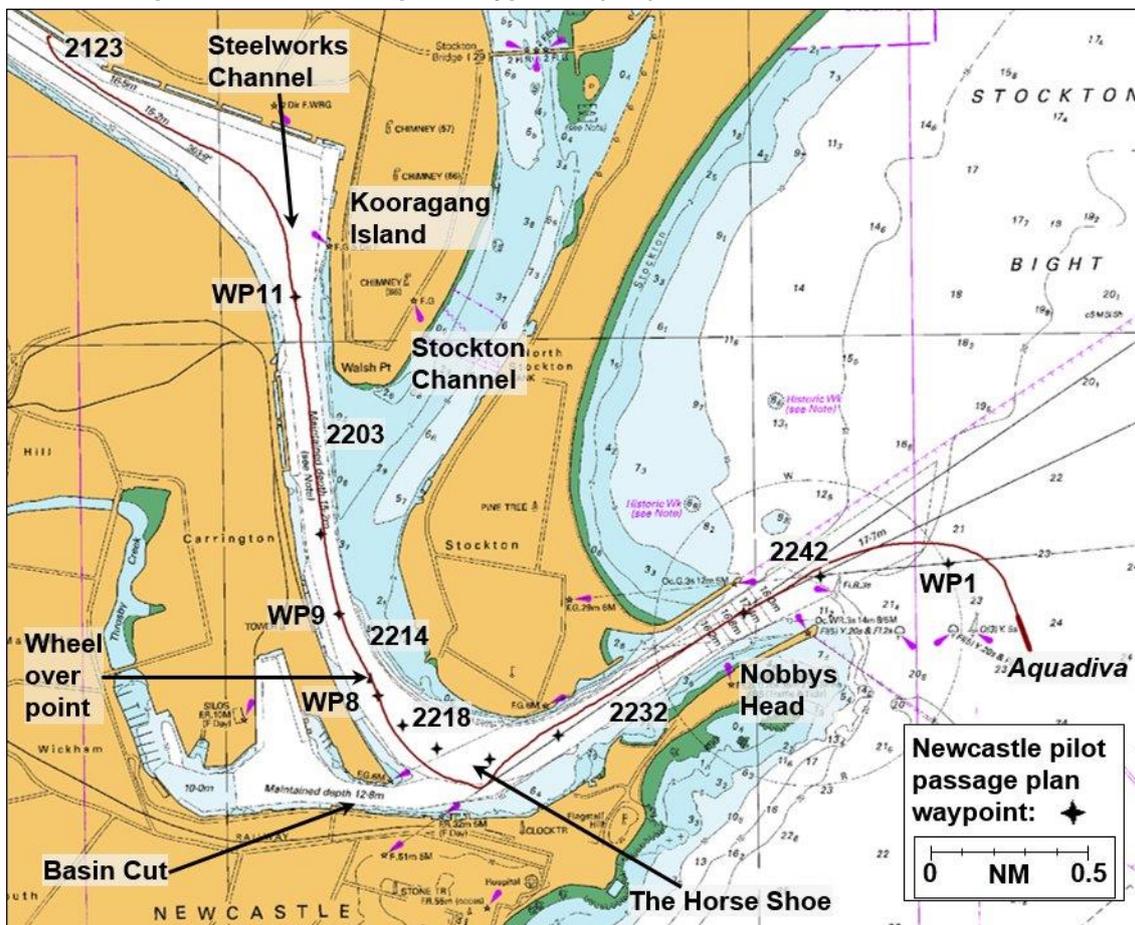
Figure 2: Extract from navigational chart Aus 207 showing *Aquadiva*'s track departing Newcastle; position times and port waypoints (WP) indicated

At 2123, with the four tugs in attendance, dead slow ahead was ordered and *Aquadiva* was under way (Figure 2 and appendix A). The pilot conned *Aquadiva* south, clear of Kooragang Island, and into the Steelworks Channel at about 3 knots.² At 2203, the pilot ordered slow ahead on the main engine and the ship's speed increased.

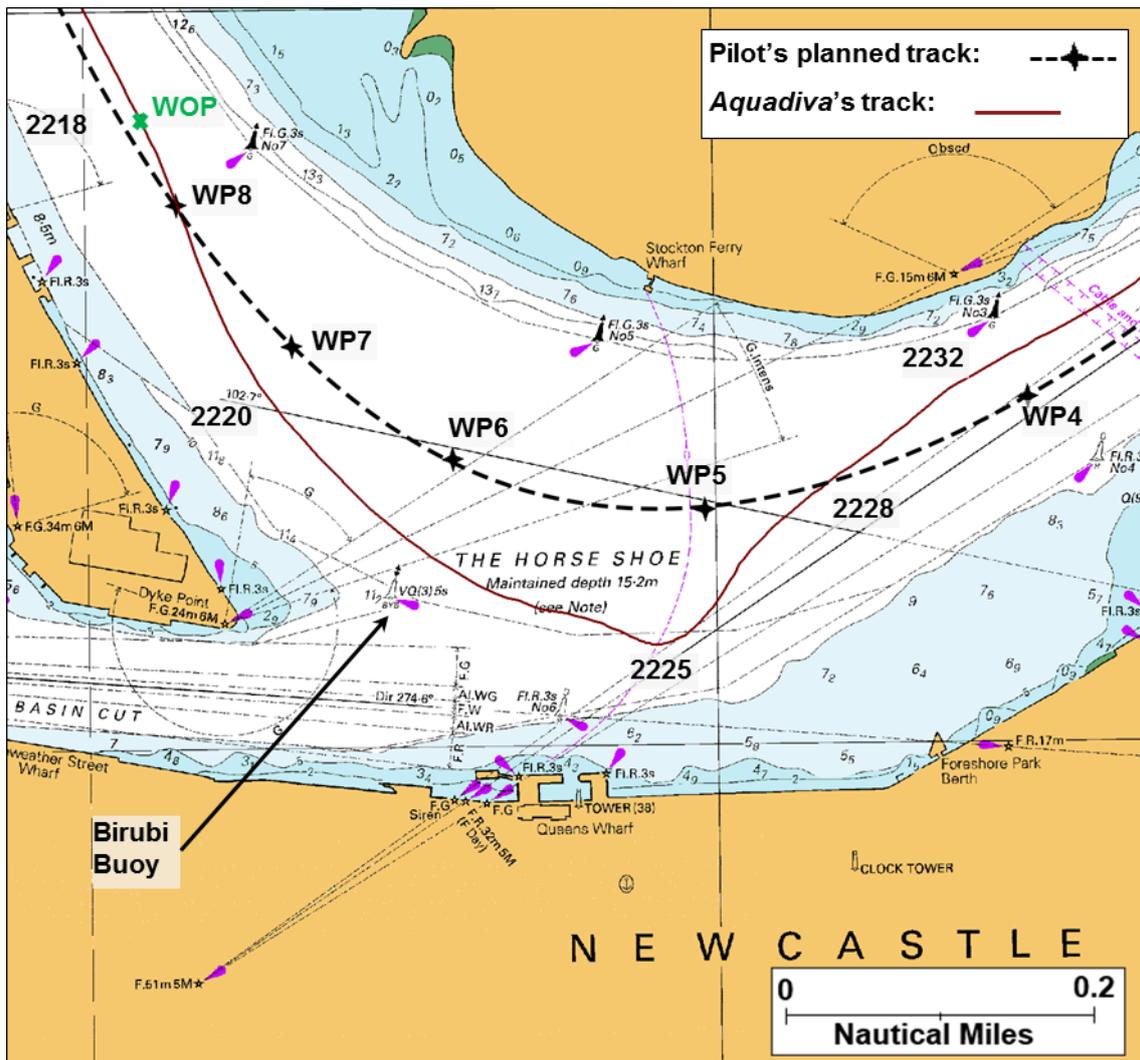
Figure 3: Extract from navigational chart Aus 208 showing *Aquadiva's* track through The Horse Shoe

The pilot's plan was for a speed of about 4.7 knots as the ship approached the wheel over point (WOP)³ for the alteration, about 120 m before WP8 (Figure 3). At 2218, at 5.1 knots, the pilot ordered 10° of port rudder followed by 20°. He wanted a rate of turn of about 13°/minute and he closely monitored the ship's rate of turn indicator, which was mounted overhead in the bridge front. The ship's bow turned to port while the ship continued to track almost straight ahead. Hard port rudder was ordered and, at 2220, the ship began to slow and turn to port. The pilot reported that he continued to focus on the rate of turn indicator to see if the ship was turning as quickly as desired.⁴

A short time later when he checked the ship's position by looking out of the windows, the pilot saw that the ship was deeper into The Horse Shoe than expected. It was now south of his intended track and closing on the east cardinal buoy⁵ (Birubi buoy). The buoy indicated safe water to the

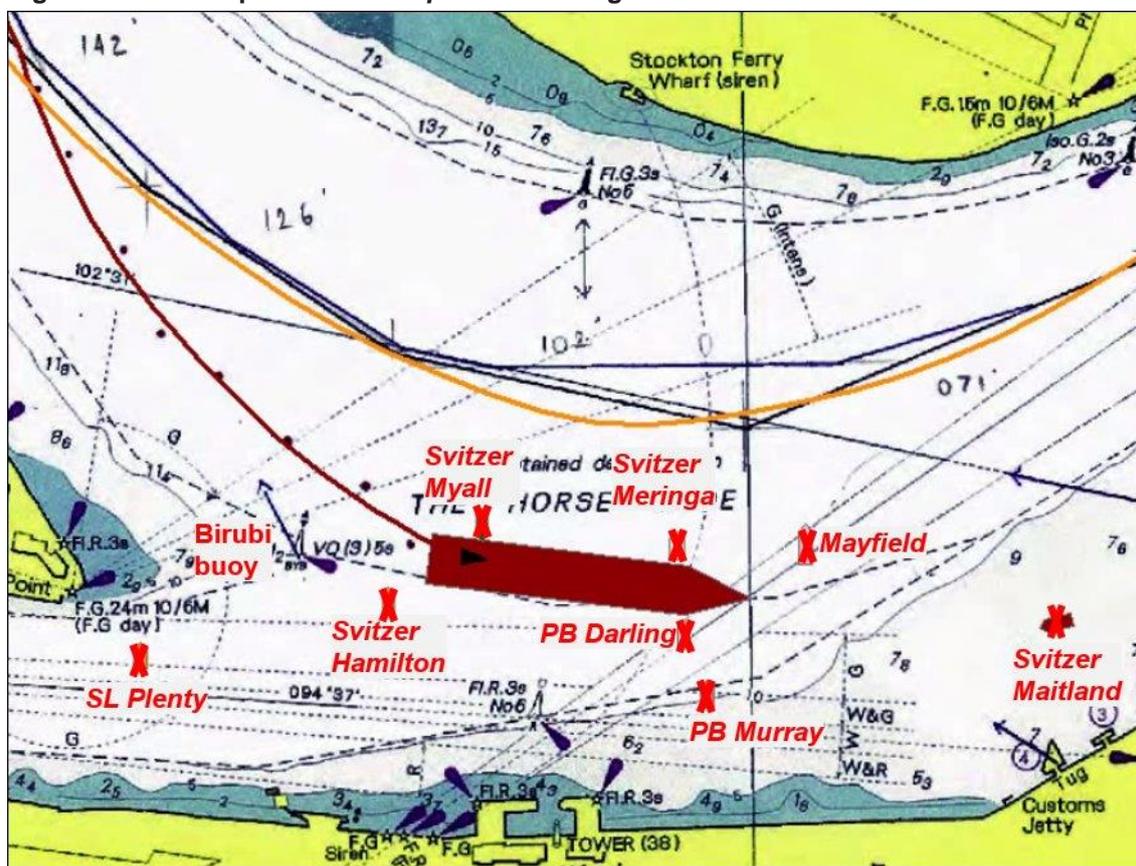
Figure 4: Relative positions of *Aquadiva* and tugs at 2223

At this stage, *Aquadiva* was north of Birubi buoy with a speed of 4.9 knots, on a heading of 116° and course over the ground of 134°. At 2222, the pilot ordered the main engine slowed and then astern. At 2223, now past the buoy (Figure 4) the engine was briefly at full astern before being returned to stop and then dead slow ahead.

At about the same time, *Svitzer Hamilton* had avoided Birubi buoy and repositioned to apply weight to take the ship's stern to starboard. *PB Darling* had also been manoeuvred to push up on the ship's starboard shoulder to move the bow further to port.

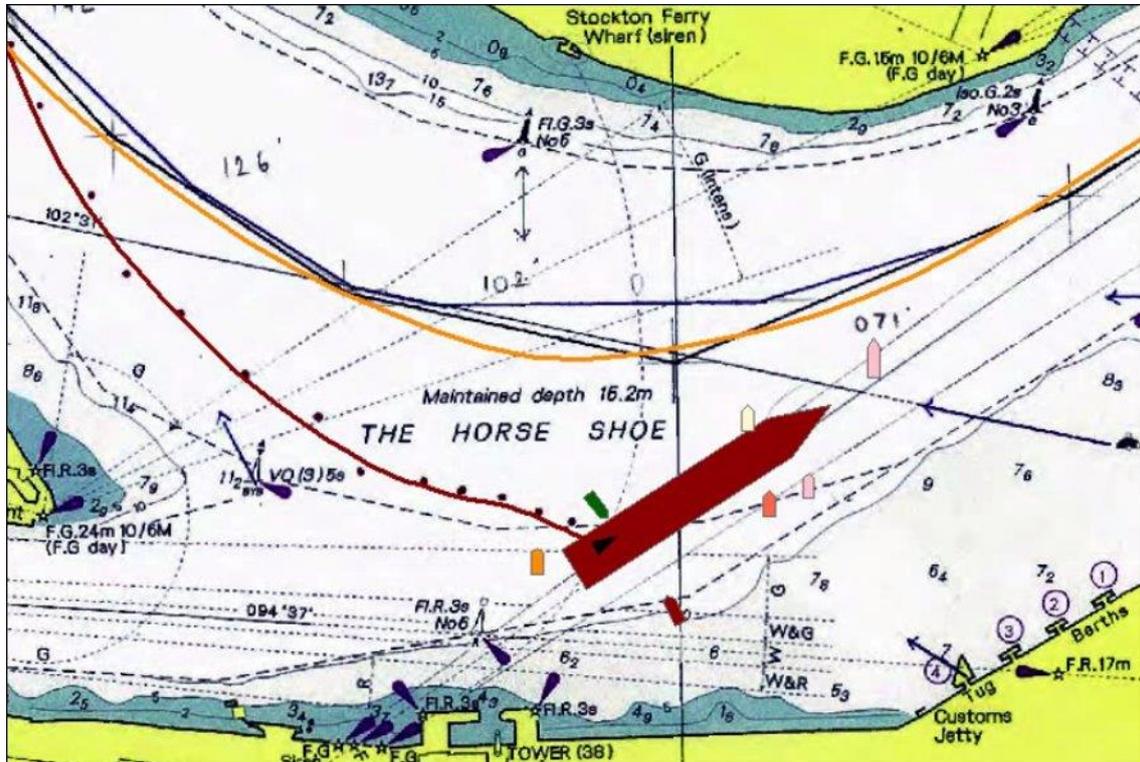
Figure 5: *Aquadiva* in its most southerly position at 2225

Aquadiva's speed continued to reduce. At 2224, the speed was 2.6 knots and the ship's bow continued to swing to port. The ship was now on a heading of 087° and positioned along the southern edge of the channel. The pilot ordered all tugs to stop. The ship continued to swing to port and, at 2225, was on a heading of 068° with a speed of about 2 knots (Figure 5). The pilot

then ordered slow ahead, followed by half ahead on the main engine. From this point, the ship was successfully manoeuvred back into the channel.

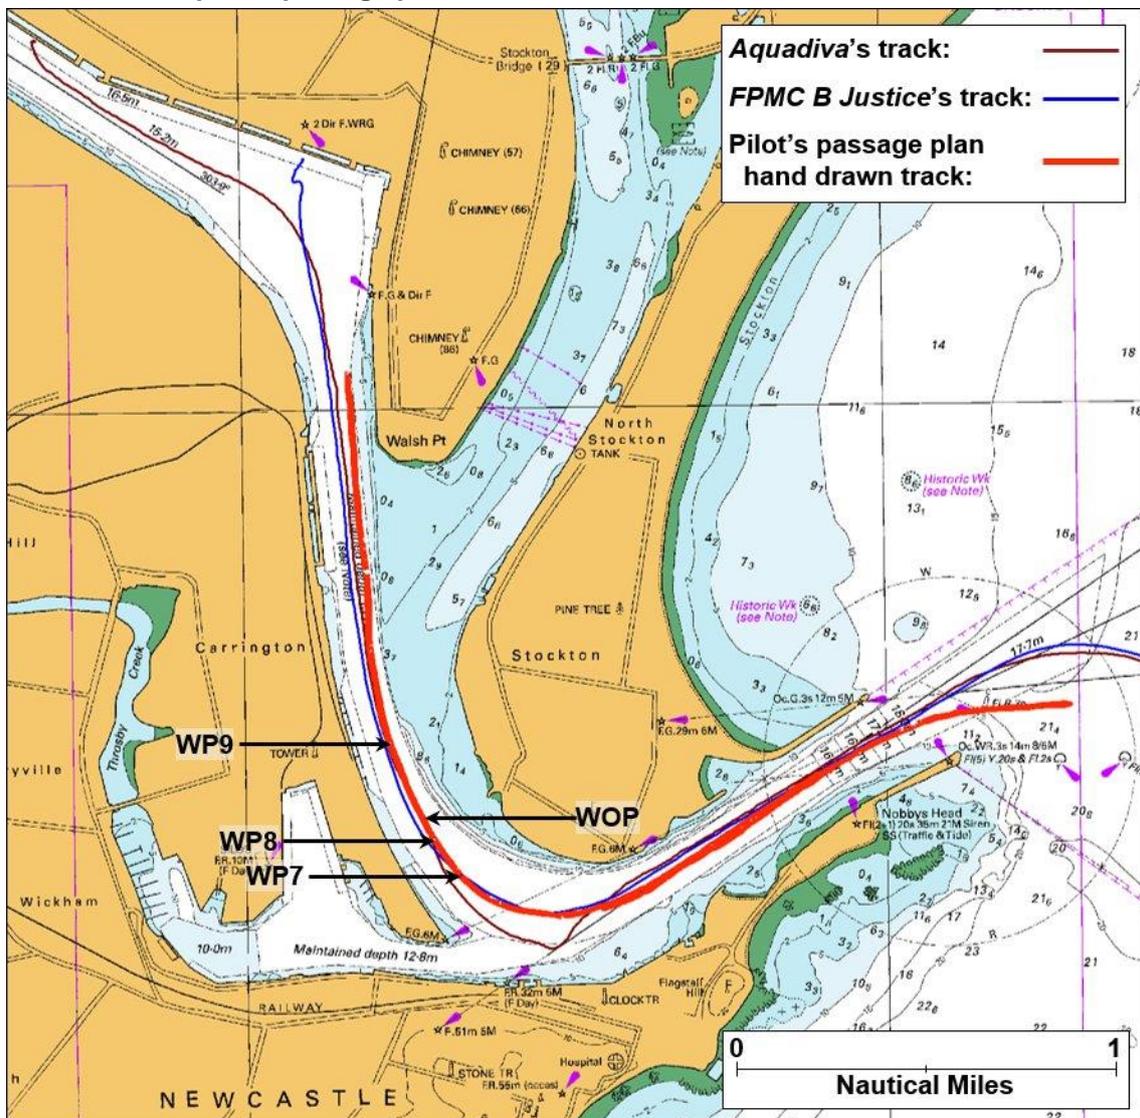
Figure 6: Extract from navigational chart Aus 207 showing a comparison between ship tracks and the pilot's passage plan track

As *Aquadiva* was piloted down the Steelworks Channel (Figure 6), the ship was close to the middle of the channel, as per the pilot's and ship's passage plans. However, as the ship approached the course alteration to port, insufficient rudder was applied to achieve the necessary rate of turn to successfully make the turn. The pilot was distracted and the ship moved sideways (slewed), wide into the turn, south of the intended route and toward the outer limits of the channel. At 2224, the ship had slowed to 2.6 knots and was atop the deep water channel 15.2 m contour, at risk of grounding. With the assistance of additional tugs, the ship's sideways movement was controlled and it was subsequently returned to the channel and the intended route.

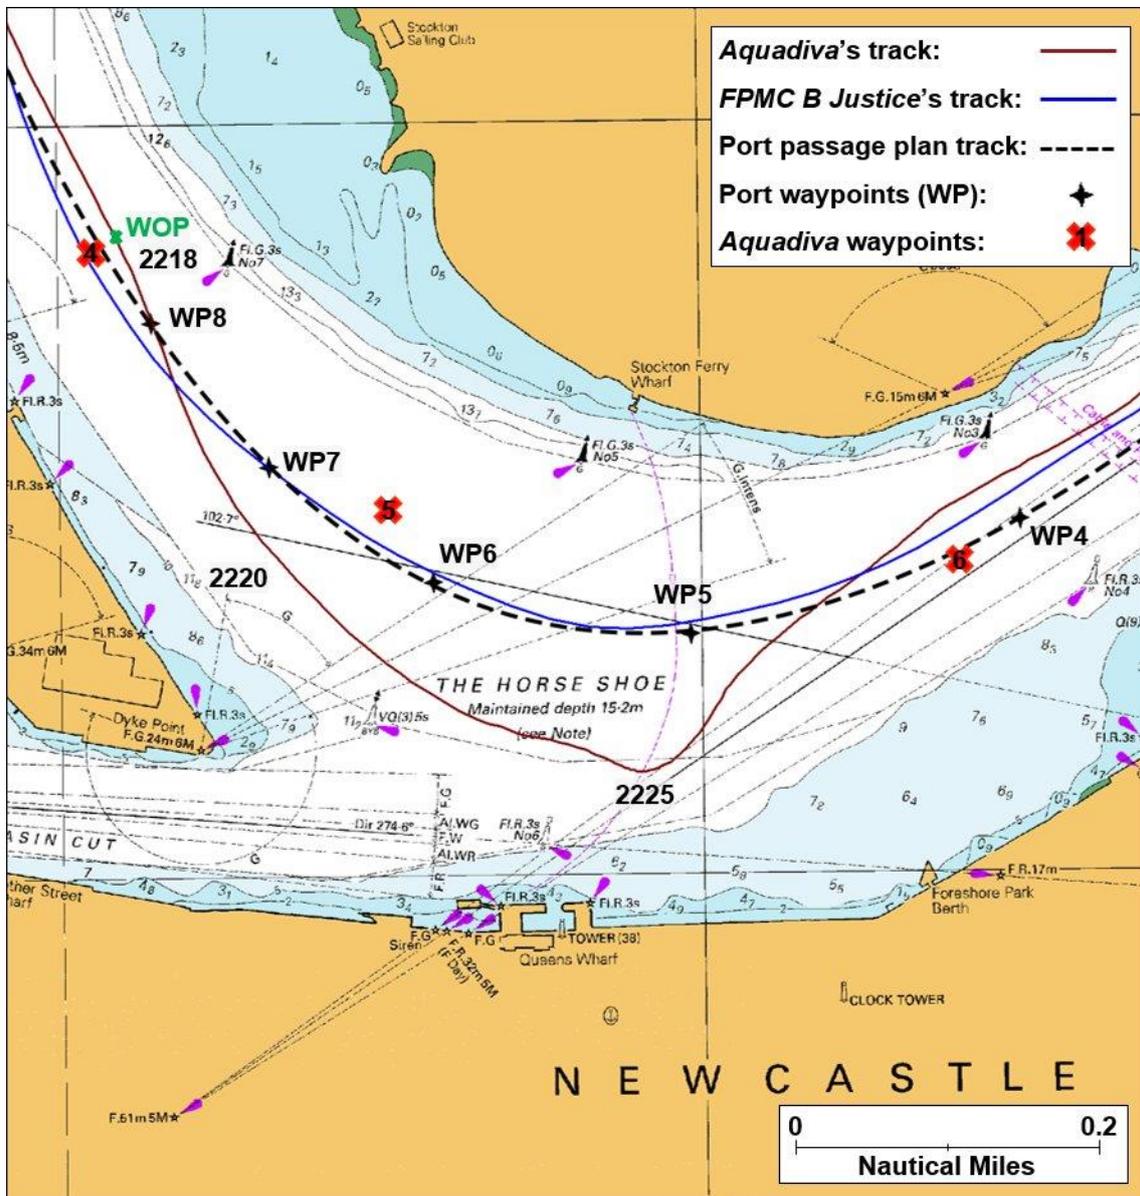
Figure 7: Extract from navigational chart Aus 208 showing comparison of tracks and waypoints through The Horse Shoe

Aquadiva's pilot intended to follow the port's passage plan (appendix D), passing through the waypoints. The ship passed through waypoints 9 and 8 as it approached the wheel over point (WOP) for the course alteration through The Horse Shoe (Figure 7). At this point, it was the pilot's usual practice to apply sufficient rudder to get the ship to turn at about 2½ times the ship's speed (about 13°/minute). On this occasion, the ship did not turn as expected and the pilot stated that his attention was focussed on the ship's rate of turn indicator. Shortly after, as the ship passed to the west of WP7, it was turning, but not quickly enough to complete the turn.

The ship continued to turn too slowly despite the application of full port rudder. However, by the time the pilot looked outside the bridge and noticed this, the ship was already significantly off course. At 2225, the ship was about 1 cable (185 m) south of waypoint 5, in a position over the outer limits of the 15.2 m channel, possibly touching bottom.

In comparison, *FPMC B Justice* had taken the turn through The Horse Shoe about 15 minutes before *Aquadiva*. Its pilot had applied rudder to commence the turn at WP9, about 3 cables before WP8. The ship began turning and, as it passed *Aquadiva*'s WOP, its rate of turn was greater than 10°/minute and the turn was under control. Figure 7 shows that the ship then tracked close to or through the remaining waypoints in completing the turn. A rate of turn of 19°/minute was achieved between waypoints 6 and 5.

This comparison shows that not enough rudder angle was applied, early enough, to get *Aquadiva* to turn sufficiently quickly to make the turn. In the critical early stages of the turn, the pilot was distracted from the primary task of monitoring and controlling the turn. This distraction was for a sufficient amount of time for control of the turn to be lost. The situation was not identified and challenged by the ship's crew.
