Collision with terrain involving Diamond DA40, VH-MPM

42 km west of Southport Aerodrome, Queensland | 26 September 2017

ATSB Transport Safety Report
Aviation Occurrence Investigation
AO-2017-096
Final – 22 May 2019

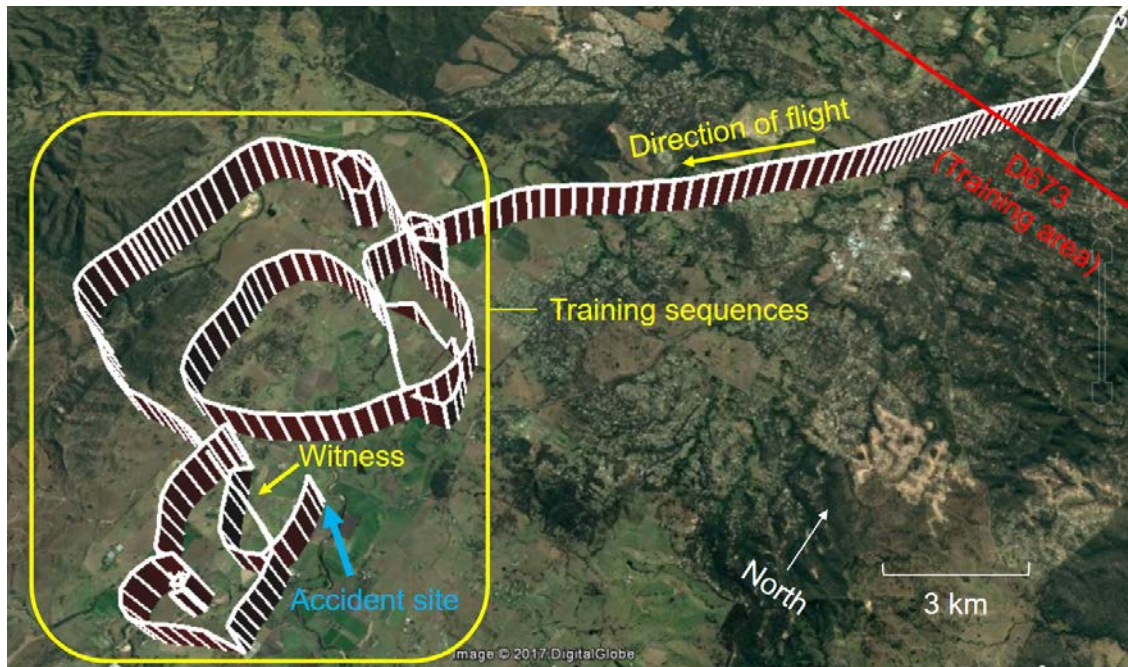
Figure 1: Overview of training area sequences

At 0927, the aircraft entered the training area and commenced sequences consistent with a RPL flight test at altitudes between about 2,600 ft and about 4,500 ft AMSL (Figure 1).²

From about 0939, radar data showed the aircraft conducted several short climbs followed by brief, rapid descents, which also included changes in heading. These manoeuvres were consistent with advanced stall³ recovery training (see *Wreckage examination*).

At 0943:08, radar data showed the aircraft commence a climb to about 4,500 ft with a reducing groundspeed, consistent with further stall recovery training. The data then showed the aircraft's flight path to be a near vertical descent with an average descent rate of about 6,000 feet per minute.

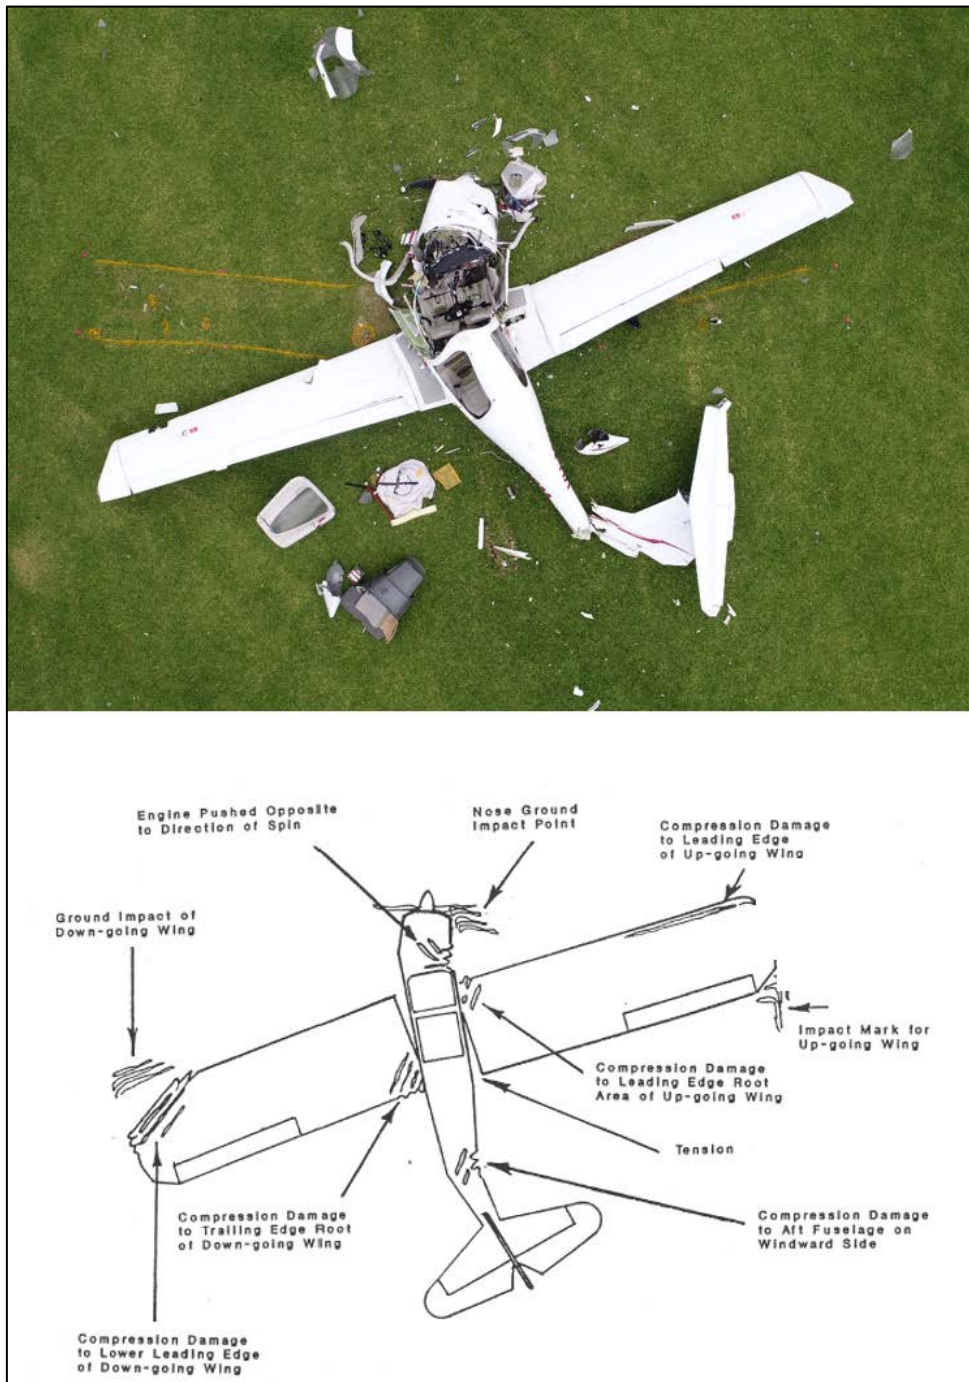
Figure 2: Wreckage comparison

The aircraft impacted terrain at an elevation of 167 ft above mean sea level. On-site examination of the wreckage and surrounding ground marks indicated that the aircraft impacted terrain left wing first, nose-down and rotating to the left at low forward speed. This was consistent with a left upright spin (Figure 2).

The forward fuselage separated at the engine firewall. The wings, centre fuselage, and rear fuselage all separated in a direction consistent with a left spin. Evidence from examination of the engine and propeller was consistent with the engine producing low power at the time of the accident. Although the throttle position could not be determined from the wreckage, evidence from the engine and propeller corresponds to the recommended power setting for spin recovery (idle).

The positions of the rudder, ailerons and elevator at the time of the accident could not be determined, however the wing flaps were retracted. Both fuel tanks were ruptured and the fuel selector was selected to the left fuel tank.

Examination of the wreckage and maintenance documentation found no evidence of a pre-existing problem that may have contributed to the accident. The accident was not survivable.

Sufficient height was available for the aircraft to recover under normal conditions, however, the flight crew did not recover from the spin before colliding with terrain. Examination of the wreckage showed that the aircraft was in a left spin when it impacted the ground.

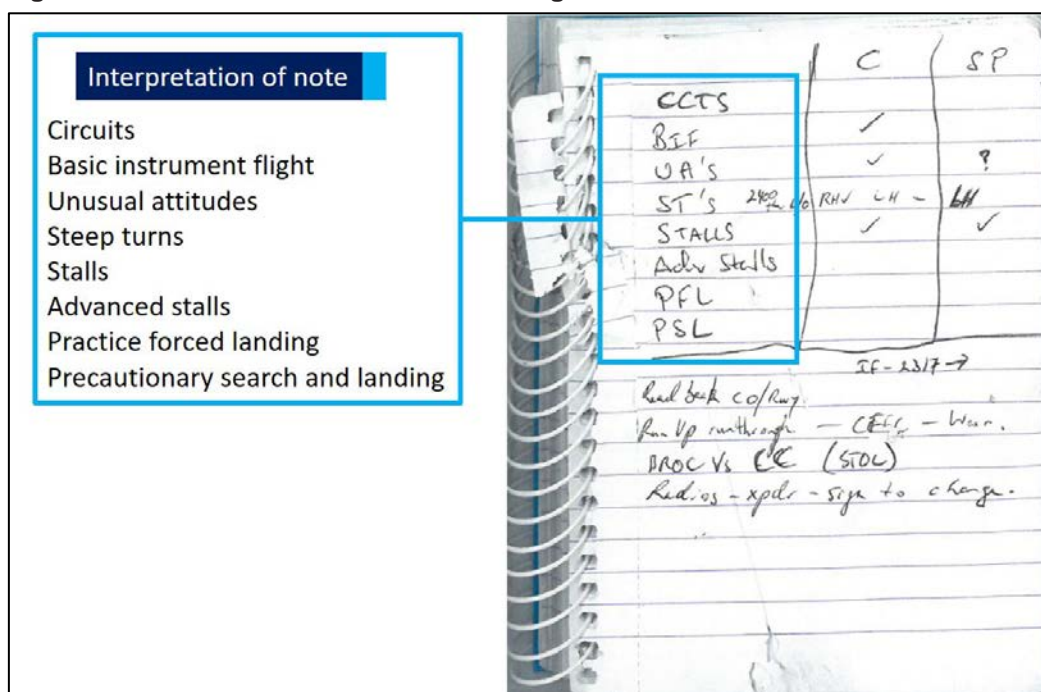
Figure 3: Instructor's note from accident flight

A handwritten note (Figure 3) was found in the cockpit and was determined to relate to the accident flight. The note listed the following sequences to be conducted in the training area:

The order of sequences and markings on the note aligned with the aircraft movements captured by radar. The note indicated that the sequences up to and including stalls had been completed. At the time the aircraft entered the spin, the instructor and student were likely conducting the next incomplete item on the list, which was advanced stall recovery training.

The instructor's note, found within the wreckage, along with radar data, indicated that they were conducting an advanced stall sequence at about 4,300 ft above ground level when the aircraft entered a spin.
