Loss of engine power and forced landing involving amateur-built Europa Classic, VH-BWI

Near Bridport, Tasmania | 17 July 2016

ATSB Transport Safety Report

AO-2016-077

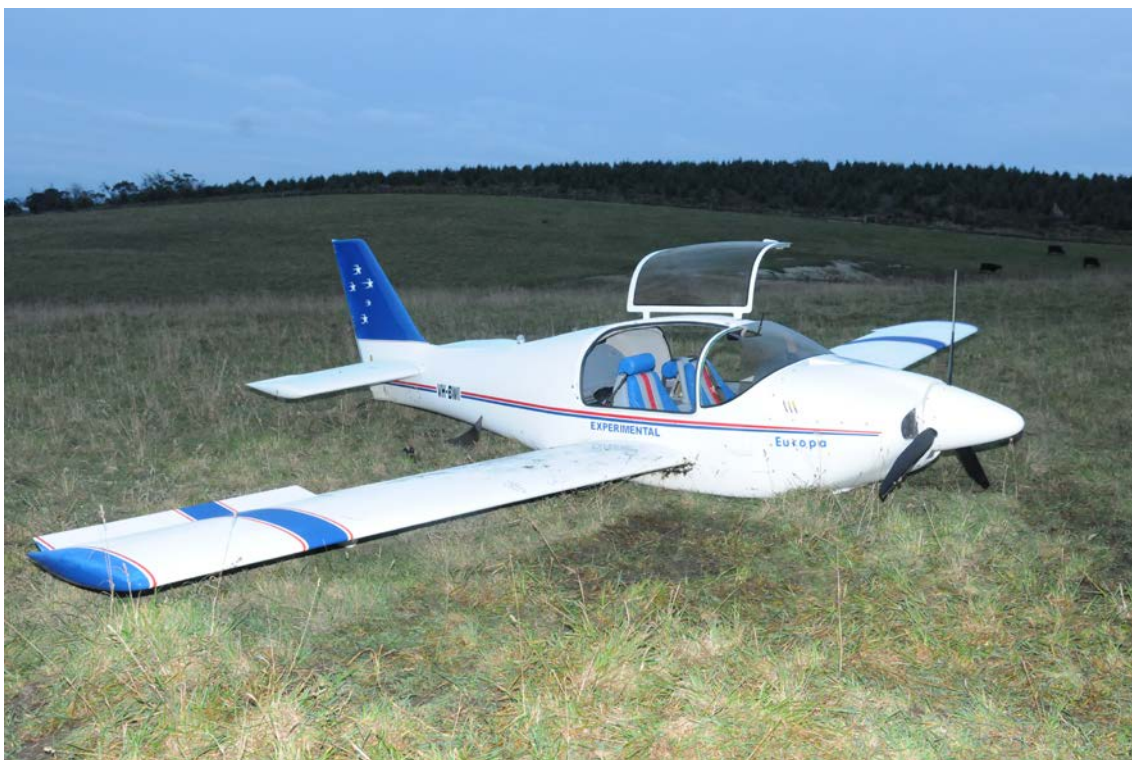
On the afternoon of 17 July 2016, two pilots departed Bridport Aerodrome in Tasmania in an amateur-built, Europa Aircraft Classic registered VH-BWI and operated in the experimental category. The ownership of the aircraft had recently been transferred and the purpose of the flight was a familiarisation flight for the new owner. After flying to the north-east of Tasmania, the aircraft returned to Bridport and completed two touch-and-go circuits. Shortly after take-off on the third circuit the engine spluttered for a short time, before stopping completely. A forced landing was conducted in a nearby paddock. One pilot sustained spinal injuries and the aircraft was moderately damaged.

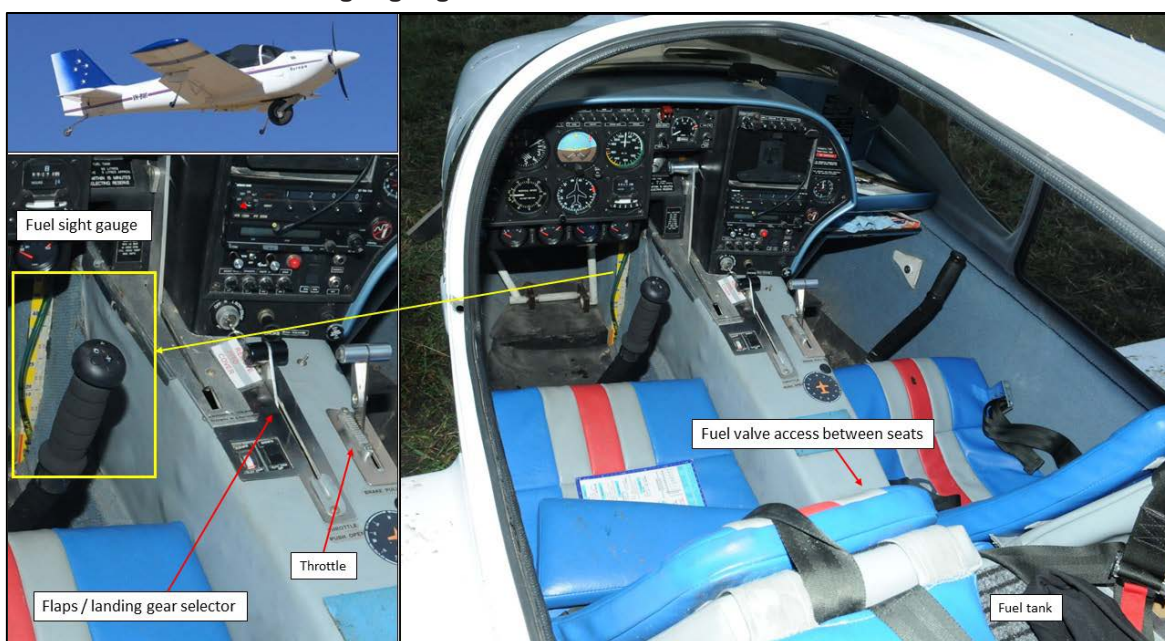
Figure 1: VH-BWI and cabin interior showing component locations. Note the instrument panel and fuel sight gauge orientation toward the left pilot. Refer to Appendix A for further detail on the fuel sight gauge.

- removing the centre console cover (refer Figure 1) to access the fuel selector valve. Pilot B was in the unfamiliar right seat and was unsure of the direction required to turn the fuel valve to

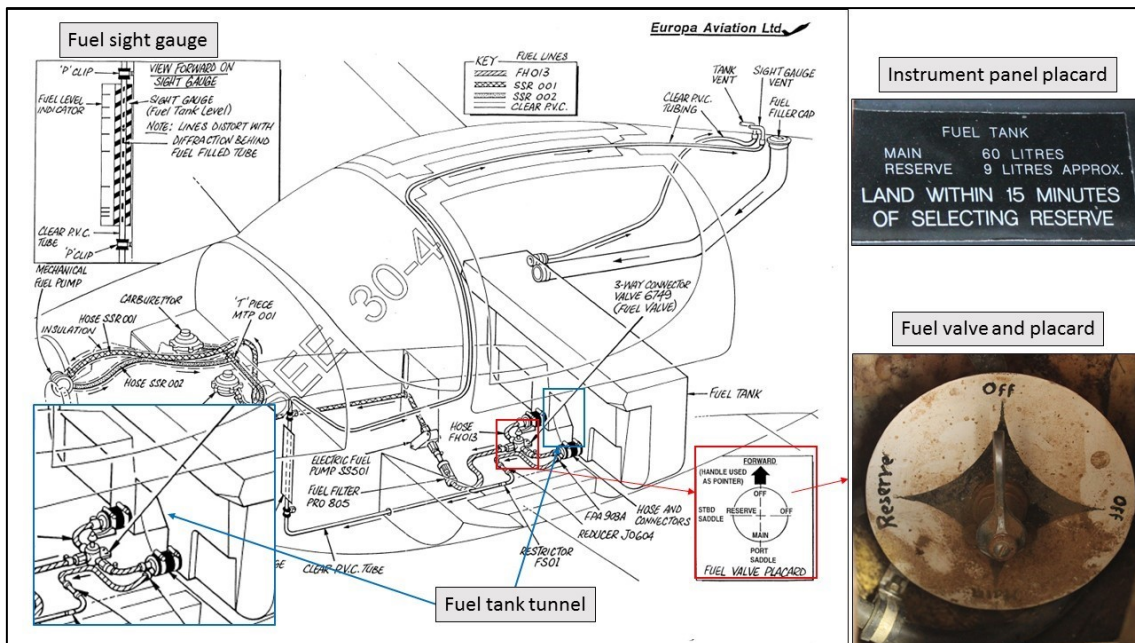
Figure A1: Fuel system components

The fuel system was designed so that the fuel level in the sight gauge was a direct reflection of the fuel available in the main tank, when the aircraft was in a level attitude. If the fuel selector was moved to the reserve tank position, the fuel sight gauge would only indicate correctly until the fuel level reached the level of the top of the tunnel, where the gauge would continue to indicate the amount of fuel remaining in the main tank only. A placard located on the instrument panel advised the pilot to land the aircraft within 15 minutes of selecting the reserve tank (Figure A1).

In 2008 Europa published a 'highly recommended' modification to introduce a fuel filter to each tank outlet, before the fuel selector valve. This modification would allow the selection of the alternate tank in the event of a filter blockage, to enable continued fuel flow to the engine. BWI did not have this modification incorporated.

Pilot B reported to replacing the sole fuel filter, with a locally purchased automotive type. This maintenance was not certified in the aircraft log book. The Europa recommended PRO 805 filter was cleanable and encased in transparent toughened glass. It reportedly filtered to 52 micron and had a maximum pressure of 7 psi. The automotive Ryco Z200 filter was reported to filter at a nominal 6-7 micron. Use of a non-standard filter could inadvertently affect fuel system operation. The filter element was examined by the ATSB and found to contain debris in the form of fine dust. The amount of debris in this instance was not considered to be sufficient for filter blockage. However, if left unchecked, accumulation of debris in the original single filter installation, had the potential to interrupt fuel flow to the engine.

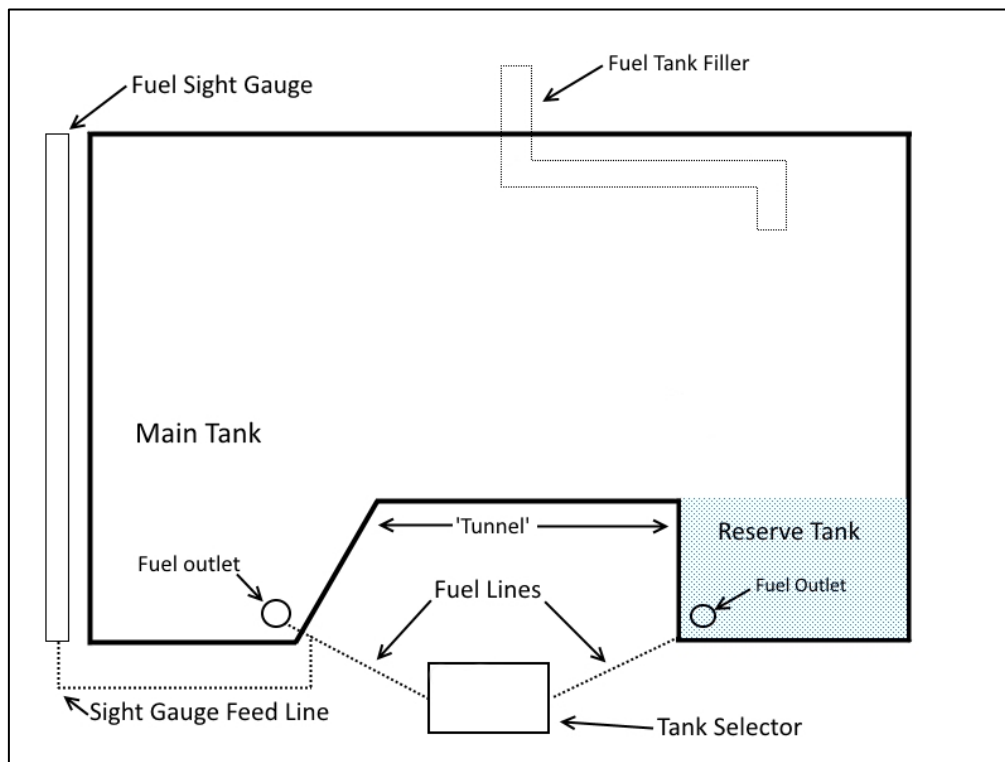
The fuel valve was likely selected to the reserve tank for the duration of the flight. Due to the design of the tank, the fuel sight gauge would have continued to indicate (in level flight) the remaining 10 litres of fuel in the main tank as the reserve tank was depleted. A casual observation of the fuel gauge while in this condition would not have led to any significant concern about the fuel quantity remaining (10 litres in the main tank and about 10 litres in reserve provided over an hour's endurance). If the fuel selector was on the main tank for the flight, the same amount of usable fuel would have been available, however the fuel sight gauge would have correctly reflected the depletion of fuel from that tank.

Europa reported that when the fuel level was below the tunnel it was possible for fuel to 'slosh around' between the main and reserve, as there were no tank baffles. Additionally, the fuel tank outlets were oriented high during take-off and other 'nose up' aircraft attitudes. These conditions could result in 4 or 5 litres per tank being unavailable to the fuel outlets. The unusable fuel quantity could vary between aircraft, depending on the differences in each build, turbulence and aircraft attitude.

Figure A2: VH-BWI fuel tank schematic (not to scale), as viewed from the rear of the aircraft. The reserve tank is shown shaded and the remainder is the main tank.

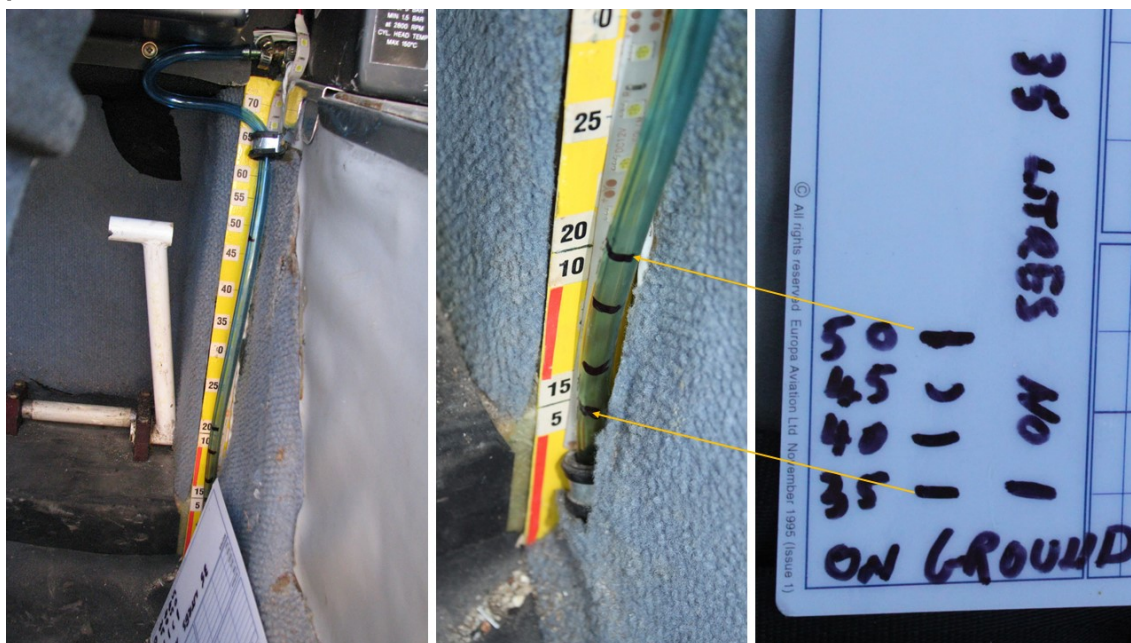
Figure A3: Fuel quantity scale located behind the fuel sight gauge. Four black marks correspond with the Pilot Check Card marks and figures that were developed following pilot B's fuel calibration.

Pilot B reported to not fully understanding the fuel system on BWI. In addition, pilot B noted that there was no method of determining the amount of fuel in the tank while the aircraft was on the ground in a tail-low attitude. Pilot B therefore conducted another fuel calibration, shortly after purchasing the aircraft. However, that calibration was not in accordance with the Europa documented procedure. It was also not recorded in the aircraft log book and the calibration figures noted within the aircraft. Pilot B's method of calibration involved draining both sides of the fuel tank and then adding fuel in five litre increments. They reported that it took the addition of about 35 litres of fuel to the tank before the sight gauge displayed a fuel quantity.

Marks equal to the incremental fuel amounts were drawn on the bottom of the fuel sight gauge tubing. There were no quantities of fuel recorded on either the tube or scale, however corresponding marks were annotated '35', '40', '45' and '50' on the back of the aircraft checklist card. The intent was to align the card with the black marks on the sight gauge tubing, which would then indicate the on-ground fuel quantity in litres. It was also noted that the words 'ON GROUND' were included next to the marks on the card (Figure A3).

¹⁹ The scale indication of 10 litres in the reserve was not consistent with the fuel calibration figure of 9 litres and Owners Manual statement of 8 litres. In this instance however, as the 'in use' reserve fuel quantity is not indicated and there is a placard advising to land within 15 minutes of selecting reserve, this difference is considered acceptable.

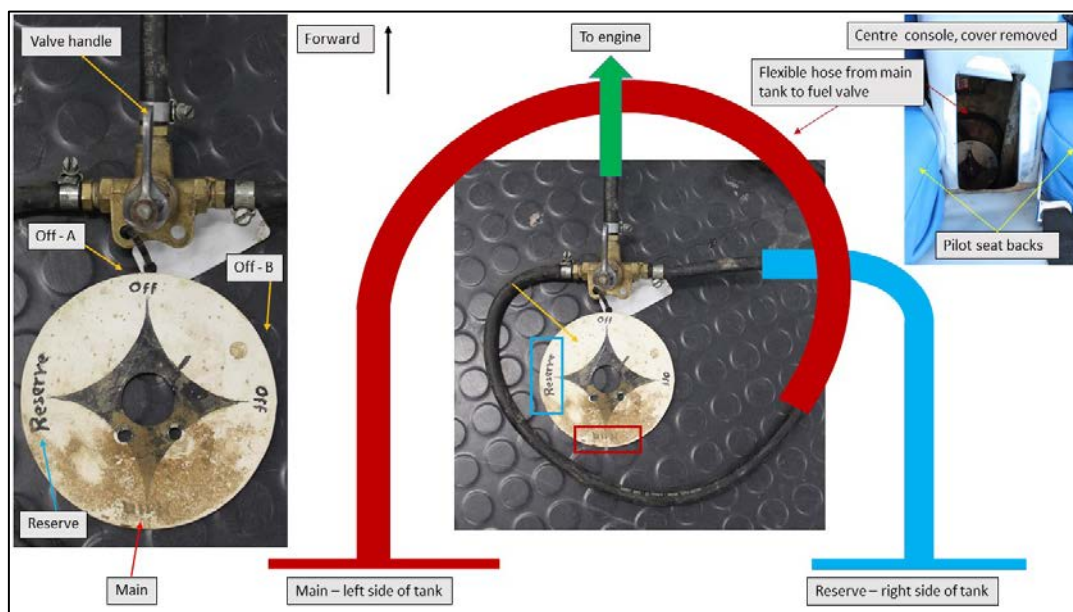
Figure A4: Schematic of fuel valve, placard and associated flexible hoses.

There were two positions marked OFF, either of which would stop fuel flow to the engine. These are marked 'Off – A' & 'Off – B' in Figure A4. To access all usable fuel on board, a positive change of tank from main to reserve, or vice-versa was required. Post-accident examination of the fuel selector valve by the ATSB revealed no abnormalities with the system and that the placard correctly depicted the valve positions.

It was noted that the hose from the main tank to fuel valve was looped around the valve. This was not a Europa-defined arrangement and the reason for it was not determined. It was also noted that if using only the valve handle and hose orientation as a guide, it would be possible to misinterpret the system. This was because the handle orientation was unrelated to the hose supplying fuel.

Post-accident examination of the fuel tank selector found it in the 'Off – A' position (Figure A4). Based on this, the fuel selector was likely to have been in the reserve tank position for the flight.
