Loss of control and collision with terrain involving Cirrus SR22, VH-PDC

Orange Airport, New South Wales | 15 May 2018

ATSB Transport Safety Report
Aviation Occurrence Investigation
AO-2018-038
Final – 6 June 2019

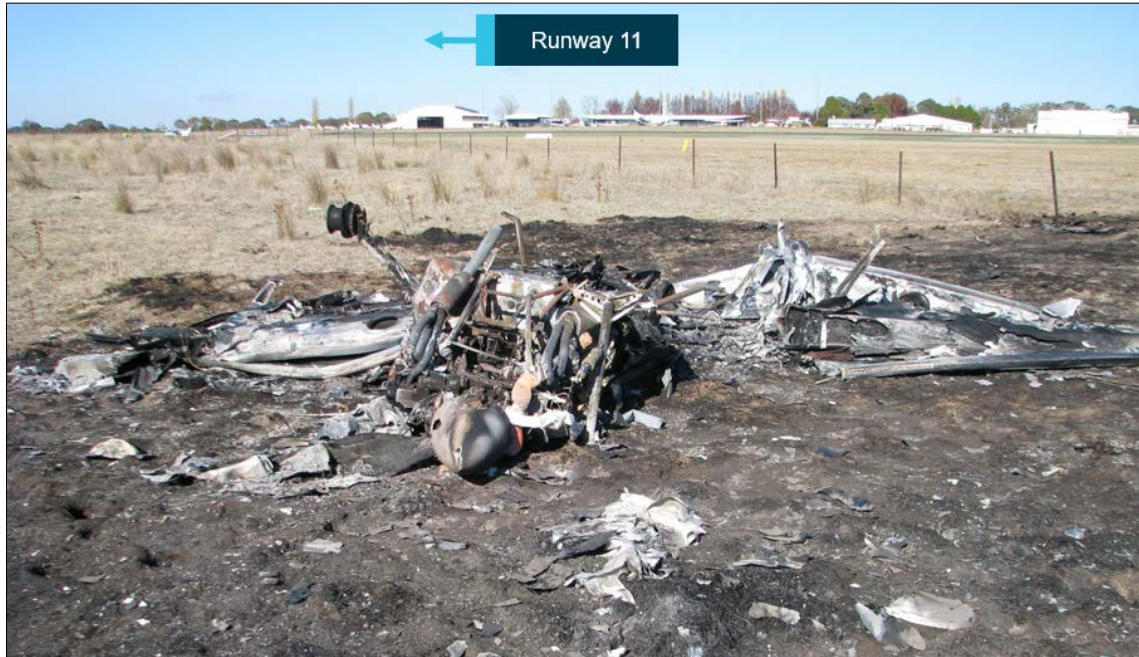
When full power was applied, the aircraft pitched⁷ up. As the pilot was attempting to transition his scan onto the instruments, the instructor, whose attention was on the attitude indicator,⁸ directed him repeatedly to level the wings—'wings level'. The pilot observed the runway lights disappear off to the right and felt the aircraft was in a roll⁹ as he was trying to focus his attention on the attitude indicator.¹⁰ Following a review of the ATSB's draft investigation report, the pilot also reported that he manipulated the flight controls in an attempt to recover the aircraft. Shortly after, the aircraft collided with the ground, struck a fence and came to rest inverted.

The pilot reported that he ‘kicked the pilot’s door window out’ to exit the aircraft, at which stage the wings were alight and a grass fire had started.¹¹ He then pulled the instructor out of the wreckage, who had lost consciousness after becoming disorientated while looking for the emergency egress hammer.¹² Emergency services located at the airport immediately responded to the accident. Figure 1 shows the wreckage site with reference to runway 11. Weather conditions were not considered a contributing factor to the accident.

Figure 1: VH-PDC wreckage

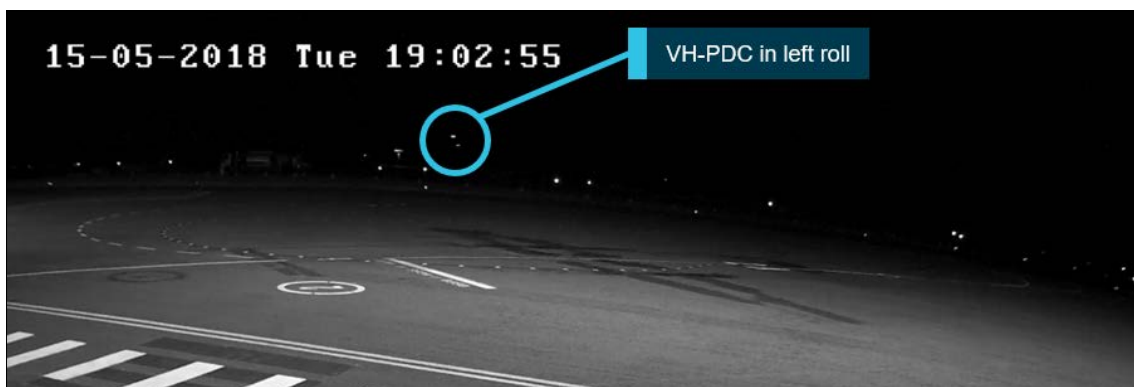
Closed-circuit television footage from Orange Airport depicted the aircraft rolling left at a low height above runway 11 before impacting the ground on the north-east side of the runway at 1903. A small fire ensued after impact, followed by deflagration of the fuel vapour about 7 seconds later. About 9 minutes later, the CAPS¹³ rocket fired. Figures 2, 3 and 4 depict the initial roll of the aircraft, deflagration of the aircraft fuel vapour and firing of the CAPS rocket.

Figure 2: VH-PDC in left roll

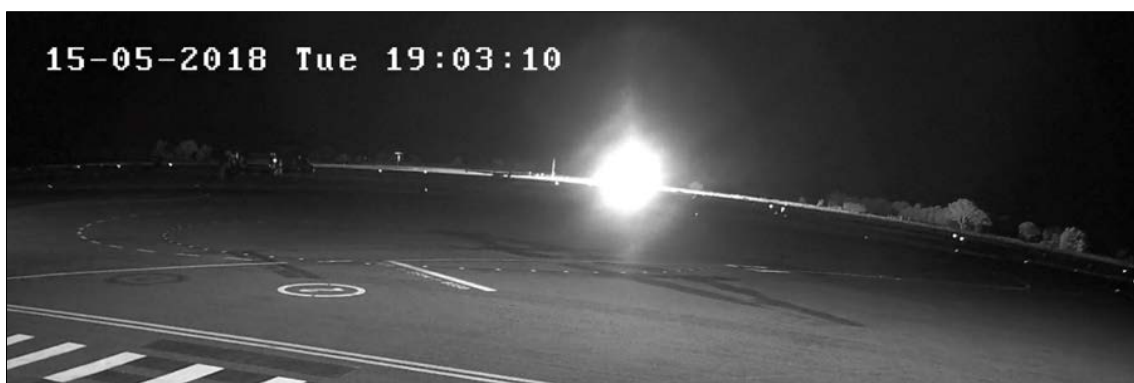
Figure 3: Deflagration of fuel vapour

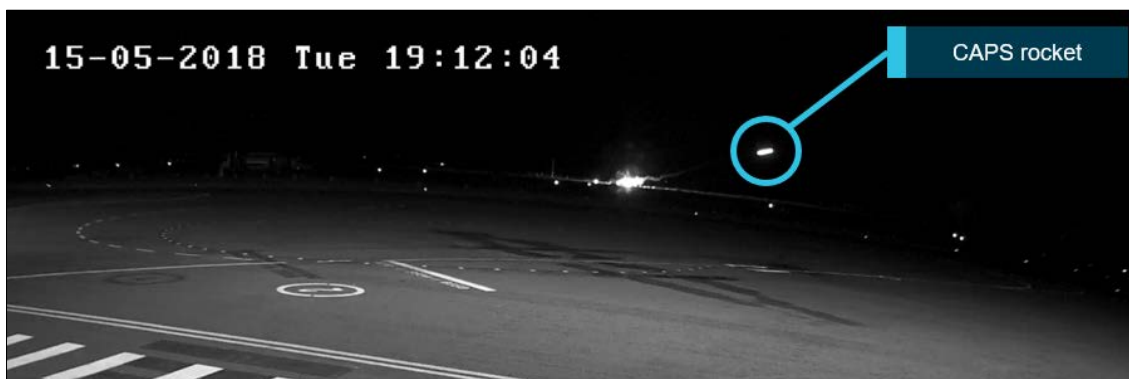
Figure 4: CAPS rocket

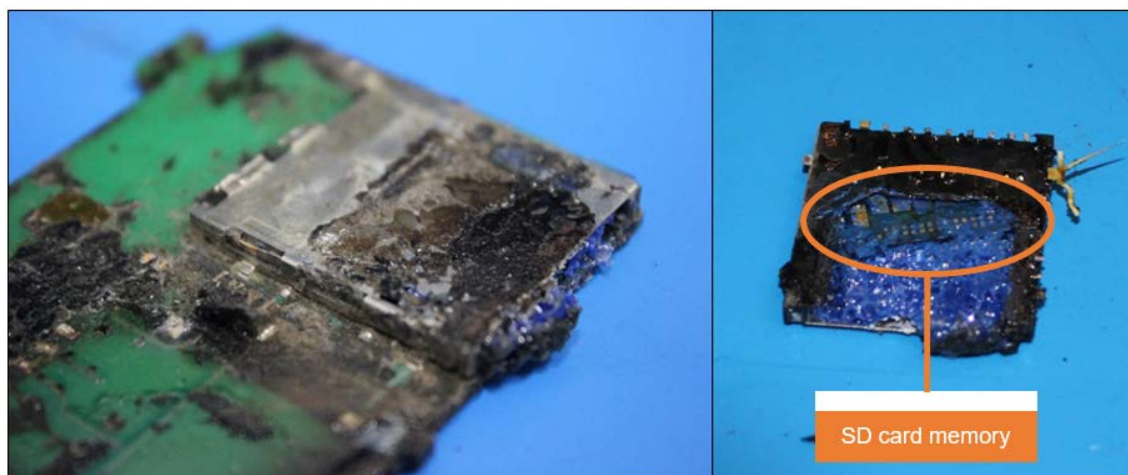
Initial observations of the MFD SD card slots revealed they were substantially fire damaged and retained two SD cards; the top slot contained the data logging card, the bottom slot contained the Garmin database card. To access the cards, the MFD was disassembled, and the circuit board holding the two cards was removed. The data logging card was found to be substantially damaged (Figure 5). The encapsulated memory device was removed from the data logging card and cleaned. The data logs were then extracted with a modified SD card reader. A total of 241 flight logs were recovered, including the accident flight (Figure 6).

Figure 5: Data logging SD card

Left: Removed MFD slot with data logging SD card. Right: removed data logging card with card memory identified.
Source: ATSB

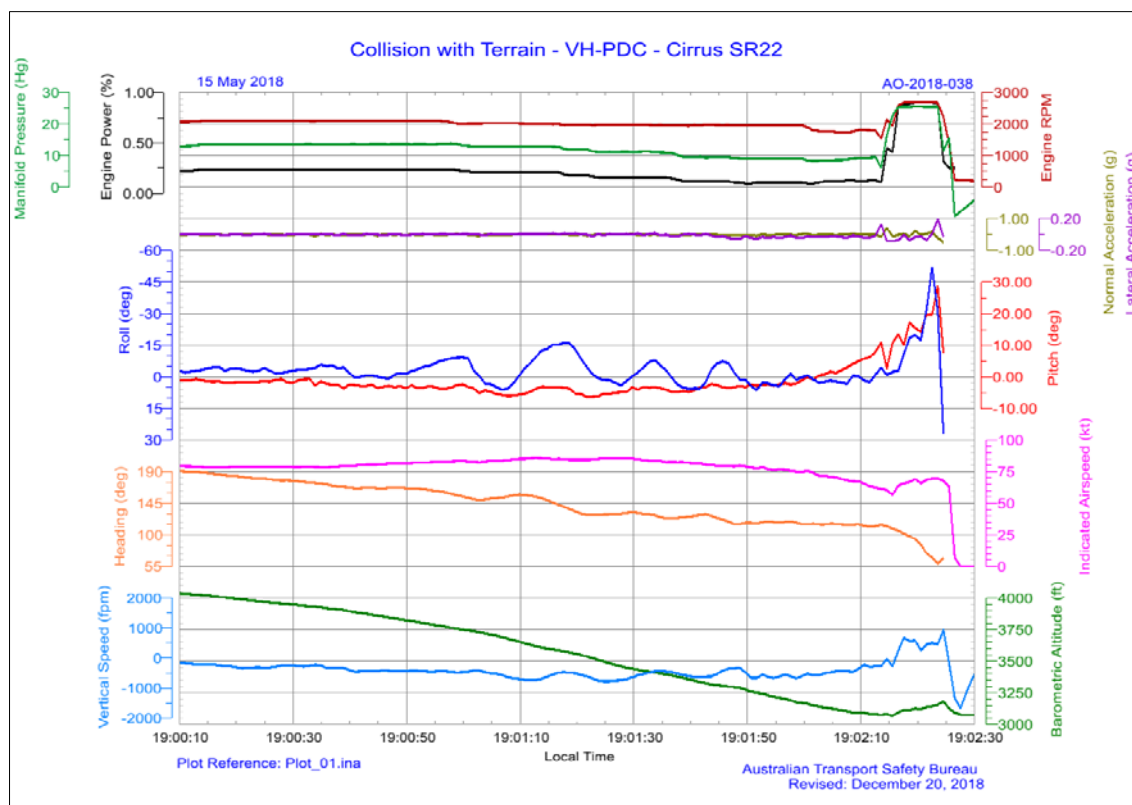
Figure 6: Recovered accident flight data

The recovered flight data indicated that after touchdown, power was initially increased to about 45 per cent (19:02:15) and a slight left roll initiated. Power was then advanced to about 90 per cent (19:02:18) and the left roll developed to a peak value of -52° (19:02:23) with a pitch attitude of $+20^{\circ}$ (nose-up)¹⁵ and airspeed varying from 56–69 kt.¹⁶ The pitch attitude then increased to a

peak value of +29° before lowering to +7° as the aircraft rolled right to a peak value of +27° at a height of about 100 ft above the runway (19:02:25).
