Unreliable airspeed indication and stall warning involving Airbus A320, VH-FNP

near Perth, Western Australia, on 12 September 2015

ATSB Transport Safety Report
Aviation Occurrence Investigation
AO-2015-107
Final – 4 April 2019

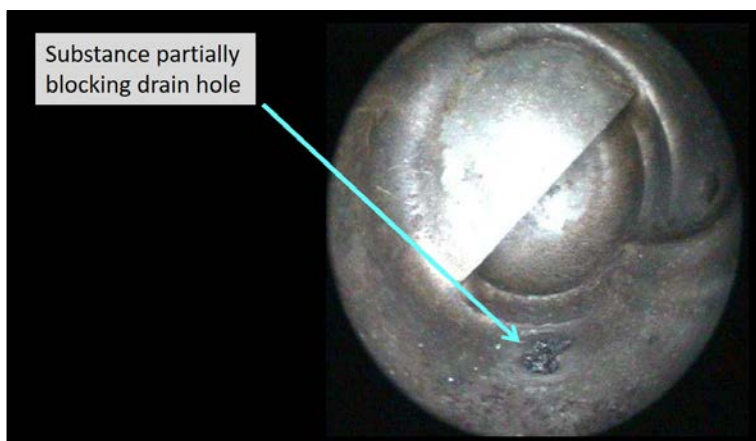
Figure 17: Image of substance partially blocking one drain hole in the captain's pitot probe

Captain's probe (pitot 1)	Failed the acceptance tests due to one drain hole being blocked by an unidentified black substance (Figure 17) and internal contamination by a red clay substance, an example of which is shown in Figure 18 (left)
First officer's probe (pitot 2)	Passed the acceptance tests and found to be in acceptable condition in accordance with the component maintenance manual
Standby probe (pitot 3)	Failed the acceptance tests due to internal contamination by a red clay substance, example of which is shown in Figure 18 (right)

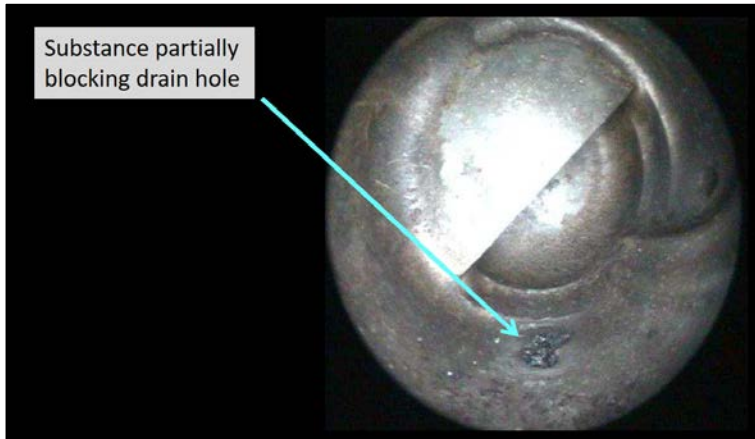
Figure A1: Image of substance partially blocking one drain hole in the captain's pitot probe

The captain's pitot probe failed the acceptance tests due to the blocked drain hole and the contamination by the red clay substance.

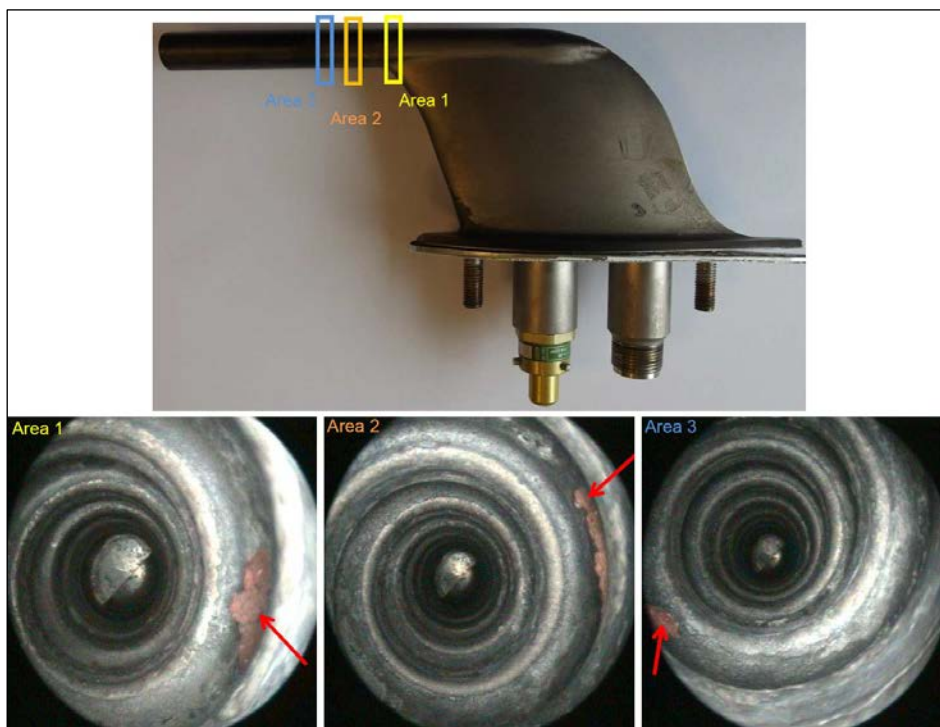
Figure A2: Image of red contamination (red arrows) in the captain's pitot probe

Contamination of the interior of the pitot tube by a red substance was also identified in three locations within the captain's pitot probe (Figure A2). Spectrographic examination of that substance identified that it consisted predominantly of oxygen, silicon, iron, aluminium and carbon and that it had an infrared spectrum consistent with an aluminium silicate clay.

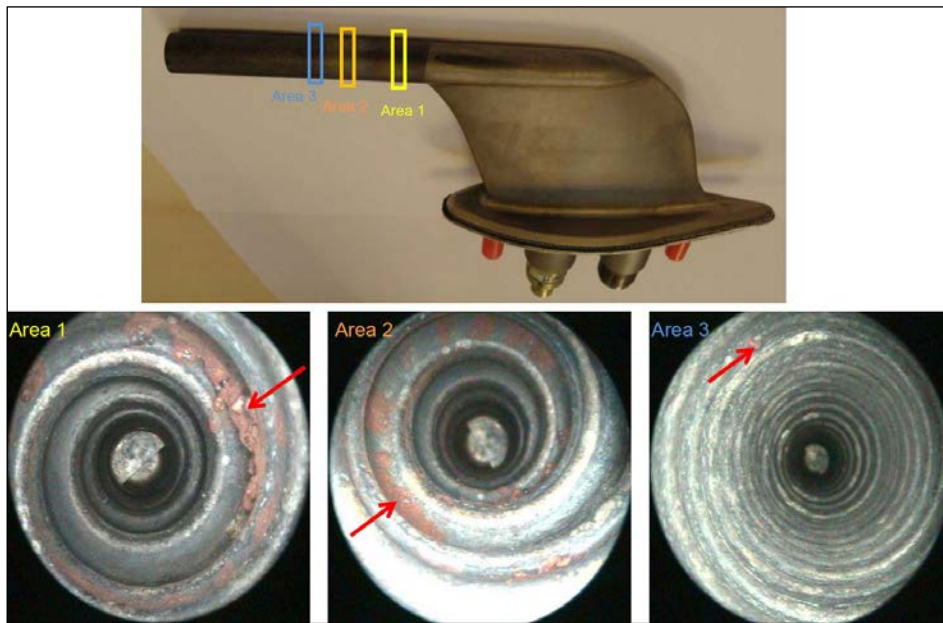
Figure A3: Image of red contamination (red arrows) in the standby pitot probe

The standby pitot probe failed the acceptance tests due to the contamination by the red clay substance.
