# In-flight upset, inadvertent pitch disconnect, and continued operation with serious damage involving ATR 72 aircraft, VH-FVR

47 km WSW Sydney Airport, New South Wales | 20 February 2014

## **ATSB Transport Safety Report**

AO-2014-032

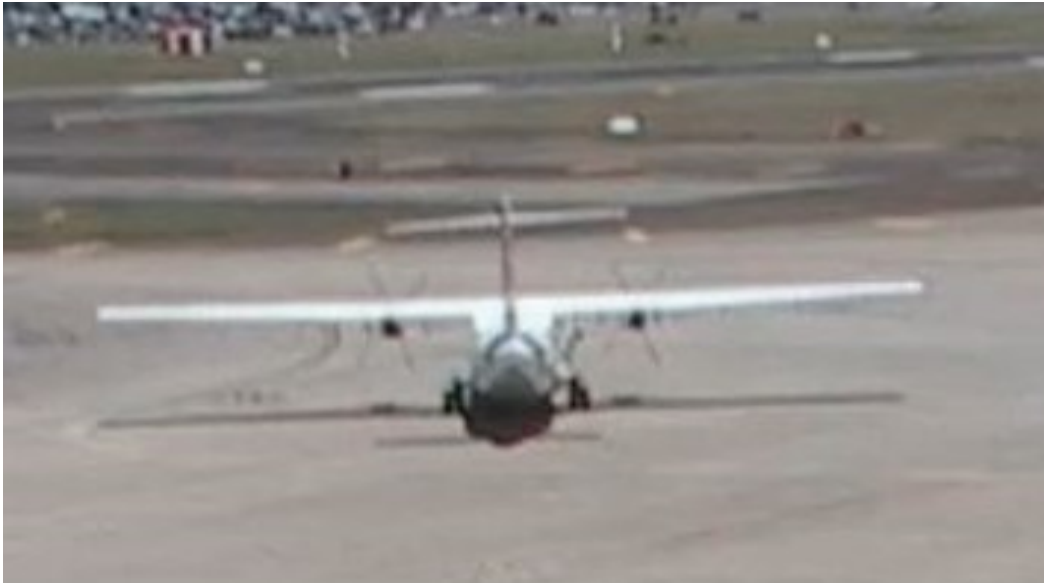
**VH-FVR under tow following completion of post-occurrence maintenance. The angle of the horizontal stabiliser relative to the angle of the wings indicates substantial structural deformation.**

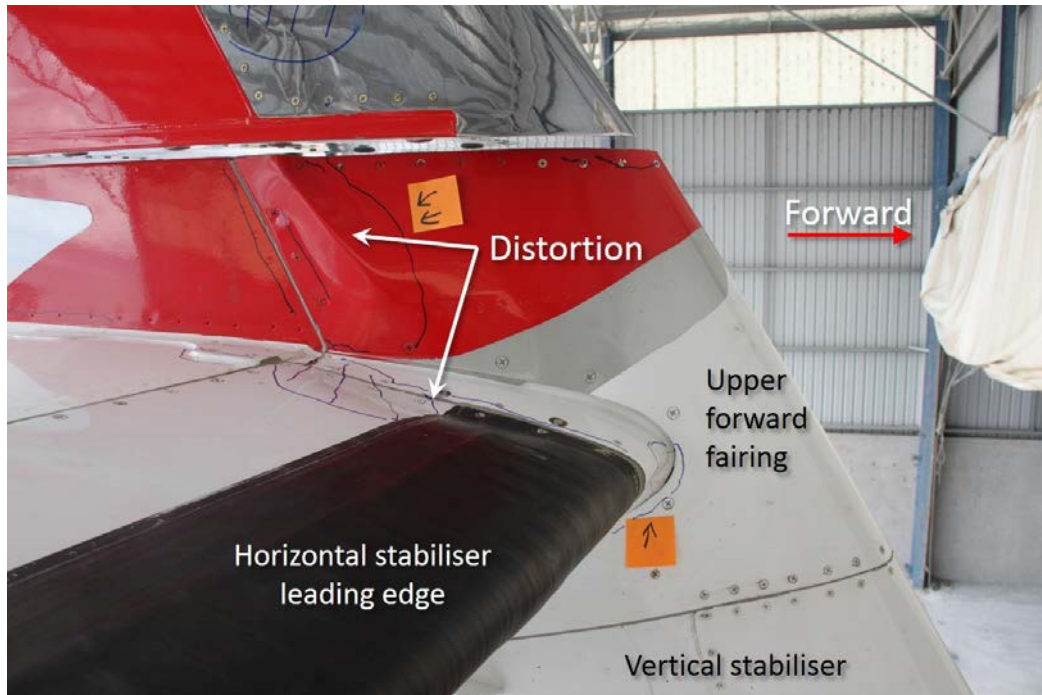
During the next 5 days the aircraft was operated on 13 flights and was subject to routine walk-around visual inspections by flight crew and engineers. No one identified any anomalies until flight crew observed some damage after a suspected bird strike. The aircraft was grounded and subjected to extensive maintenance that included replacement of the horizontal and vertical stabilisers.

**Upper tailplane of VH-FVR showing damage to horizontal and vertical stabilisers that was evident when the damage was identified 5 days and 13 flights after the in-flight upset/pitch disconnect and associated maintenance**

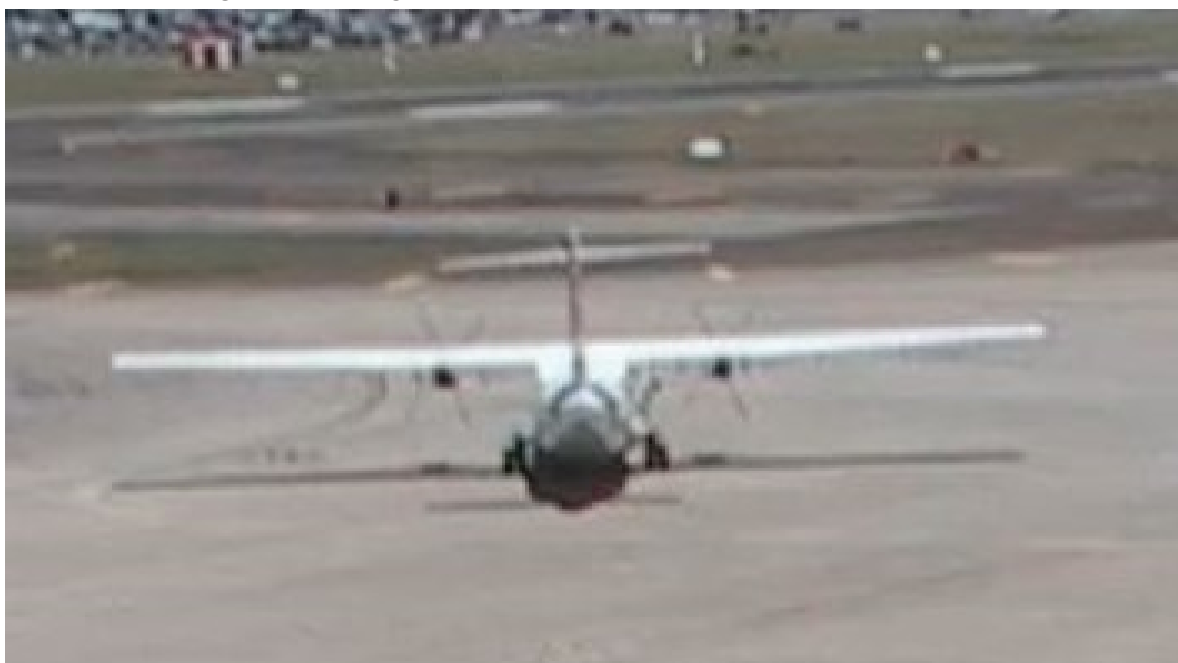
**Figure 4: Aircraft being towed away from remote bay at 1215 on 21 February 2018 (still image copied from closed circuit TV footage). Note the angle of the horizontal stabiliser relative to the angle of the wings.**

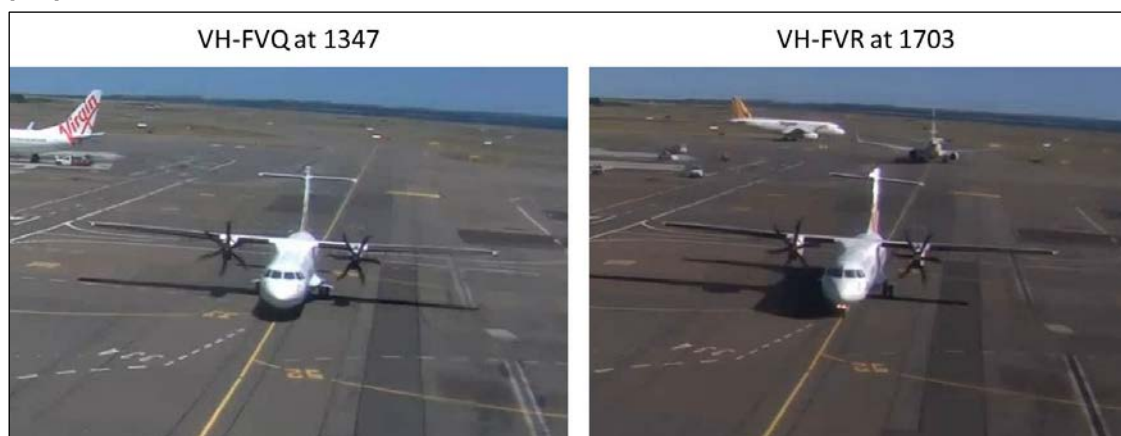
**Figure 5: Images from Sydney Airport CCTV footage showing the deformation to the horizontal stabiliser of VH-FVR (right) as compared to an undamaged ATR 72, VH-FVQ (left).**

The image was taken as the aircraft taxied to the bay on 20 February 2014. Note that the left tip of the horizontal stabiliser VH-FVR is visibly lower than the right when compared to the angle of the wing.

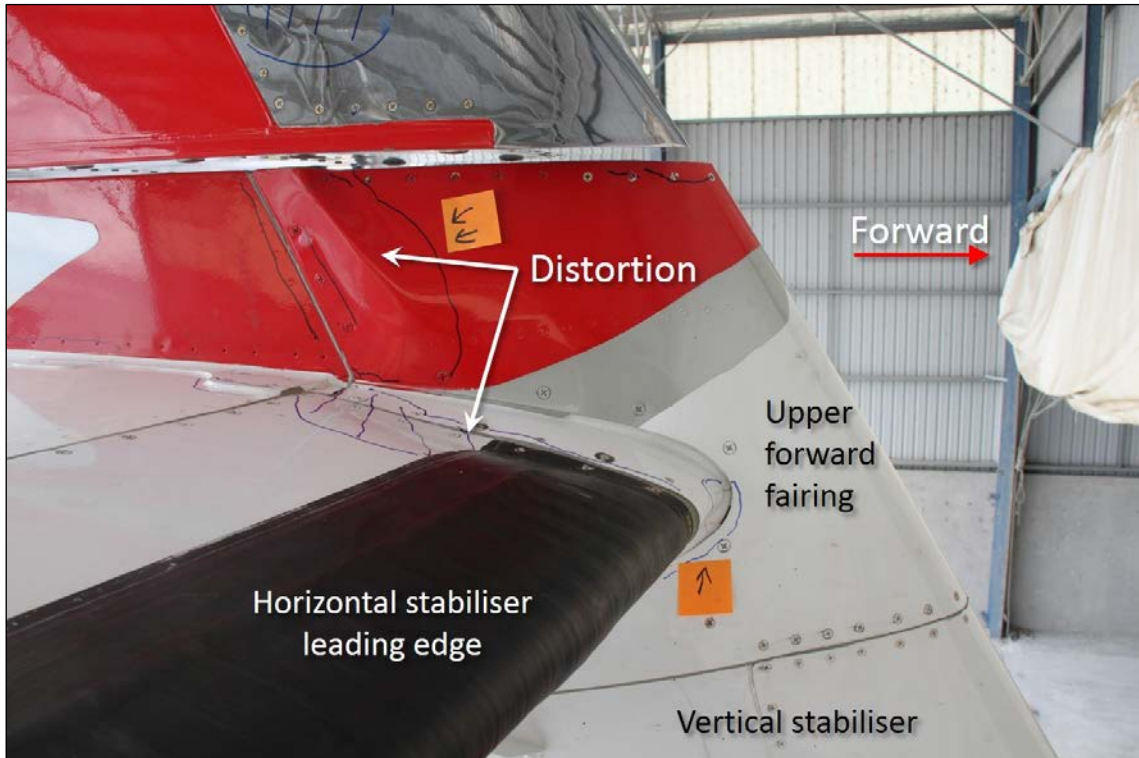
**Figure 6: Distortion in the upper forward fairing right side horizontal stabiliser leading edge prior to removal of any fairings or access panels.**

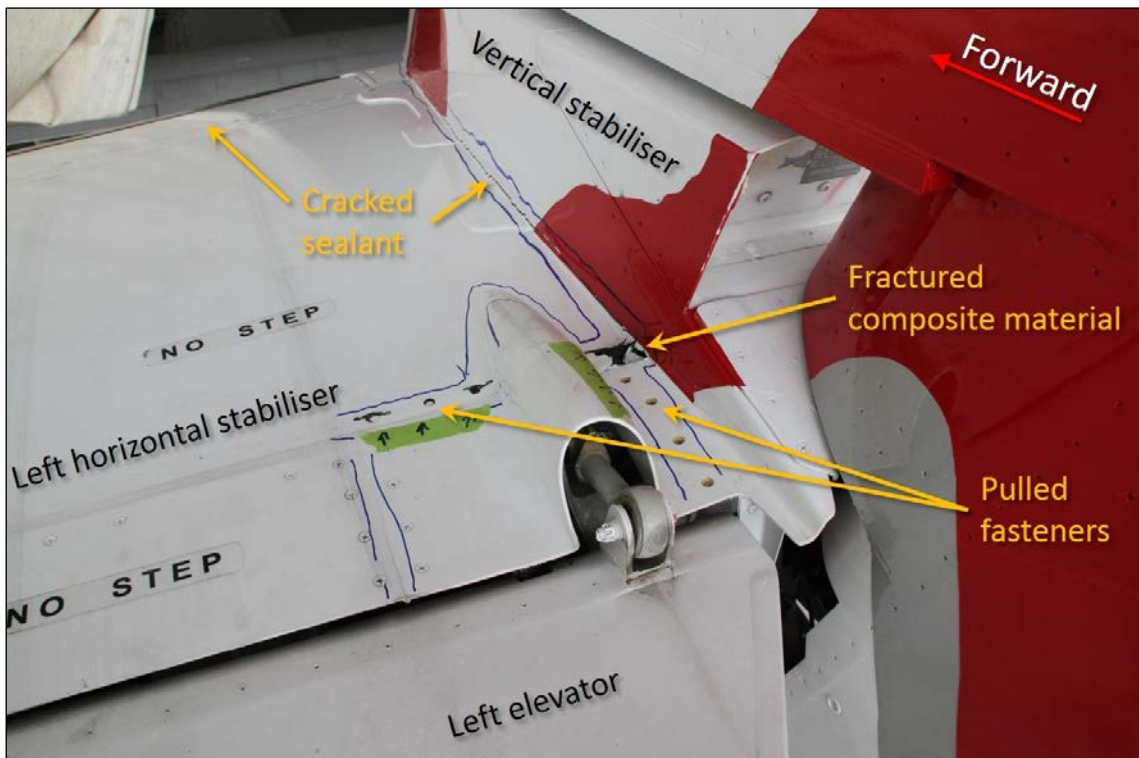
**Figure 7: Damage visible on the upper left side of the horizontal stabiliser included cracked sealant, fractured and exposed composite material, and fasteners pulled through the composite material**

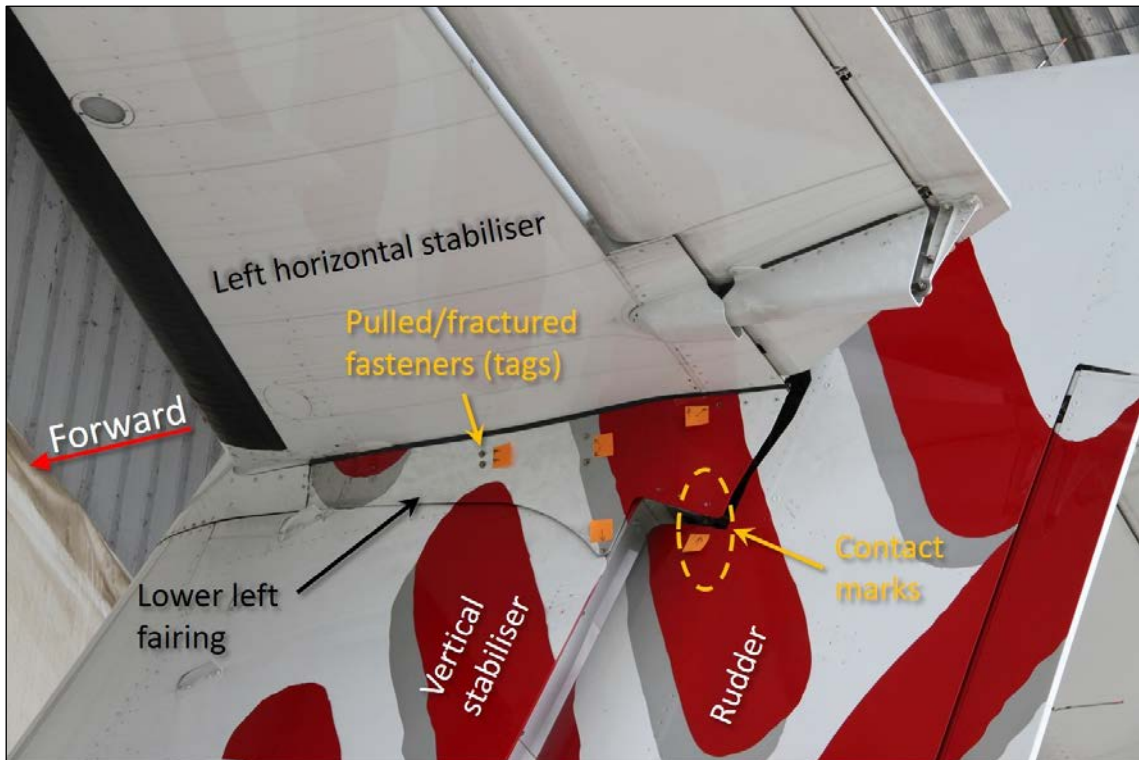
**Figure 8: Damage visible on the lower left side of the horizontal stabiliser included fasteners pulled through the lower left fairing, fractured fasteners for securing the fairing and contact marks between the fairing and the rudder.**

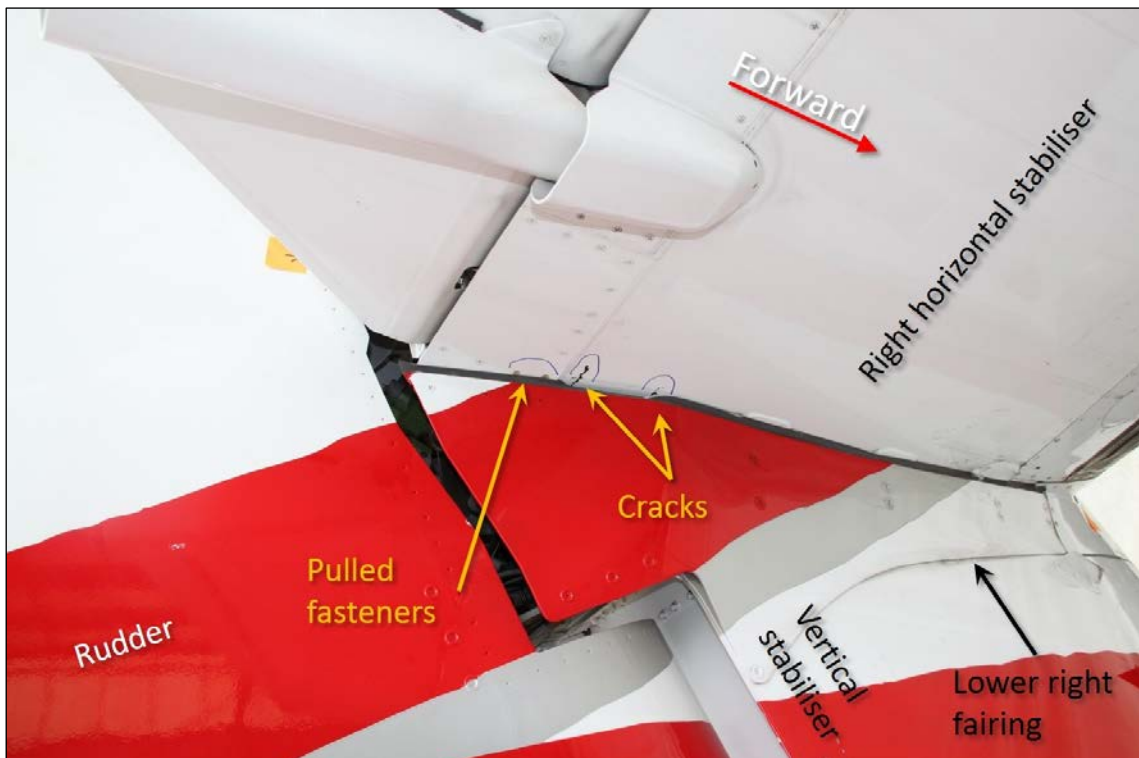
**Figure 9: Damage visible on the lower right side of the horizontal stabiliser included fasteners pulled through the lower skin and cracks in the lower skin panel.**

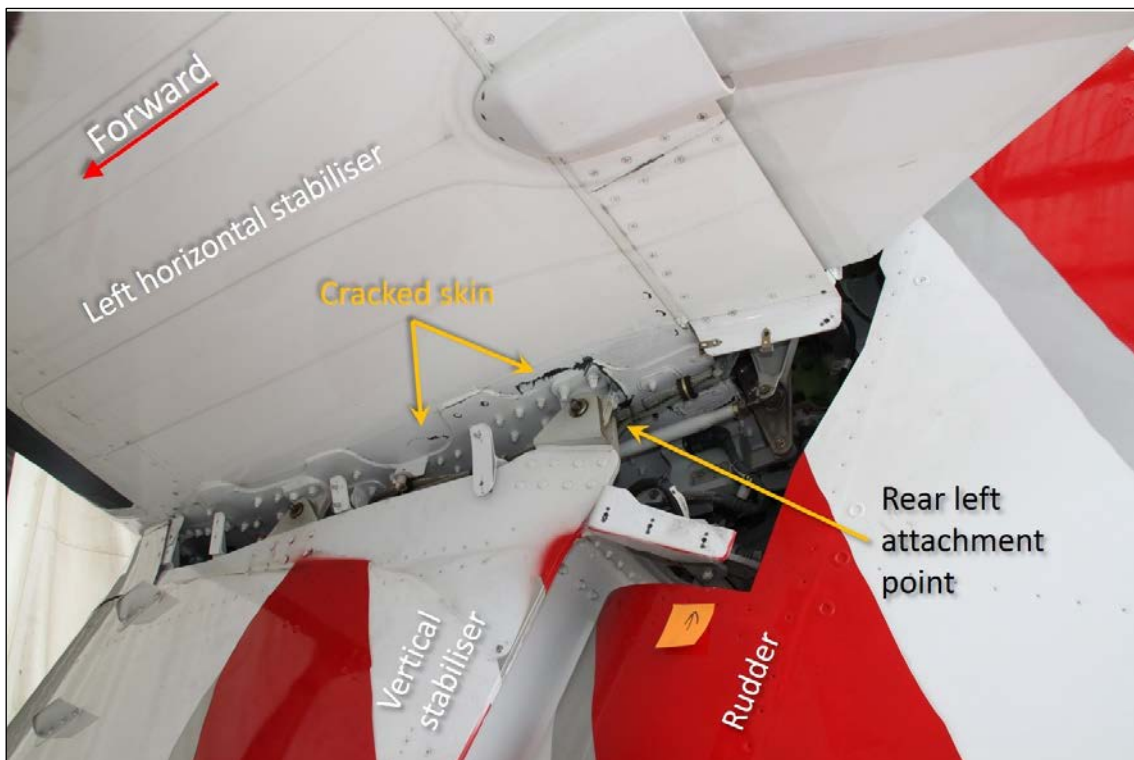
**Figure 10: Horizontal-to-vertical stabiliser attachment with the lower left fairing removed showing the cracking in the skin panel adjacent to the attachment fitting.**

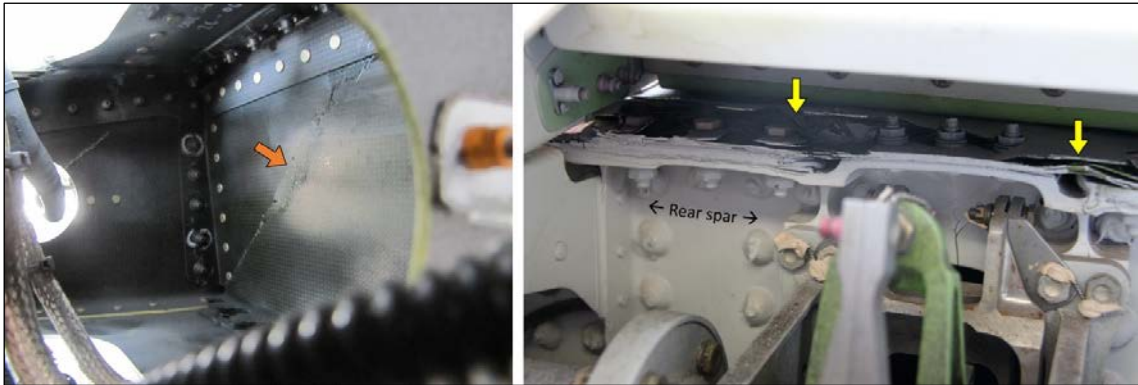
**Figure 11: Crack in the horizontal stabiliser front spar (left) identified by orange arrow. Cracking and delamination in the composite skin at the rear spar (right) identified by yellow arrows.**

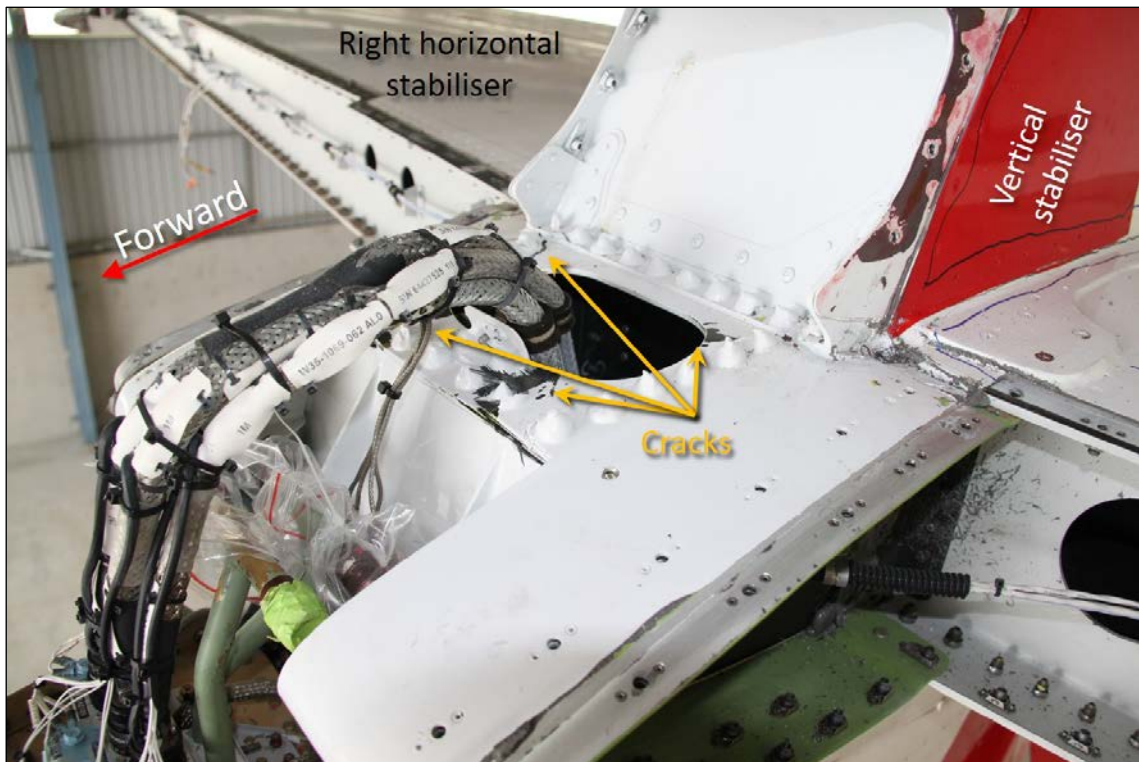
**Figure 12: Damage in the centre leading edge section above the forward attachment points, included cracking and delamination in all corners of the cut-out and cracks in the ribs (not shown) and deformation of the material around the attachment points (not shown).**

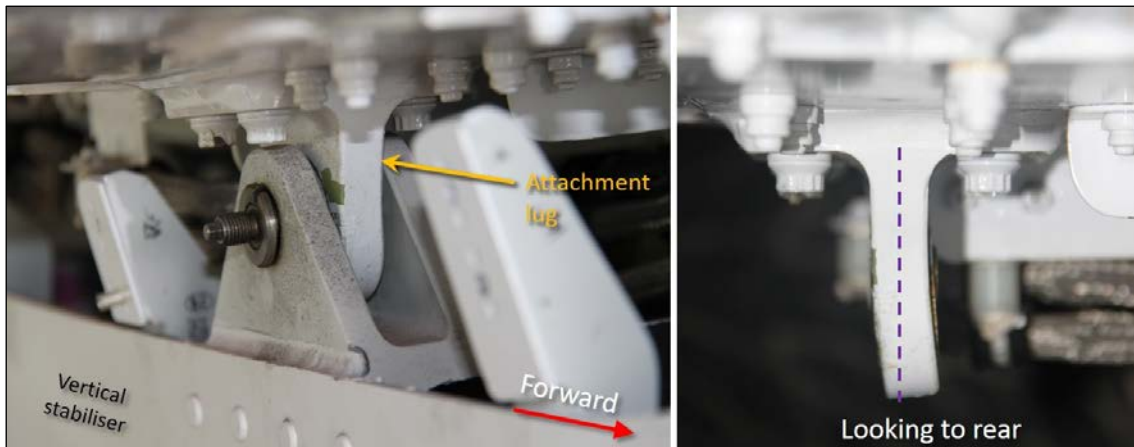
**Figure 13: Mid-right attachment lug.** Left image shows the lug while connected to the vertical stabiliser. Cracks and missing white paint (green patch) were indications of distress. Right image shows the lug following removal of the horizontal stabiliser.

The purple dashed line has been added as a visual reference to highlight the bending in the lug. The damage to the mid-left lug was similar.

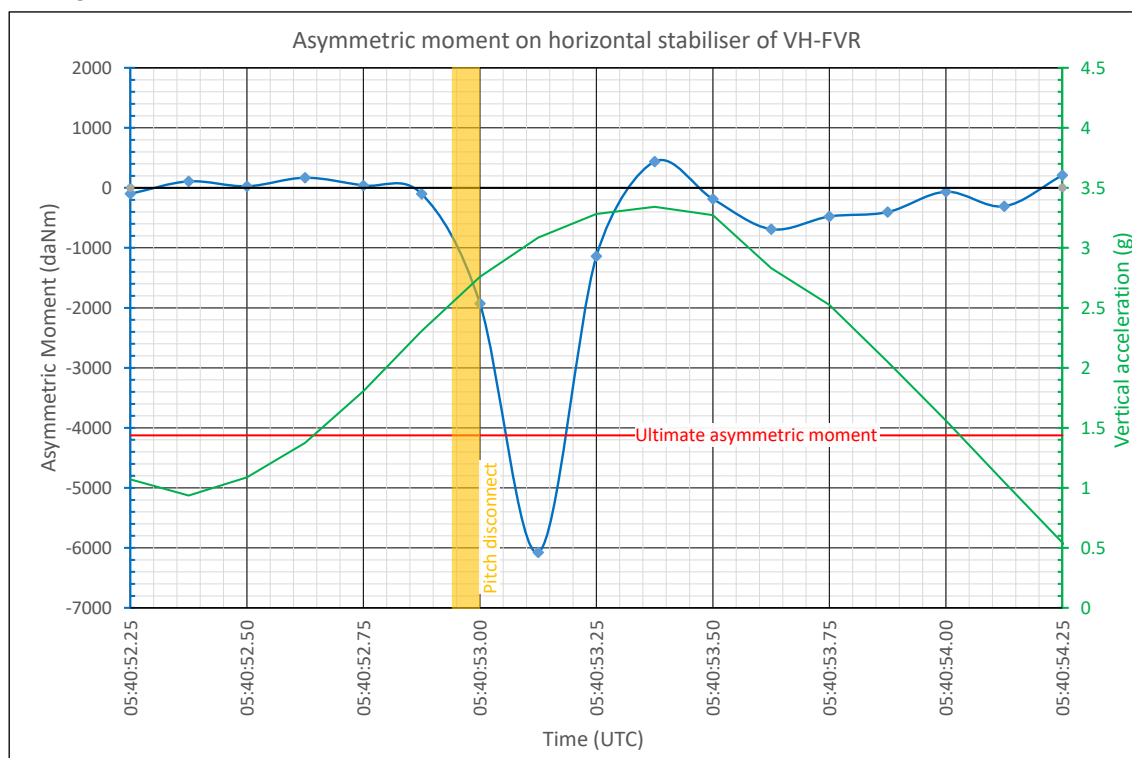
**Figure 43: Variation in the calculated asymmetric moment in the horizontal stabiliser during the pitch disconnect event. The data calculated by ATR are represented by blue diamonds. A curve has been fitted to the data to represent the variation of the moment during the event.**

The ultimate load (asymmetric moment) is shown by a red line and the time of the pitch disconnect identified by a vertical yellow line. Also included on the chart, in green, is the vertical acceleration recorded on the FDR.
