Collision with terrain following an engine power loss involving Cessna 172M, VH-WTQ

12 NM (22 km) north-west of Agnes Water, Queensland on 10 January 2017

ATSB Transport Safety Report
Aviation Occurrence Investigation
AO-2017-005
Final – 17 October 2019

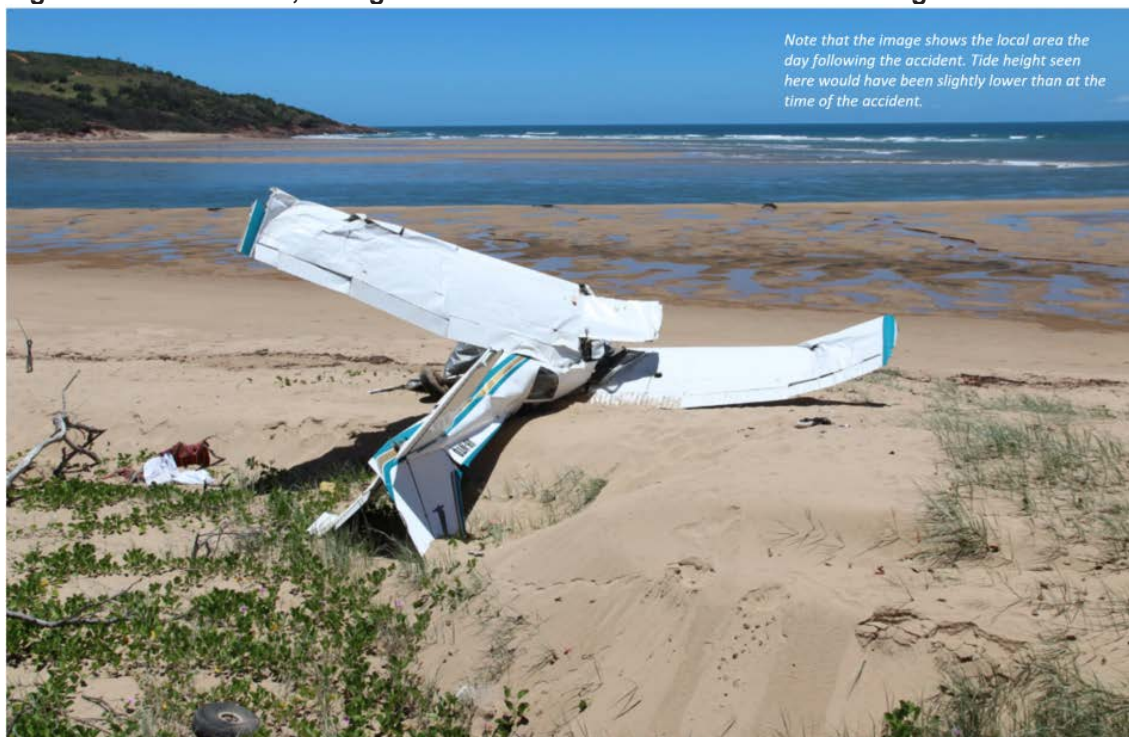
Figure 5: Accident site, facing north-east with Bustard Head in the background

One of the rear-seat passengers was fatally injured and the other three occupants sustained serious injuries during the impact. The aircraft was destroyed. Figure 5 shows the aircraft wreckage (see also *Wreckage and impact information*).

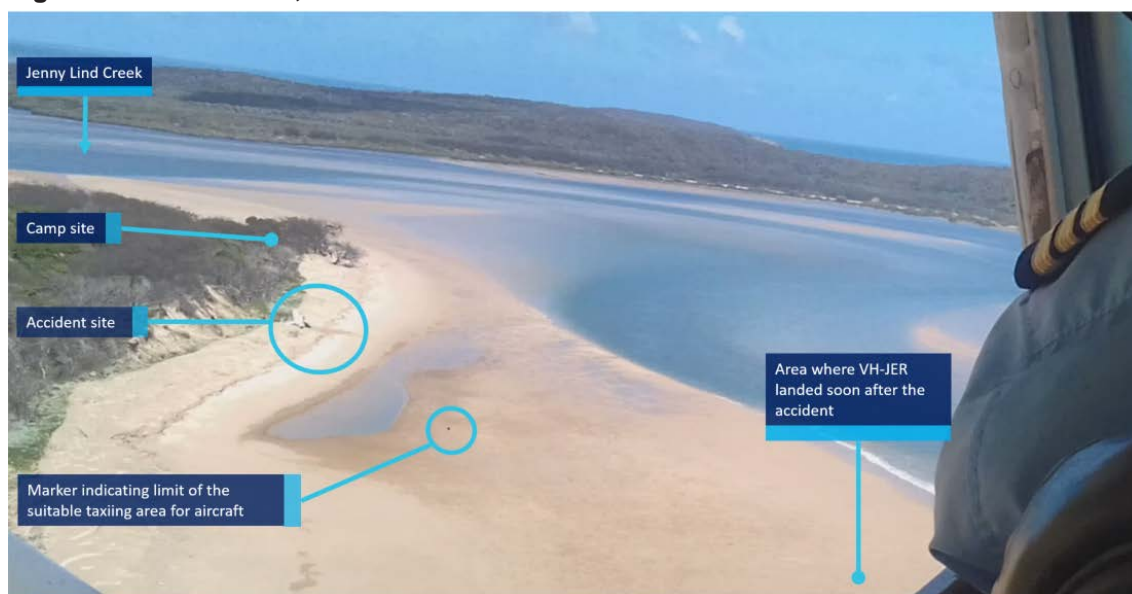
Figure 6: Accident site, as viewed from VH-JER

Following the impact, the aircraft cabin was inverted and the occupants were all held in place by their restraints. A significant amount of fuel was observed to be leaking from the aircraft's fuel tanks. The camp site employee, the chief pilot and other first responders extracted the occupants and moved them away from the wreckage to provide first aid. One of the rear-seat passengers was unresponsive, so the first responders provided cardiopulmonary resuscitation (CPR) but she could not be revived. A subsequent post-mortem examination determined that her injuries were not survivable (see also *Occupant injuries*).

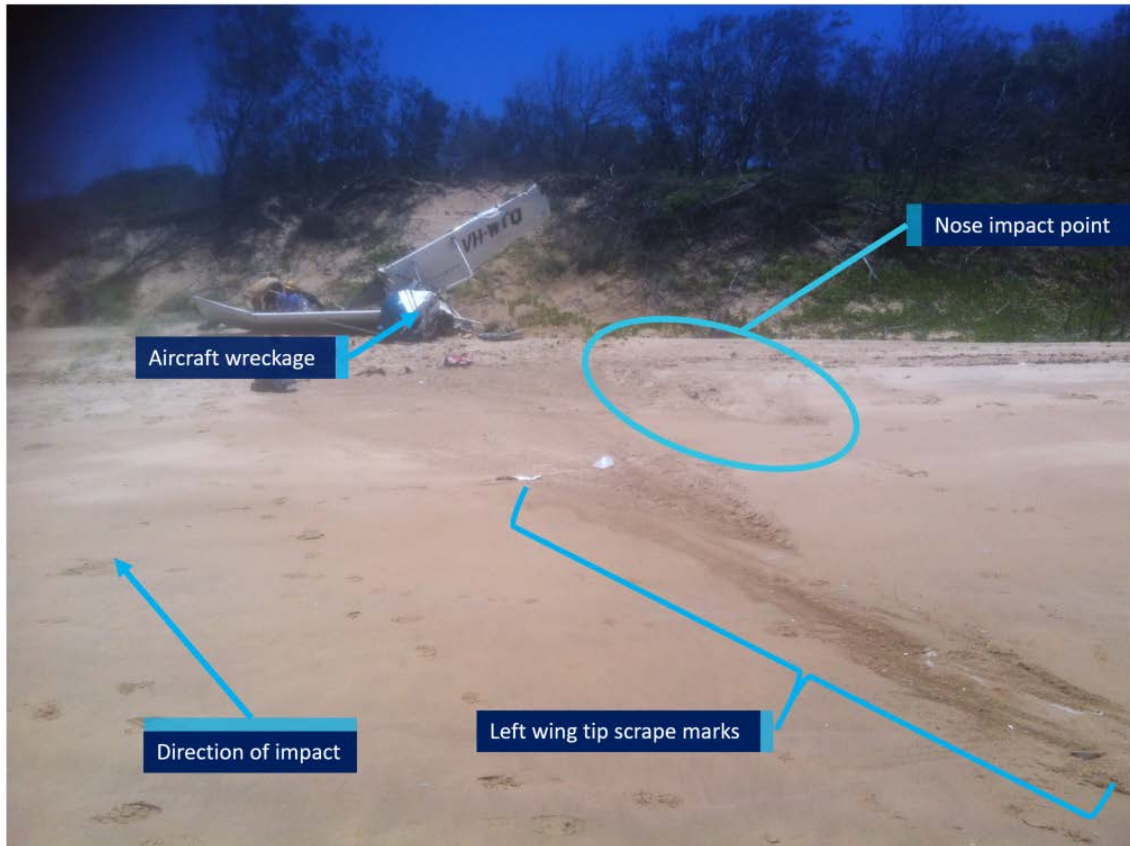
Figure 8: VH-WTQ accident site showing impact marks

The distance between the nose impact point and the main wreckage was about 5 m on a magnetic bearing of 210°. The wreckage distribution and distance from the impact point indicated that the aircraft impacted terrain in a significant nose-down and left-wing low attitude. The aircraft came to rest facing in the opposite direction to flight.

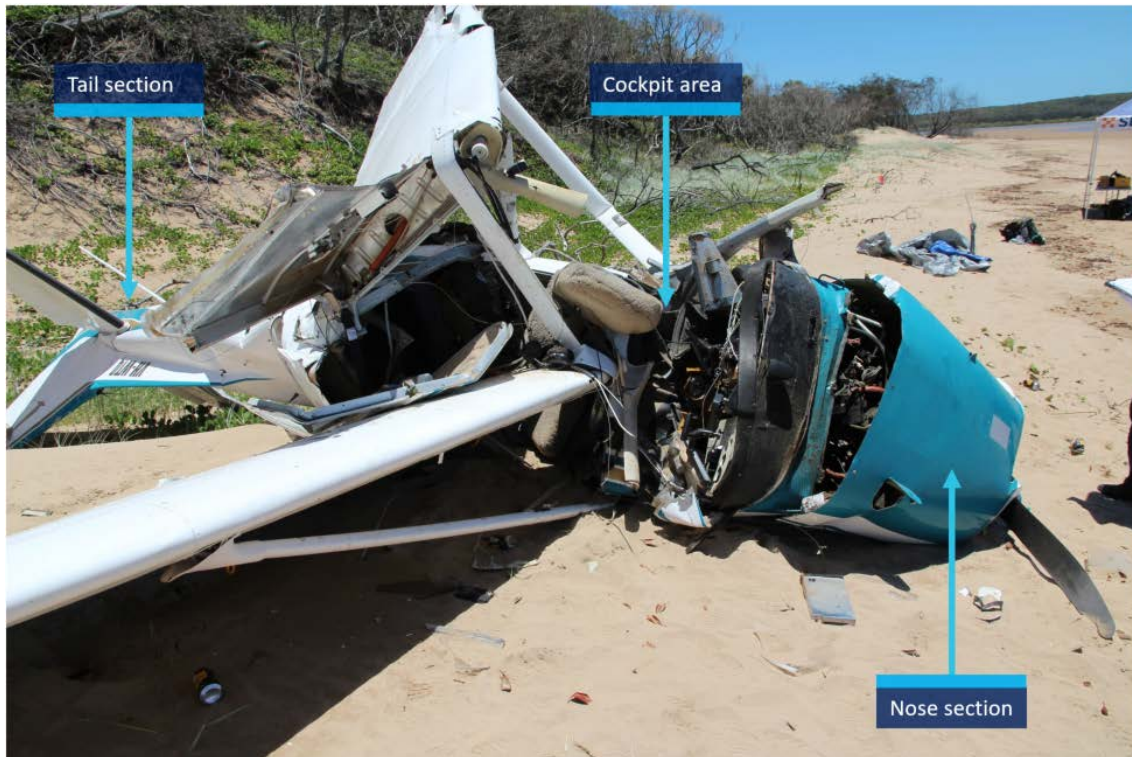
Figure 9: VH-WTQ aircraft wreckage viewed from the right

The aircraft was significantly disrupted by ground impact forces. The main fuselage structure had fractured at the rear of the engine firewall and just aft of the rear passenger seats. The cabin area was twisted and compressed and both wings had separated from the fuselage structure at the wing root (Figure 9).

The aircraft structure was examined for pre-impact defects, with none identified. All of the aircraft and its components were accounted for at the accident site. There was no indication of any fire.

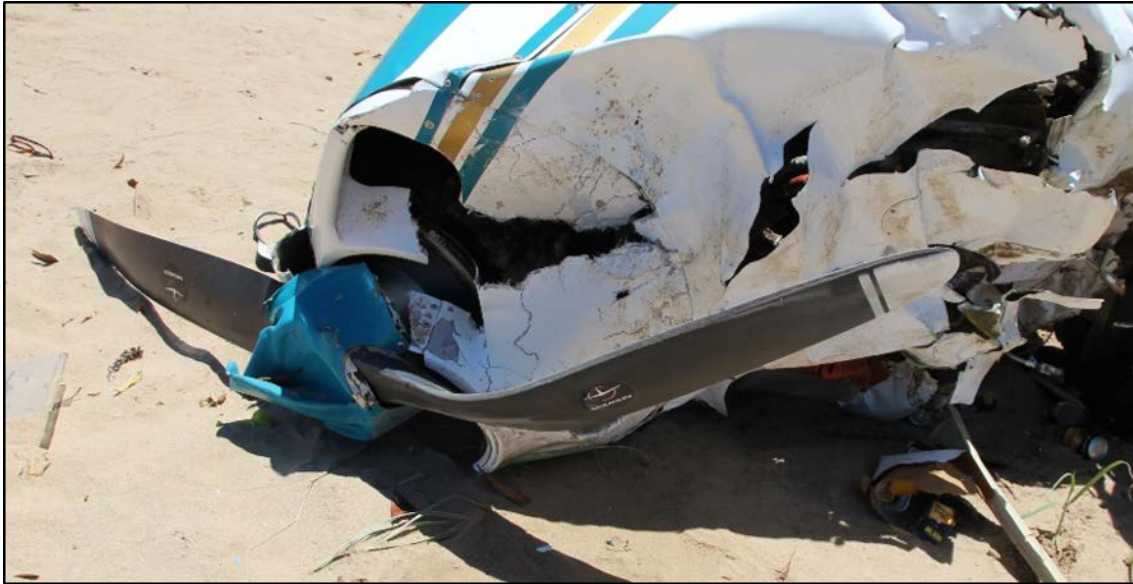
The propeller was examined on site for evidence of correct and secure fitment, with no issues identified. The propeller blades were examined for evidence of rotation damage at the point of impact. Only minor abrasion damage was observed on the blades with no other indications of rotation (Figure 14). That damage was consistent with very low or no power being delivered by the engine at impact.

Figure 14: Propeller blades showing slight paint abrasion damage

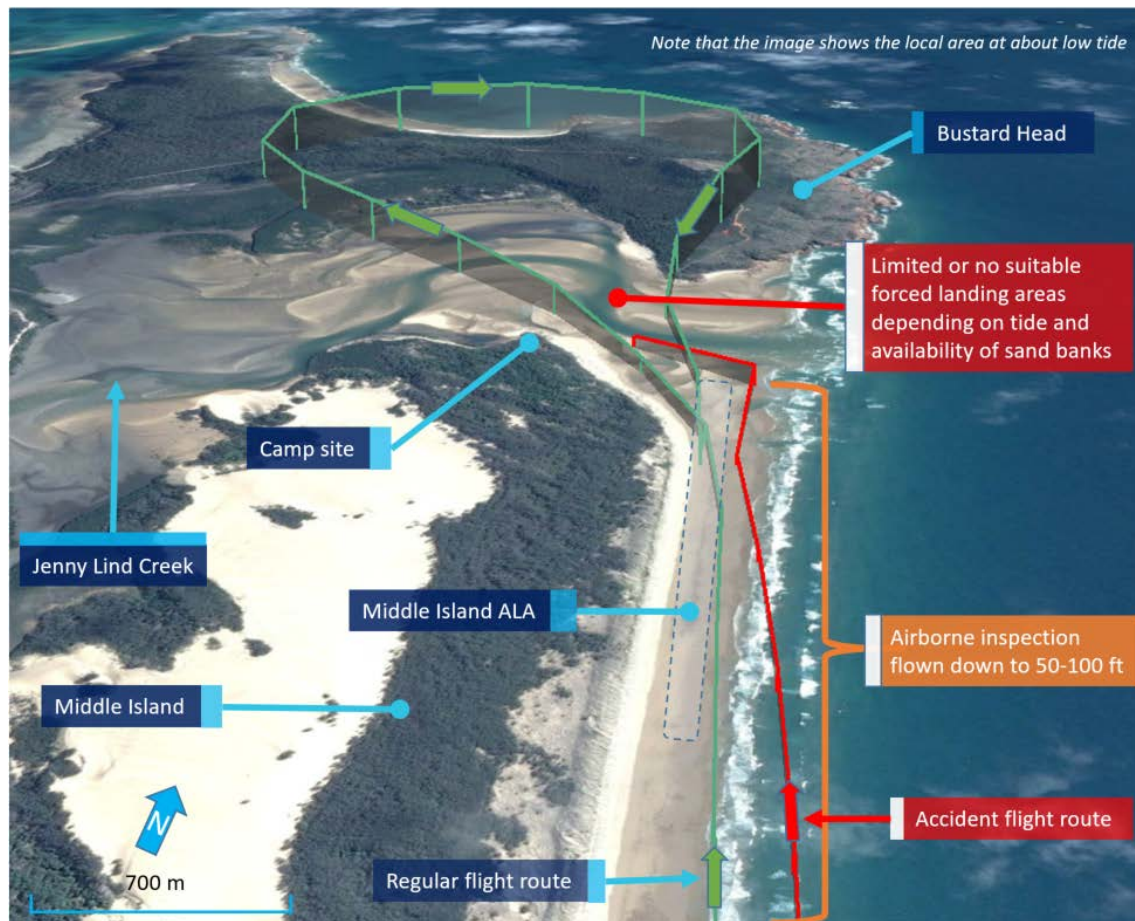
Figure 21: VH-WTQ GPS-derived regular flight path for an airborne inspection on the southerly beach landing area (green line)

In general, the aircraft passed within 300 m to the east of the lighthouse (which had a focal height of 336 ft) on Bustard Head during the approach to landing, often at an altitude of about 450–500 ft AMSL, passing directly over terrain which was up to 280 ft AMSL. In a small number of cases, the right turn over Jenny Lind Creek was completed to the west of Bustard Head, with the aircraft reaching an altitude of 350–600 ft prior to the approach.

In all cases, there was a significant segment of the airborne inspection and climb out that had no suitable forced landing areas in the event of an aircraft emergency such as an engine power loss (Figure 21 and Figure 22). In none of the cases was a standard (four-leg) circuit pattern flown after the inspection.

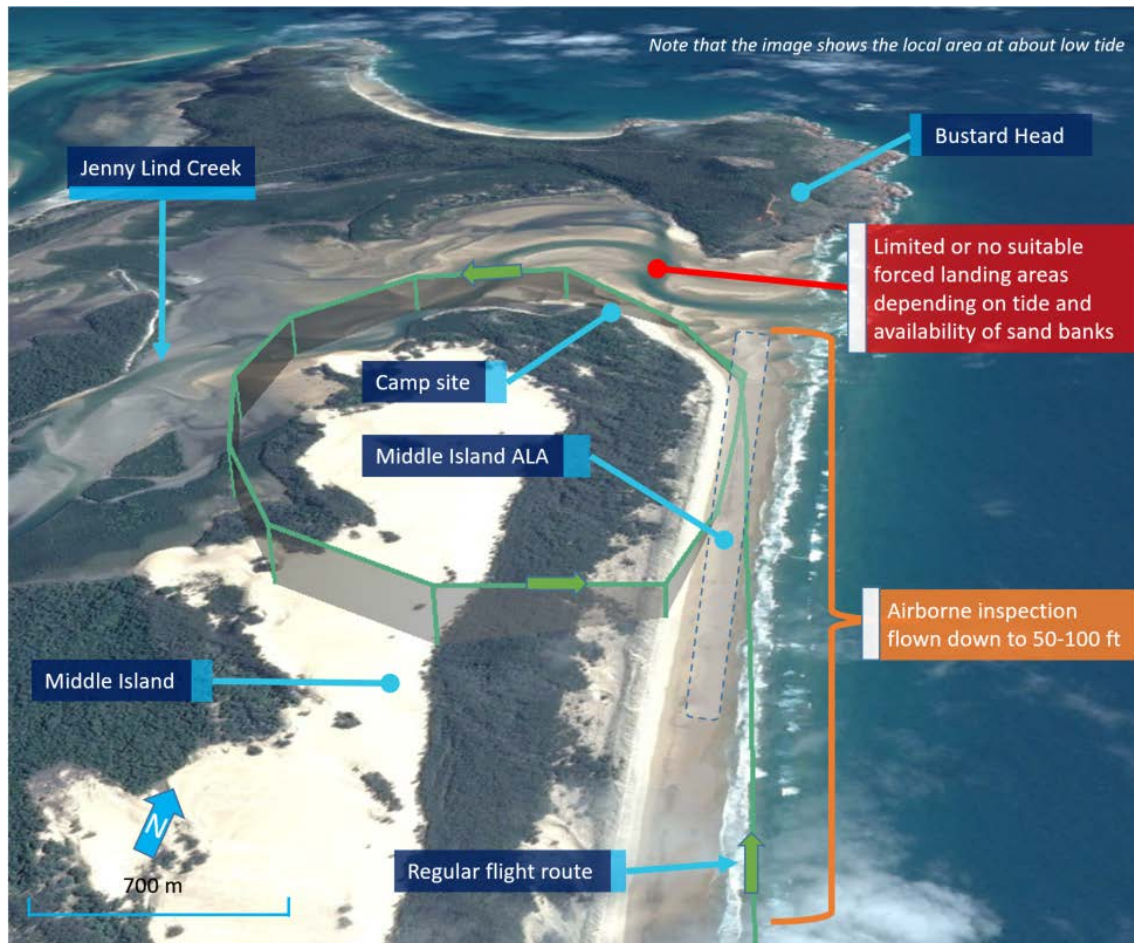
Figure 22: VH-WTQ GPS-derived regular flight path for an airborne inspection on the northerly beach landing area (green line)

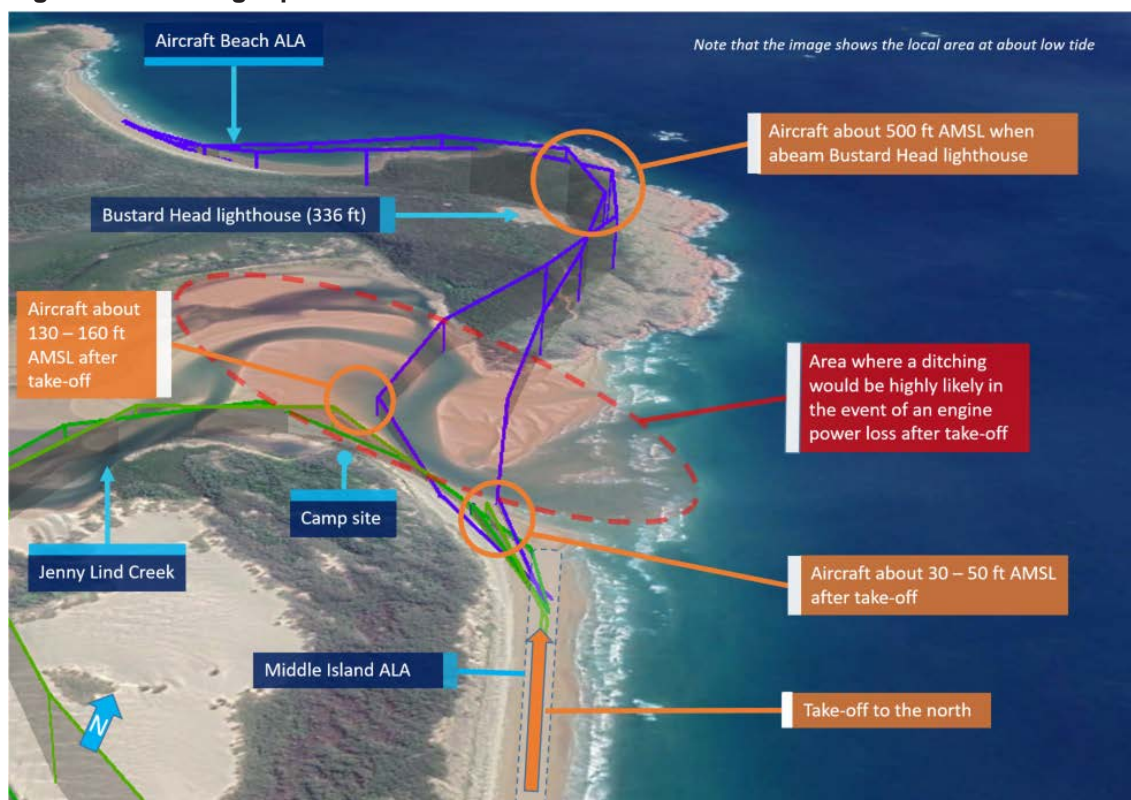
Figure 25: GPS flight paths of take-offs to the north flown in VH-WTQ

In summary, there were several flights in VH-WTQ during the period from 12 November 2016 to 4 January 2017 at Middle Island where turns were conducted at less than 200 ft after take-off, including some flights over water. In addition, a number of flights involved segments where, if there was an engine failure, a forced landing on to water or hazardous terrain could not have been avoided. It was also relatively common practice to conduct manoeuvring below 500 ft AGL prior to being established on final approach.

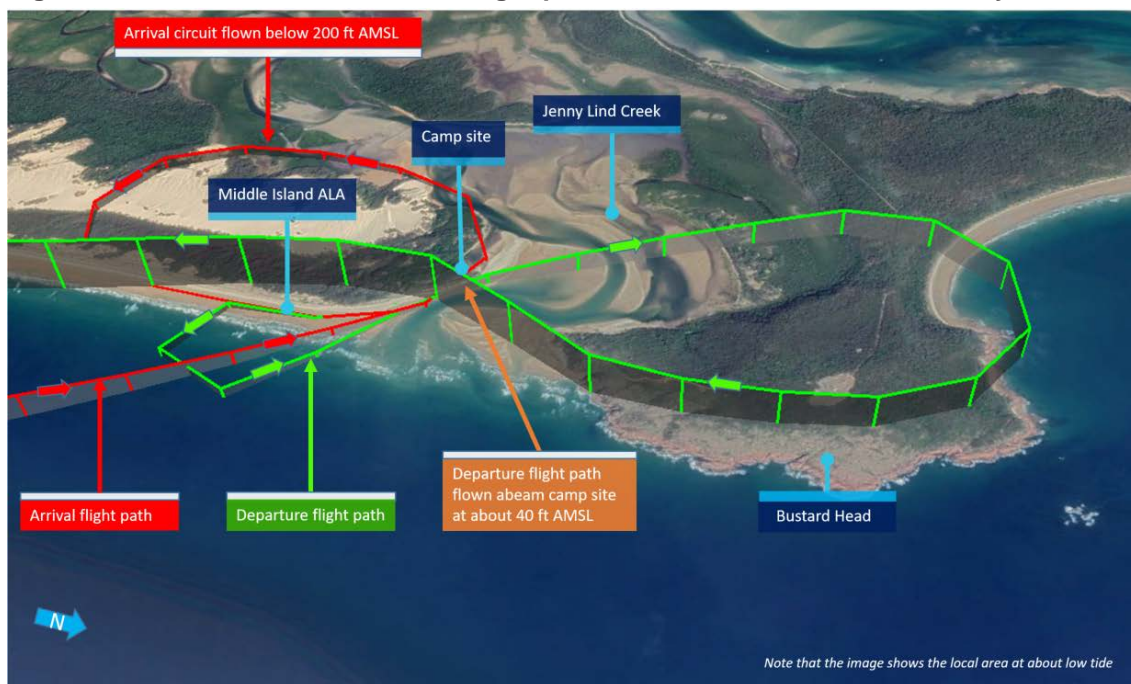
Figure 26: Additional observed GPS flight paths flown in VH-WTQ on 1 January 2017

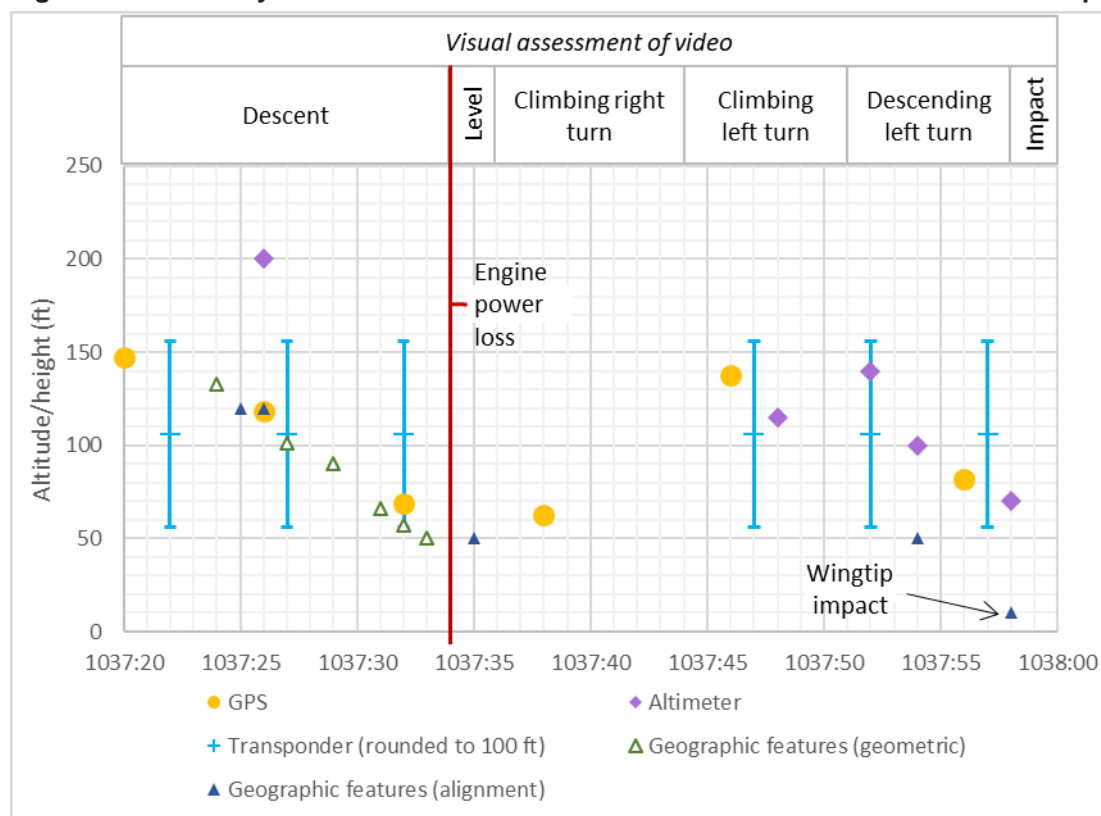
Figure B5: Summary of information about the aircraft's altitude from 1037:20 until impact

The GPS altitude and the altimeter both appeared to be higher than the aircraft's actual altitude in the last 10 seconds of flight (after the engine power loss). This is consistent with the GPS's reduced accuracy in manoeuvring flight, and possibly with the altimeter being affected by sideslip during that period.
