# Runway excursion and collision with terrain involving Van's RV-6A, VH-OAJ

Somersby (ALA), New South Wales, on 18 March 2018

**ATSB Transport Safety Report**  
Aviation Occurrence Investigation  
AO-2018-025  
Final – 22 October 2019

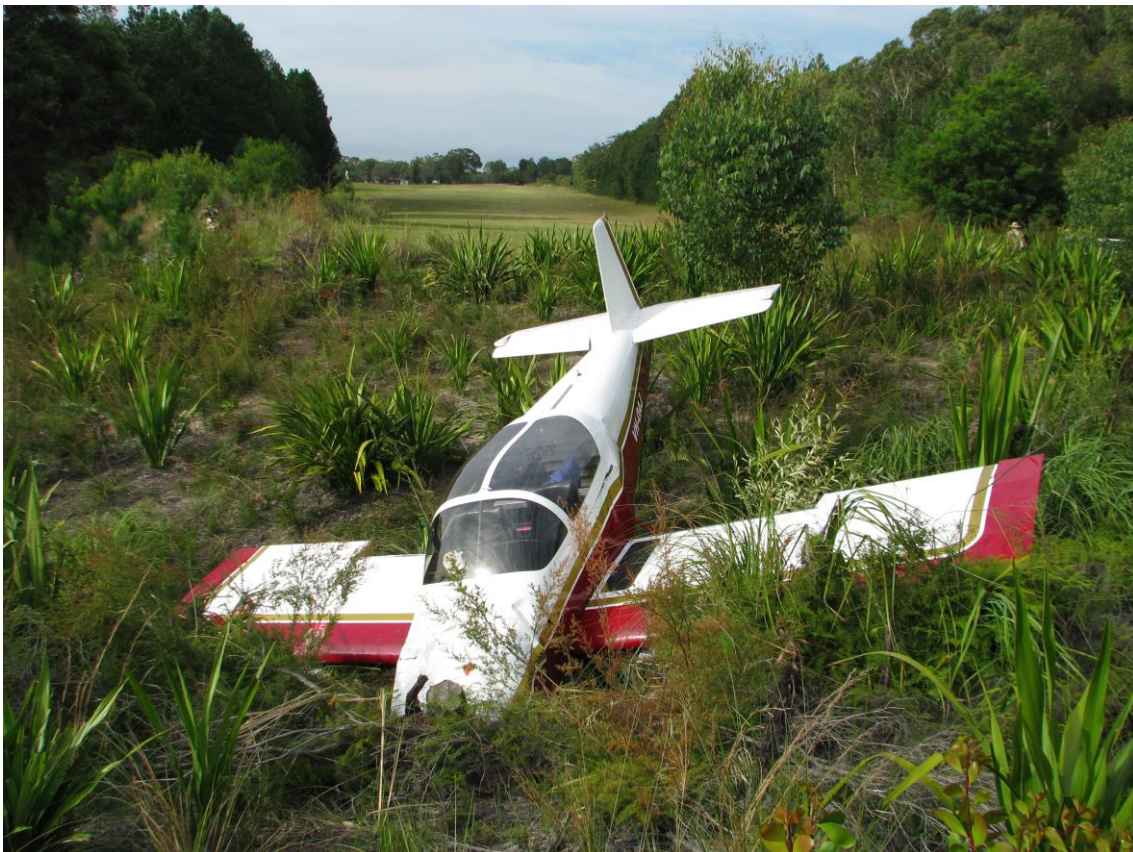
**Figure 2: View of the accident site showing OAJ, looking back along the runway**

As a result of the impact, the pilot was hospitalised with serious injuries, including a dislocated neck and cardiac arrest. Two days later, the pilot succumbed to his injuries. The aircraft was substantially damaged.

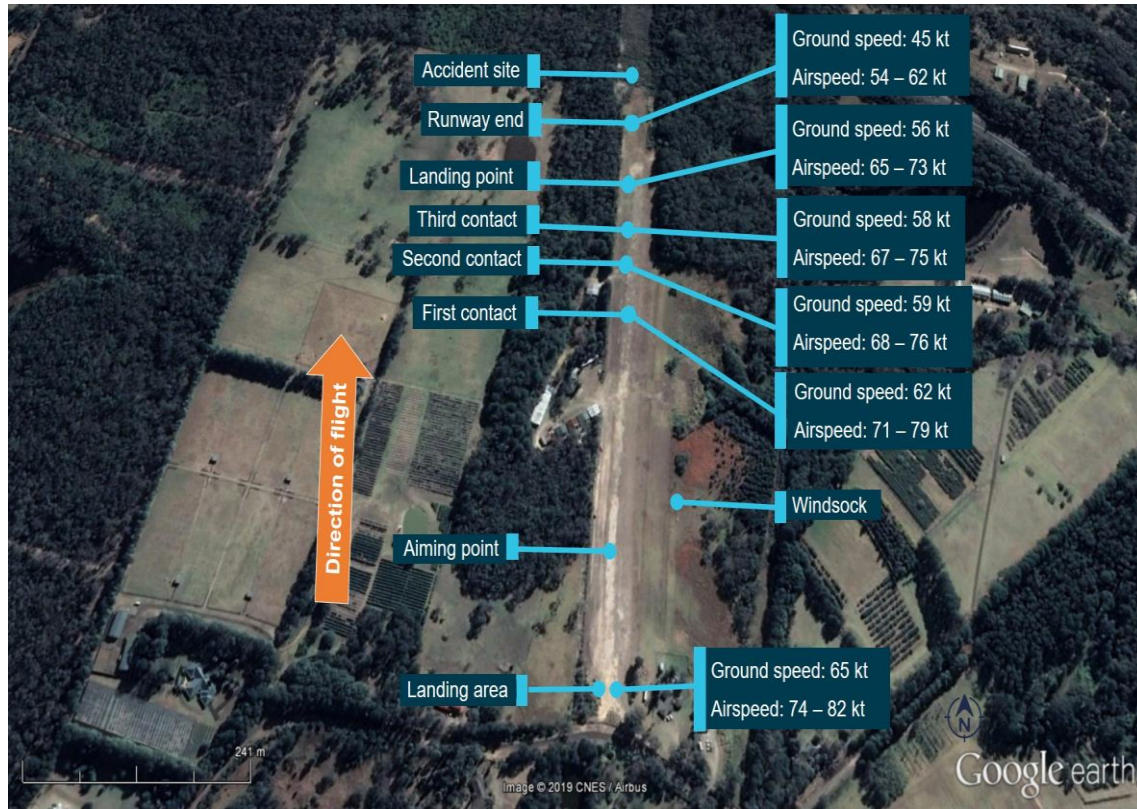
**Figure 3: OAJ's groundspeeds and approximate airspeeds during the landing**

From the data, it was found that the measured ground speed of the aircraft on final approach was 65 kt when entering the landing area. Factoring in the headwind component,<sup>4</sup> the airspeed was between 74 and 82 kt. Figure 3 shows the aircraft's ground speed and approximate airspeed on approach, and at various points during the landing.

Marks on the runway consistent with the wheels on OAJ, were identified at the initial wheel contact, subsequent contacts, and landing point (as annotated in Figure 3 above) described by the witness. Multiple other marks consistent with the left and right wheels skidding were identified near the end of the runway (Figure 4). Damage to the vegetation between the end of the runway and the accident site were consistent with the propeller rotating as the aircraft passed.

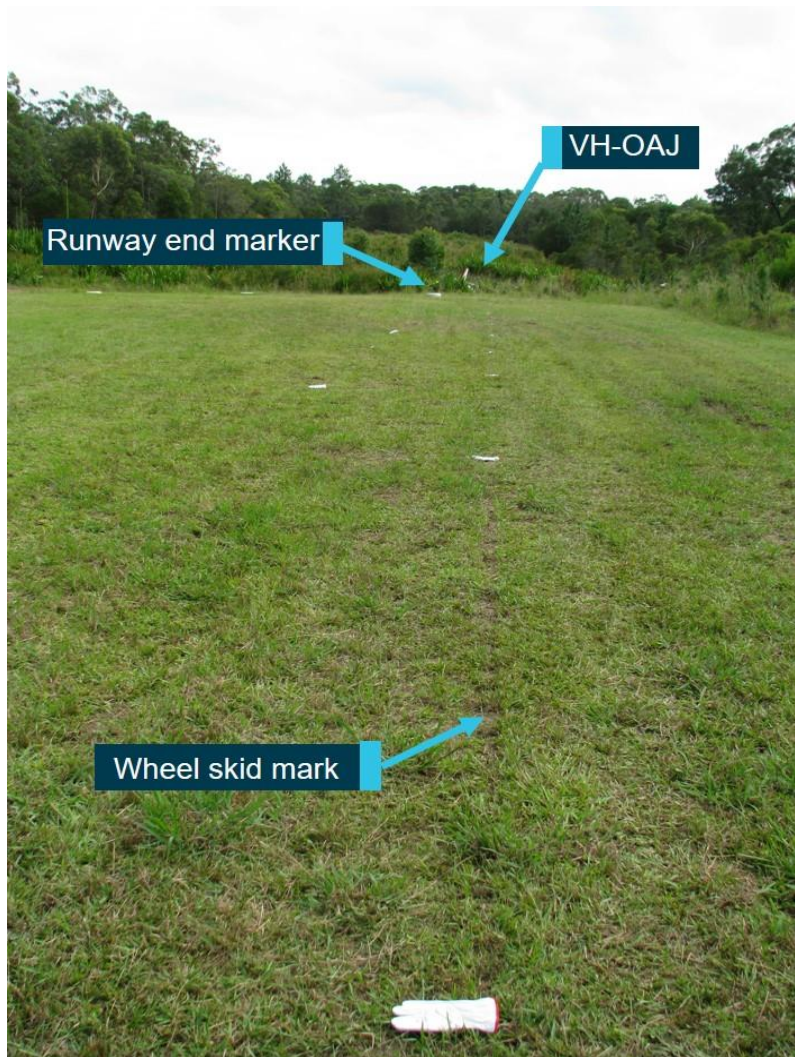
**Figure 4: Marks in the surface of the runway consistent with wheel skid**

*Note gloves placed by ATSB to indicate the start of the skid marks. The tail of OAJ is visible in the image beyond the end of the runway.*  
Source: ATSB

- Braking skid marks were found towards the end of the runway, indicating the intention was to brake, rather than increase power.
- The engine and propeller were found to be operating at low power prior to the impact.
- GPS recording of decreasing ground speed until impact.

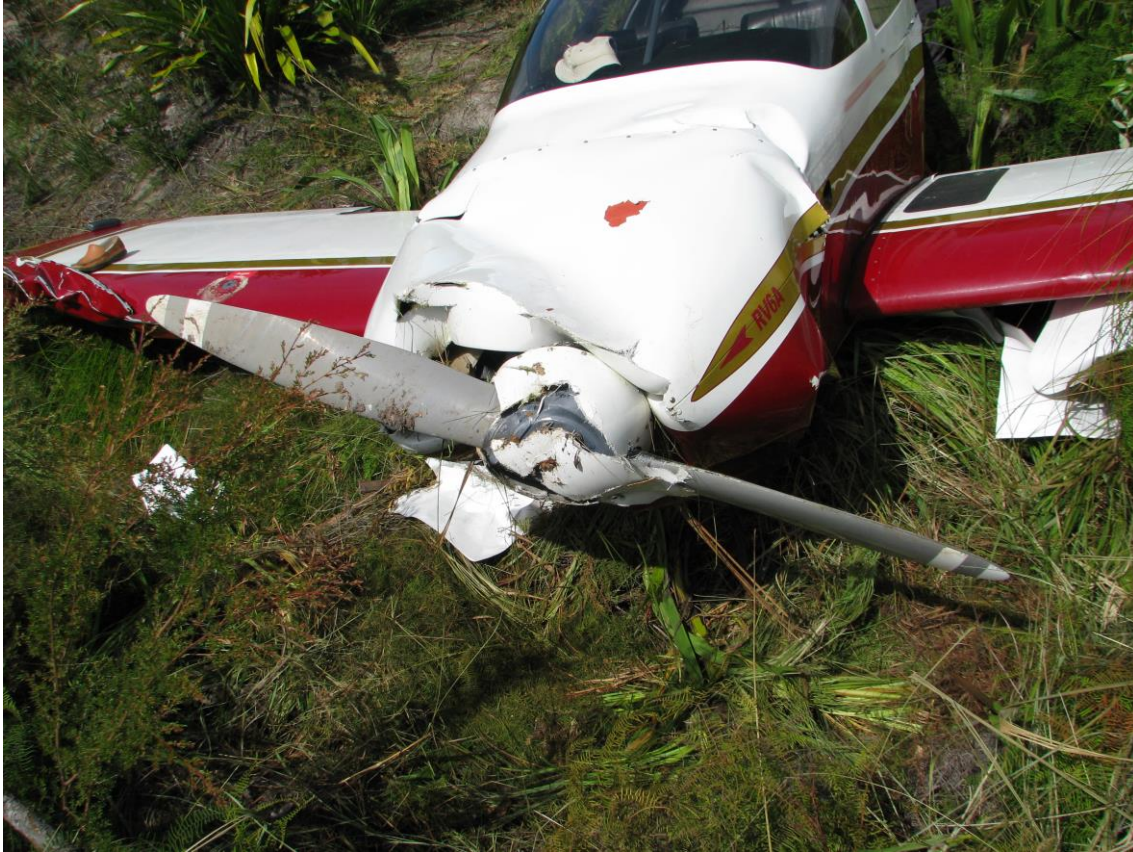
**Figure 5: Damage to OAJ**

- crushing damage to the forward portion of the aircraft including nose, landing gear, propeller and engine, and the outboard section of the right wing
- fracturing of the right wing flap control rod from overload failure
- buckling deformation of both sides of the fuselage behind the cockpit
- fracturing of the right wing fuel tank, resulting in a fuel leak.

The damage to the aircraft was consistent with the engine and propeller operating under low power at the time of the collision (Figure 5). No evidence was identified on-site of any mechanical defect that would have precluded the normal operation of the aircraft.

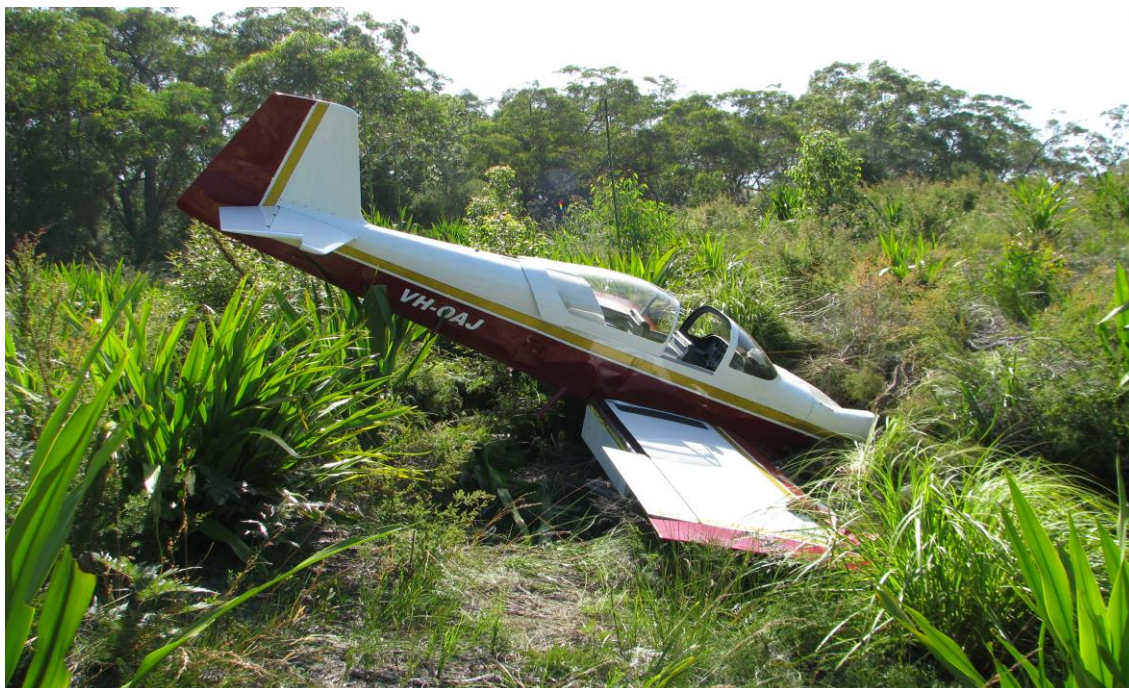
**Figure 6: Side view of OAJ in the watercourse**

The aircraft wreckage was found in a small watercourse 20 m past the northern end of the runway where it came to rest in a right-wing low, nose-down attitude. The witness, who was also the first responder, reported that the master switch was on and the fuel selector switched to the right tank. He reported that he switched both of them off to ensure the safety of the accident site.

The area beyond the northern end of runway 35 was cleared of tall trees for approximately 160 m. The land in this area consisted of low vegetation over a sandy base with some undulation in the terrain. In this area, approximately 20 m beyond the runway end, a small watercourse ran roughly perpendicular to the runway. A depression in the terrain associated with this watercourse increased in depth from the western (left)<sup>6</sup> side to the eastern (right) side. The watercourse consisted of a shallow gully within the depression with vertical sides. This gully was covered by thick low-growing vegetation. The aircraft impacted, and came to rest by the side of the shallow gully (Figure 6). The ALA owner also stated that the 30 to 50 m before the final stopping point of OAJ had been considered clearway area by the operators at Somersby and not used for take-off or landing.

The ATSB recommends the Civil Aviation Safety Authority publish guidance for the inclusion of a safe runway overrun area in their regulatory advisory document for Aeroplane Landing Areas.

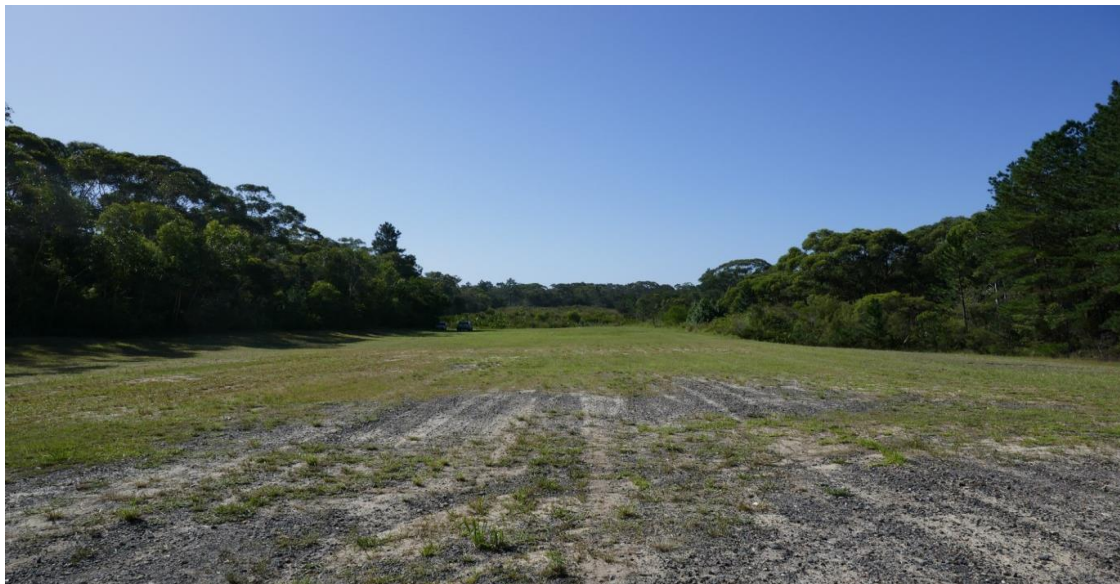
**Figure 7: View of runway 35 from the south**

A line of trees ran adjacent to most of the western side and a small part of the eastern side of the runway, around 15 m from the edge of the runway (Figure 7). The tall trees were at the beginning of runway 35 over the road that ran perpendicular to the runway.

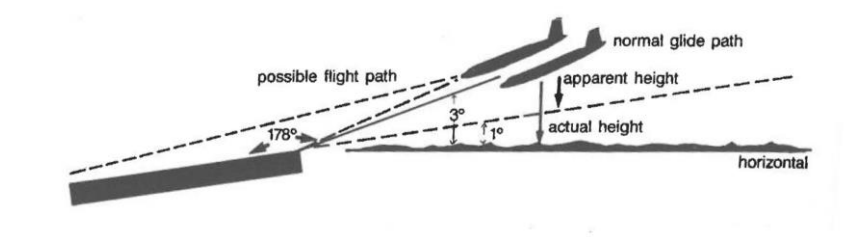
**Figure 10: Runway illusion for downward sloping runway**

A normal approach has a 3° glide path to a level runway. Research (Hawkins 1987, Wickens and Hollands 2000) into approach and landing phases of flight has found that when flying over flat and level terrain before a down sloping runway, the pilot may interpret the visual scene as indicating that both these surfaces are flat and level. Consequently, the pilot may perceive they are low on approach and may climb to 'correct' their perceived height. This leads to a longer landing, or runway overshoot (Figure 10).

Example shows a 2 degrees runway slope. Note the Somersby runway slope was 1.15 degrees.  
Source: Hawkins 1987
