Hard landing involving ATR 72, VH-FVZ

Canberra Airport, Australian Capital Territory | 19 November 2017

ATSB Transport Safety Report
Aviation Occurrence Investigation
AO-2017-111
Final – 12 November 2019

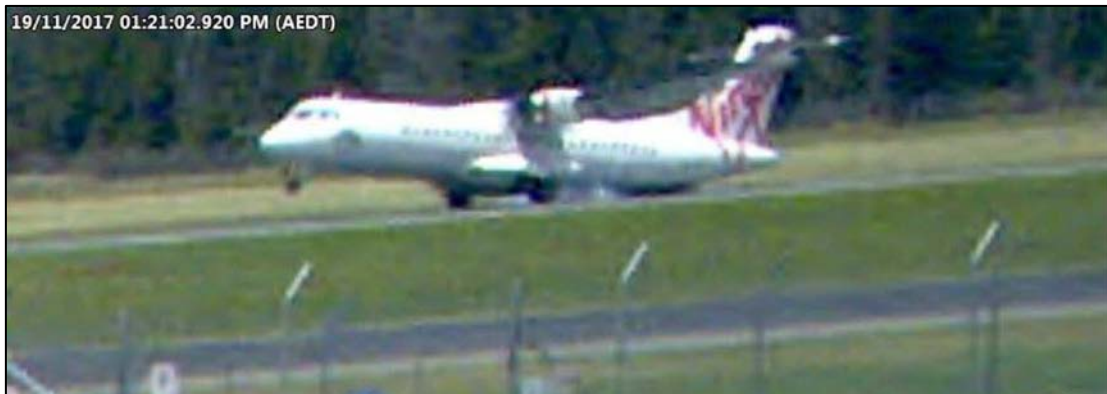
Figure 1: Occurrence touchdown

As the aircraft descended through about 50 ft above the runway, the recorded descent rate increased to 784 feet per minute, above the normal descent rate for the approach of about 575 feet per minute. At 1320:59, at a height of 27 ft and two seconds prior to touch down, the aircraft encountered a wind shift (see the section titled *Recorded flight data*) which further increased the descent rate. The PF and PM both reported that they felt a sudden increase in descent rate at that point. In response, the PM immediately called more urgently for an increase in power and manually intervened by advancing the power levers slightly, increasing power on both engines from 1.5 per cent torque to 3 per cent torque. Two seconds later, anticipating a bounced landing, the PM instructed the PF to commence a go-around. However, almost immediately the aircraft touched down at a normal pitch attitude, but heavily on the main landing gear, tail skid and

underside of the rear fuselage (Figure 1). The aircraft did not bounce and the PM cancelled the go-around, took control and completed the landing roll.

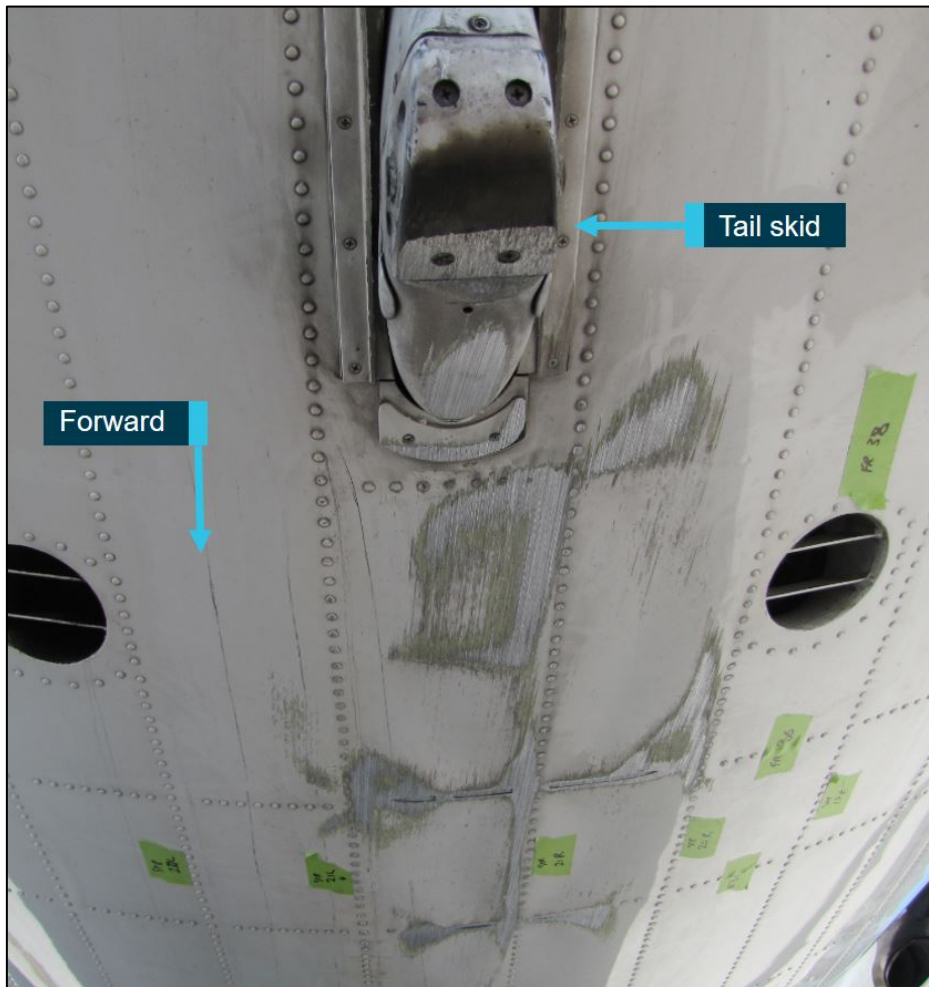
Figure 6: Damage to the tail skid and underside of the rear fuselage

Technical examination identified that the aircraft sustained impact and abrasion damage to the tail skid and the underside of the rear fuselage forward of the tail skid (Figure 6). Reskinning of sections of the fuselage underside, replacement of the tail skid and a drain deflector mast was required before the aircraft was returned to service.

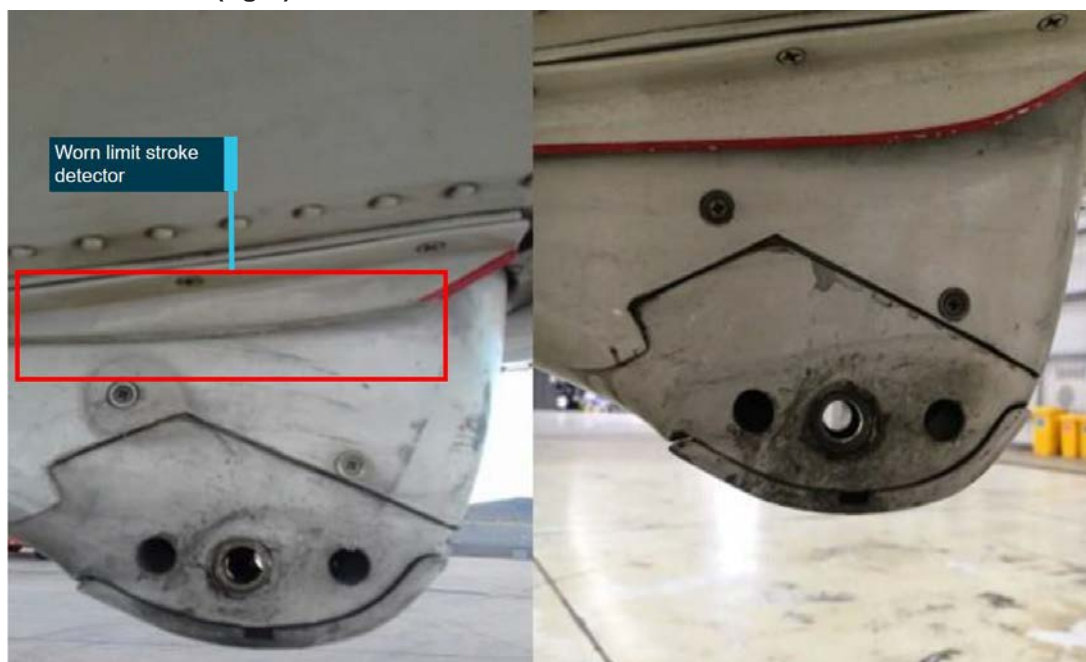
Figure 7: Figure showing the limit stroke detector from FVZ (left) and an undamaged stroke indicator (right).

Damage and wear to the tail skid and associated stroke indicator indicated that the tail skid was fully compressed during the landing (Figure 7). After landing, the main landing gear oleos⁶ remained fully compressed, indicating they had lost gas pressure.

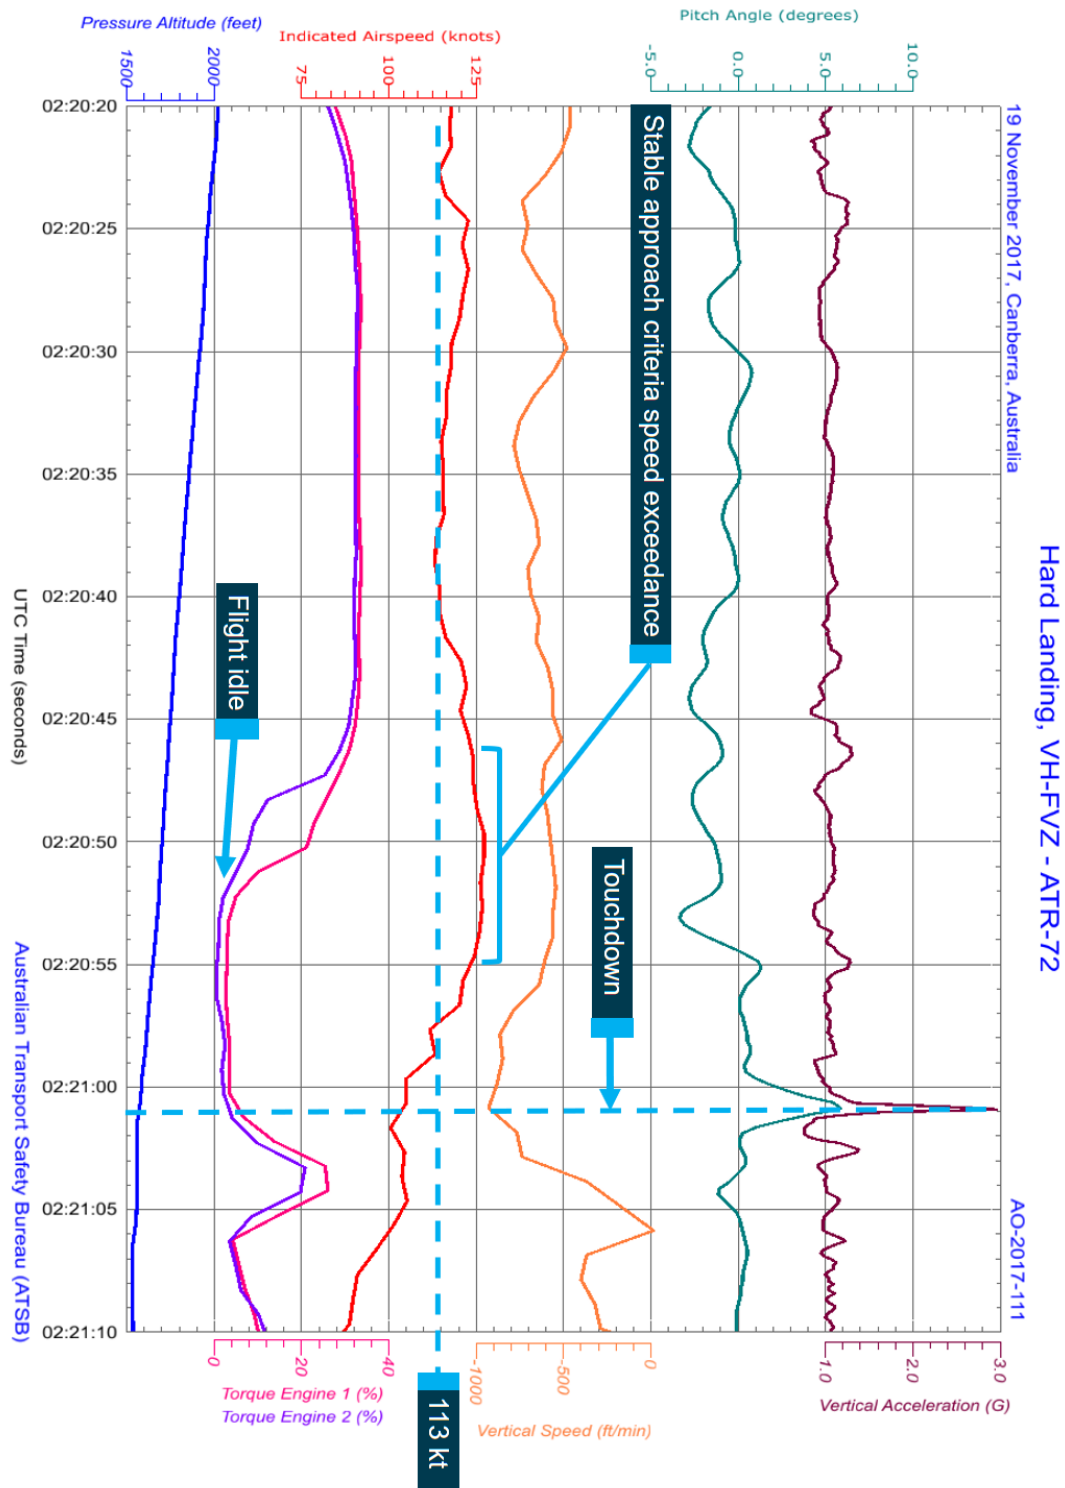
Figure 8: Graphical representation of flight recorder data

The recorded flight data showed that the aircraft speed fluctuated in the turbulent conditions throughout the approach, and generally exceeded the speed target of 113 kt (Figure 8).

At 13:20:50, speed increased above 123 kt, to a maximum of 127 kt, exceeding the stabilised approach criteria speed limitation by up to 4 kt for a total period of 9 seconds. Engine power then reduced from about 26 per cent torque to flight idle as the aircraft descended through a height of 118 ft. The power remained at flight idle until increasing marginally to 3 per cent, one second before touch down. Over the last six seconds of the approach, the recorded speed reduced from 125 kt to 105 kt.

The data also showed that at touchdown, the aircraft pitch attitude was 6° nose-up.
