# Engine inlet cowling failure involving Airbus A330, B-6099

Sydney Kingsford Smith Airport, New South Wales | 11 June 2017

**ATSB Transport Safety Report**  
Aviation Occurrence Investigation  
AO-2017-059  
Final – 20 November 2019

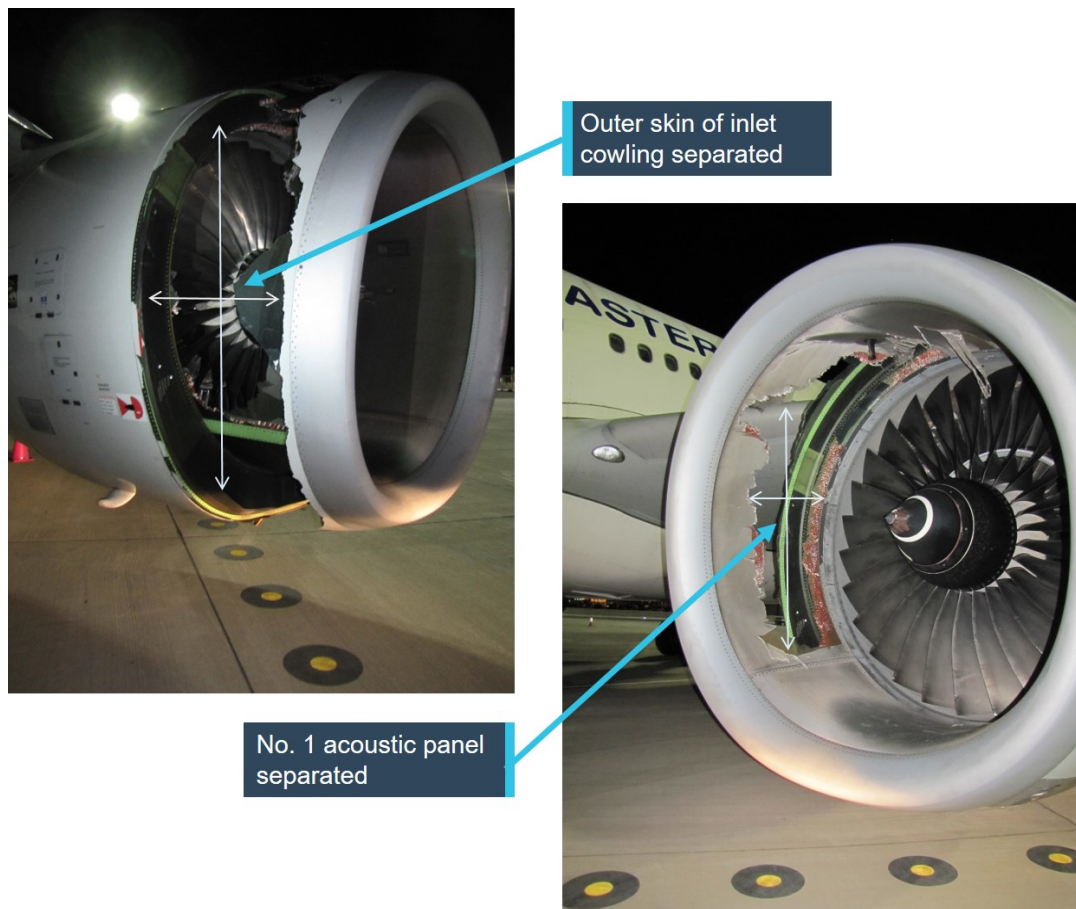
The aircraft was taxied to the terminal where passengers disembarked and maintenance engineers inspected the aircraft. Damage to the left engine inlet cowling was identified, including the No. 1 and No. 3 acoustic panels, and the inboard side outer inlet cowling skin (Figure 2). In addition, substantial damage was identified to the left engine fan blades and the cold stream duct.<sup>5</sup> Minor airframe damage to the left wing trailing edge flaps, landing gear door, and left side of the horizontal stabiliser was also identified.

**Figure 2: Left engine inlet cowling acoustic panels and inboard side outer inlet panel destroyed**

The investigation found that the No. 1 acoustic panel (inboard upper) had collapsed (Figures 2 and 4) where a large portion of the centre section was missing. The inboard outer skin panel was almost completely missing, with only small sections remaining attached around the rear bulkhead and the leading edge lipskin assembly. The No. 2 acoustic panel (lower panel) remained intact.

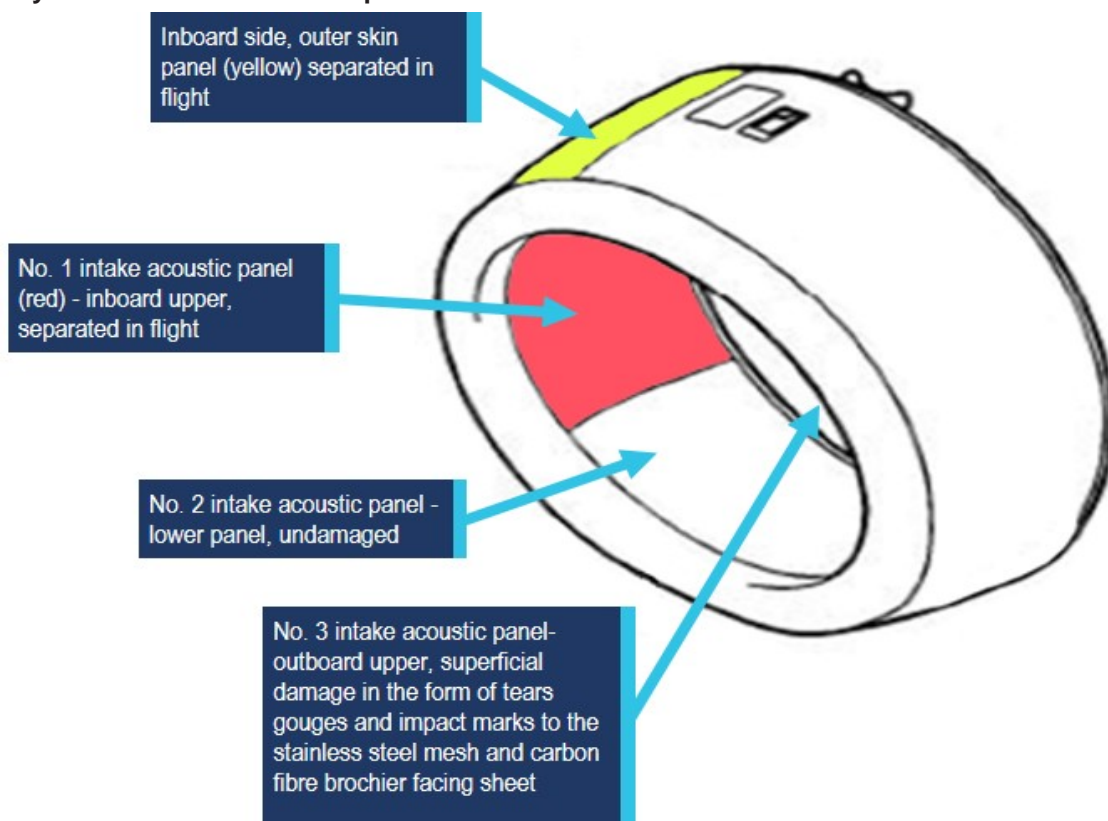
**Figure 3: Left engine inlet cowling components, highlighting the inboard side outer skin in yellow and No. 1 acoustic panel that failed in red**

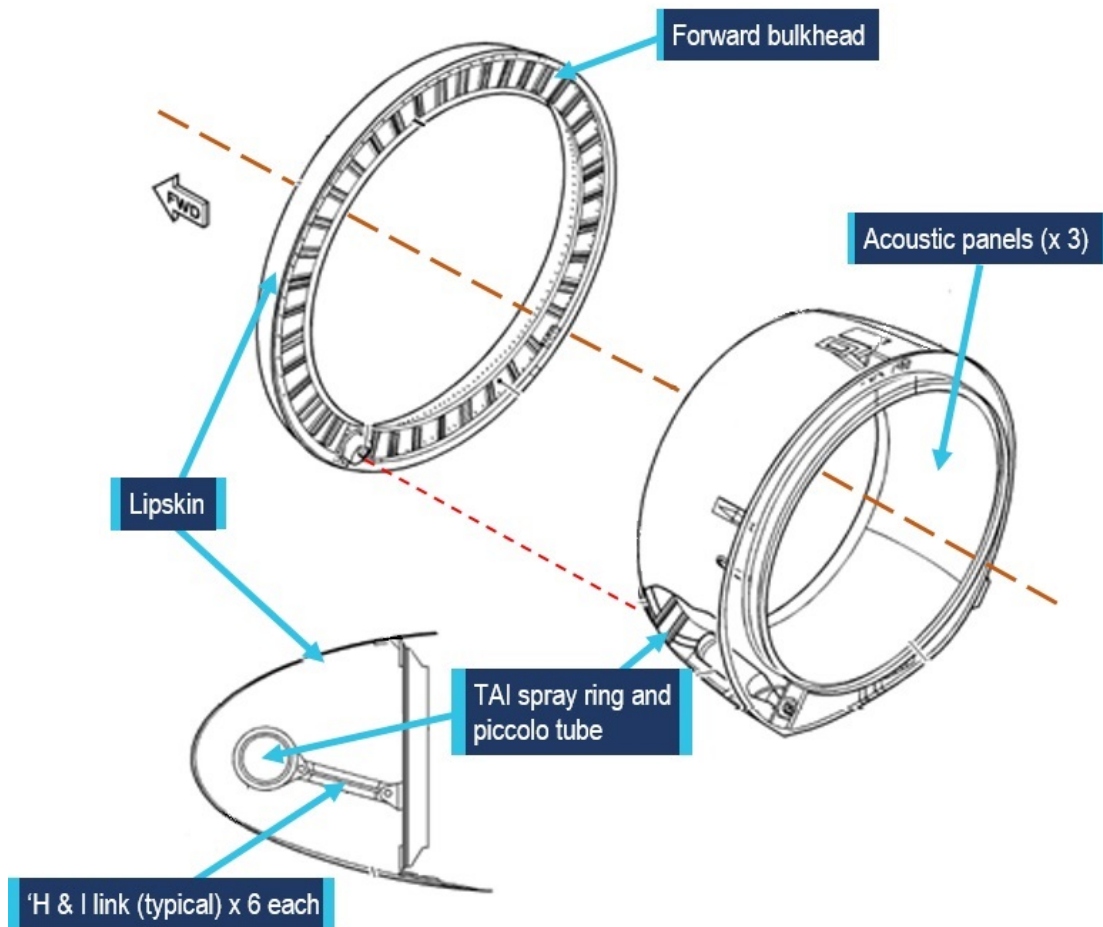
- In addition to the above observations, borescope inspections of the inlet cowling assembly forward structure found the thermal anti-ice (TAI) spray ring and piccolo tube intact. However, several TAI 'H' and 'I' links that secure the TAI spray ring to the forward bulkhead were found fractured and damaged at several locations. The forward bulkhead was also cracked around the radius for about one-third of the circumference. The investigation determined that the H and I link fractures, bulkhead cracking and other minor cracking was pre-existing and not a result of the acoustic panel failure. The existing European Aviation Safety Agency airworthiness directive 2016-0086R1 indicated this type of damage would typically result from acoustic excitation and vibrations. No evidence was found to suggest that these defects contributed to the failure of the No. 1 acoustic panel in this event.

**Figure 5: Location of the 'H & I links' that retain the thermal anti-ice spray ring within the inlet cowling**

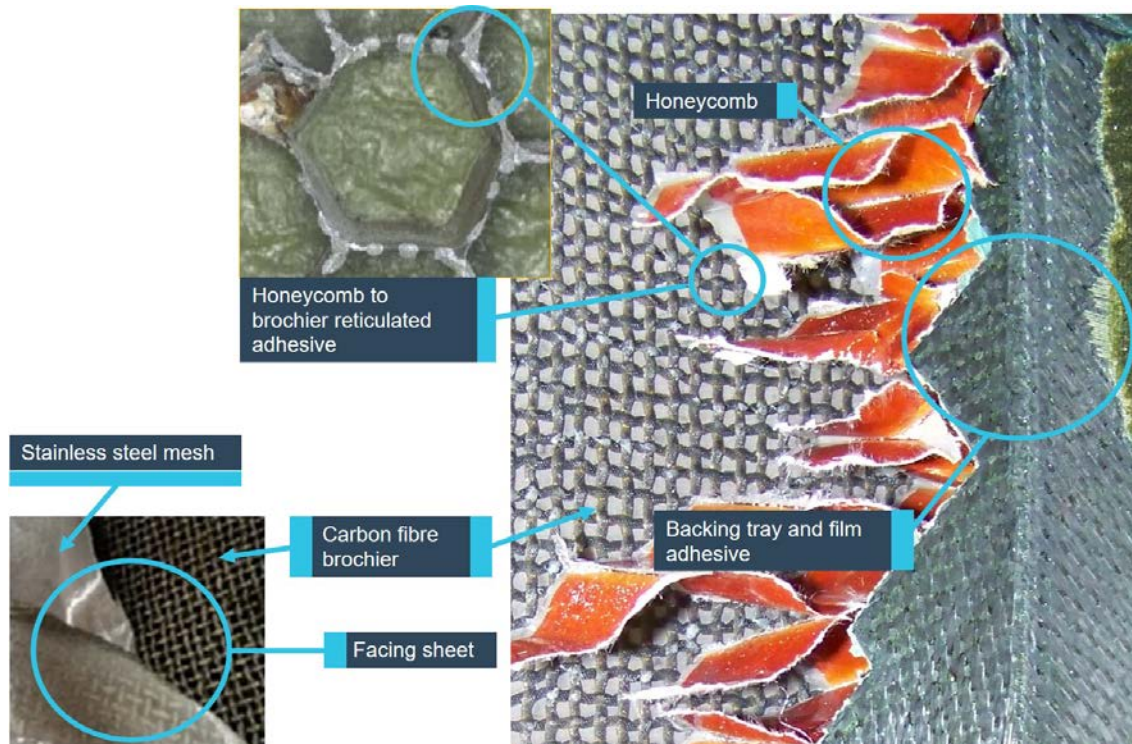
The majority of the failed No. 1 inlet cowling acoustic panel was ingested into the engine and was not recovered. Examination was therefore limited to the remaining material available (Figure 6), including the adjacent panels that did not fail.

The fracture surfaces of the remaining structure showed a range of failure mechanisms including tearing, shearing and peeling of the honeycomb core from the inner facing sheet and carbon fibre backing tray. As the section of the No. 1 inlet cowling acoustic panel that likely initiated the failure sequence was not recovered, the findings were inconclusive.

**Figure 6: Damaged acoustic panel showing construction and honeycomb to brochier bond elements**
