# Loss of control and collision with water involving Grumman American Aviation Corp G-73, VH-CQA

10 km west south west of Perth Airport, Western Australia | 26 January 2017

## **ATSB Transport Safety Report**

AO-2017-013

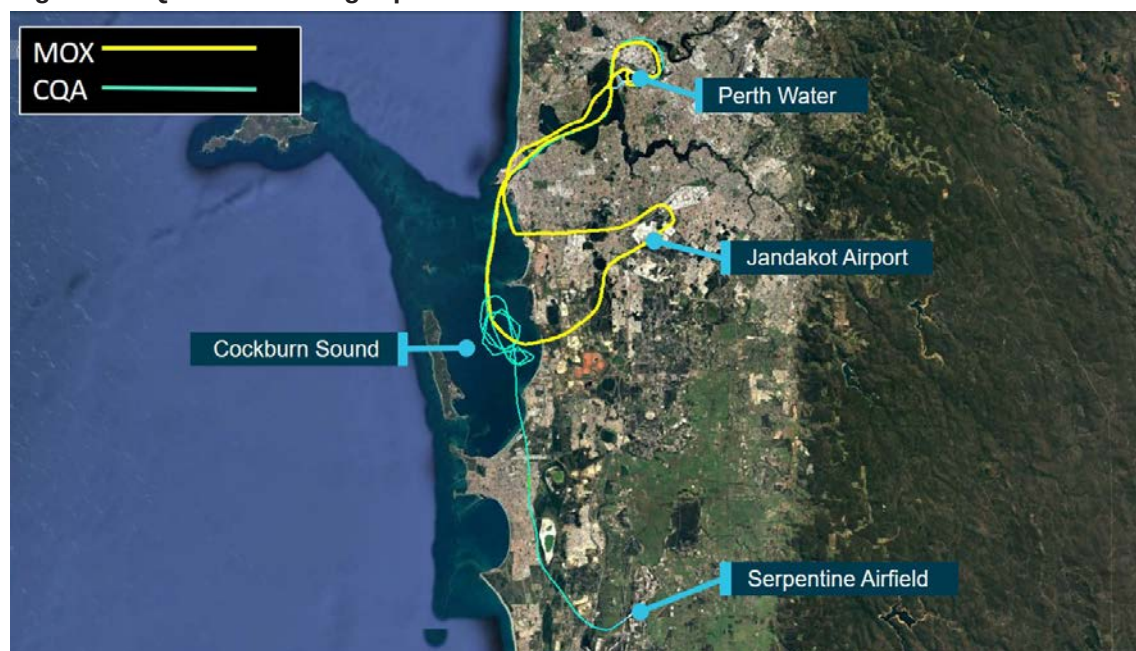
**Figure 1: CQA and MOX flight path**

Upon meeting up, the pilot of CQA assessed that MOX's speed was too high for the two aircraft to travel together and requested that the Caravan pilot slow his aircraft down. The pilot of MOX agreed to slow down with a request that CQA 'didn't get too close'. Both aircraft then flew the prescribed route to Perth Water, the location of the air display. The weather was fine with a recorded wind of about 20 km/h from the south-west and a temperature of about 39°C.

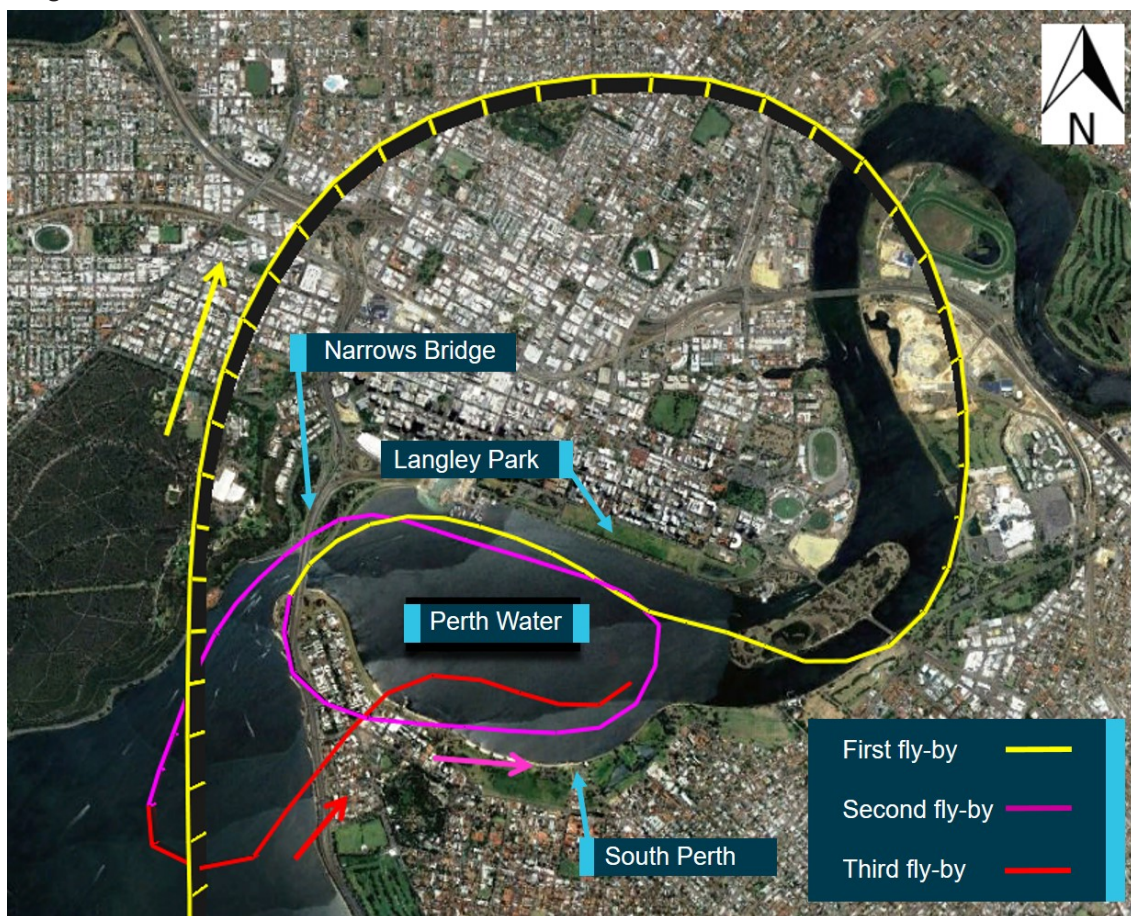
**Figure 2: CQA air display flight track, showing the first pass in yellow, the second in magenta and the third in red**

Flight data and video footage showed that CQA took longer to initiate the left orbit and subsequently flew at about 500 ft over the built-up area of the South Perth peninsula that connects to the Narrows Bridge, at the western end of Perth Water. CQA then descended to about 200 ft over the south of Perth Water while repositioning for a second pass.

Analysis of available track data (as depicted in Figure 2) found that the Mallard's speed on entry to the accident turn was approximately 10 kt slower than at the equivalent point in the previous orbit and within around 10 kt of the aircraft's stall speed for a coordinated turn at an estimated 30° angle of bank at the commencement of the turn.

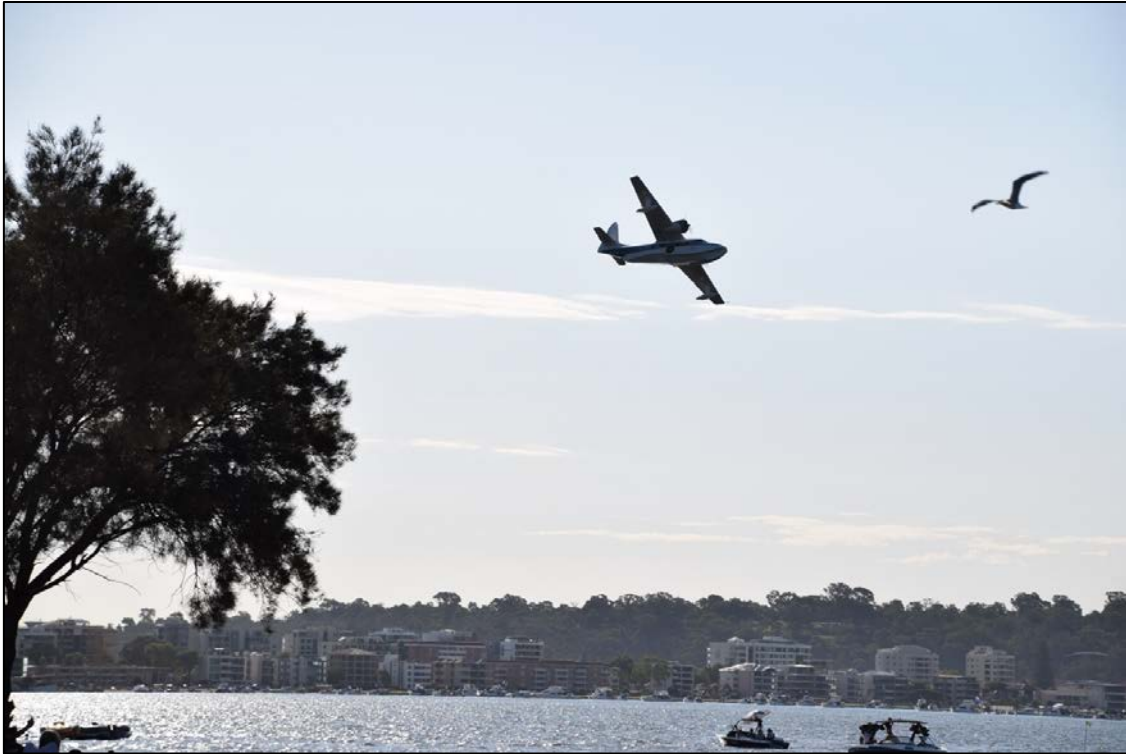
**Figure 3: CQA's pass along South Perth, just prior to the final left turn**

When MOX conducted its second splash-and-go in front of Langley Park, CQA was about half an orbit behind, flying in an easterly direction along South Perth foreshore. Following completion of the splash-and-go, the pilot of MOX climbed over the Narrows Bridge to about 1,000 ft for the return flight to Jandakot. CQA's second fly-by of Langley Park was lower than the first, descending to just above the water surface, before a climb was also initiated to clear the Narrows Bridge.

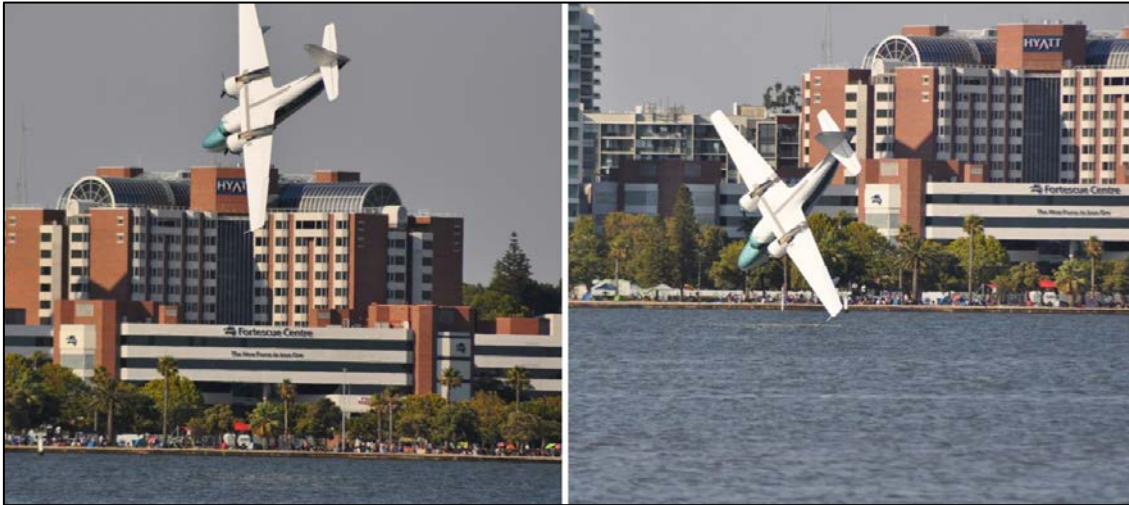
**Figure 4: CQA just prior to the collision with water (looking north)**

Damage to the aircraft was consistent with the observed collision with water in a steep nose-down attitude and subsequent contact with terrain, about 1.5 m below the surface. Examination of the wreckage did not identify any evidence of in-flight break-up, component failure or other anomalies that may have contributed to the collision with terrain, or that would have prevented the engines and propellers from operating normally. This was consistent with witness reports, images and video of the aircraft during the display.
