Wirestrike and collision with terrain involving Robinson R44, VH-KCH

near Mansfield, Victoria, on 6 July 2019

ATSB Transport Safety Report
Aviation Occurrence Investigation
AO-2019-031
Final – 28 November 2019

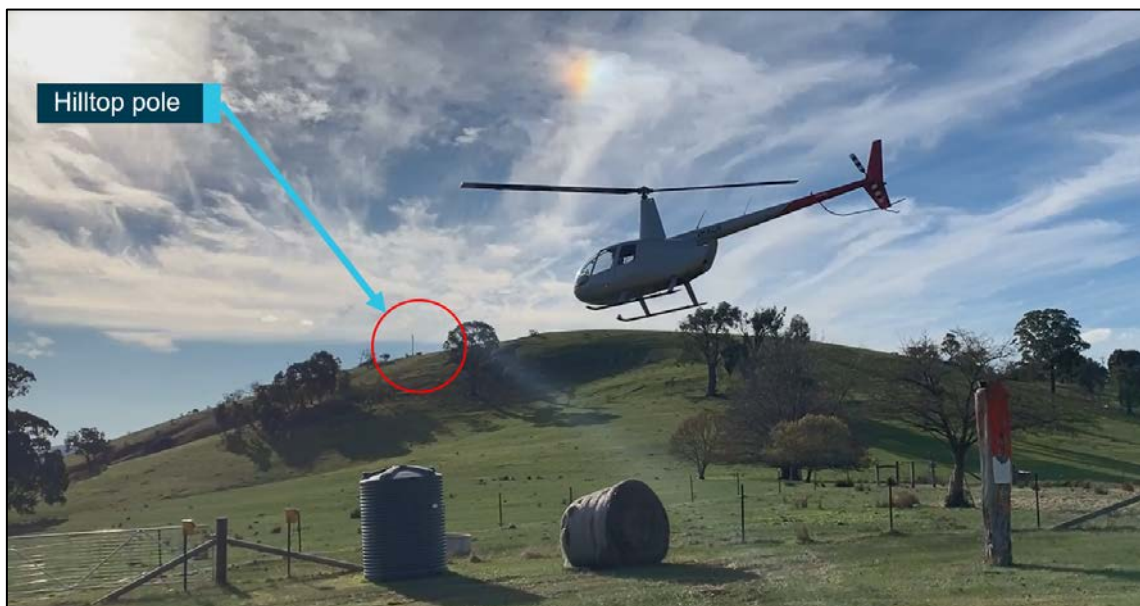
Shortly after 1505, the helicopter lifted off and climbed gradually. The pilot reported that he focused on clearing two trees on the departure path, and that he did not notice a powerline pole on the nearby hilltop (Figure 1). The helicopter accelerated to an airspeed of at least 50 kt and travelled about 400 m from the take-off site.

Figure 1: Helicopter shortly after take-off (hilltop pole visible from that location)

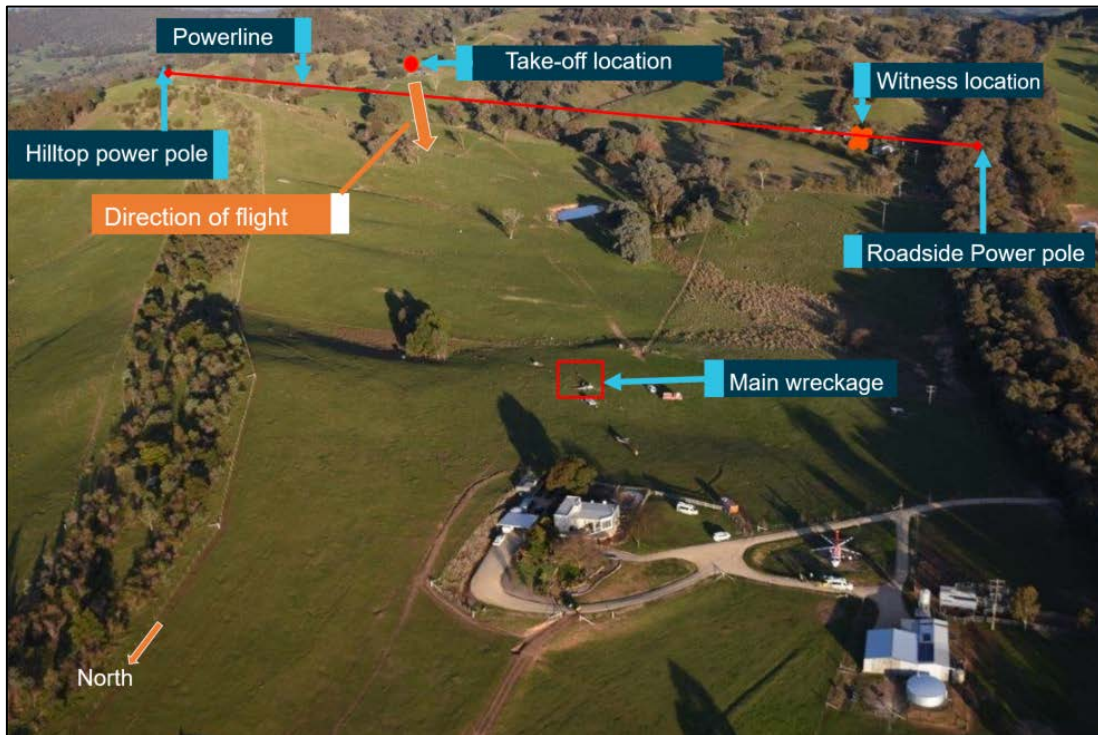
At 1506, the helicopter struck a two-wire powerline, 158 ft above ground level (Figure 2). The pilot reported that he did not see the wires, but felt a jolt and observed that the windscreen had cracked. He did not identify that the helicopter had struck a powerline, and focused on controlling the helicopter to a run-on landing. The helicopter descended rapidly, travelling about 400 m after the wirestrike, in which time the pilot felt another jolt. The aircraft collided with the ground in an upright position before it spun around and rolled over. The pilot sustained minor injuries and the passenger was seriously injured. The helicopter was substantially damaged (Figure 3).

Figure 2: Overview of the accident location

The single phase, two wire (conductor) 22 kV powerline was strung across the spur line. It traversed a valley from a pole on the top of a hill to a pole located near the main road. The span ran perpendicular to a line of poles leading to a neighbour's house. The span length was 559 m between poles and the maximum clearance above the valley was 48.1 m (158 ft).

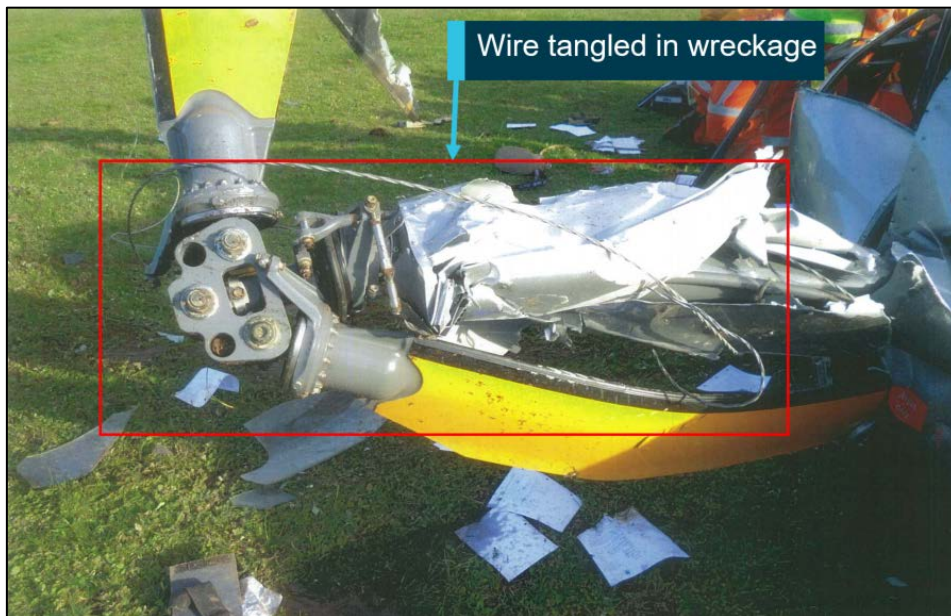
Figure 3: Accident site showing wire tangled in the wreckage

Following the wirestrike, the helicopter pulled the two wires off the pole, which then parted and fell to the ground. Some of the wire remained attached to the helicopter (Figure 3) with the rest of the span on the ground and resting in trees.
