# Pressurisation event involving AirAsia Indonesia Airbus A320, PK-AXD

160 NM north of Perth, Western Australia, on 15 October 2017

**ATSB Transport Safety Report**  
Aviation Occurrence Investigation  
AO-2017-098  
Final – 26 November 2019

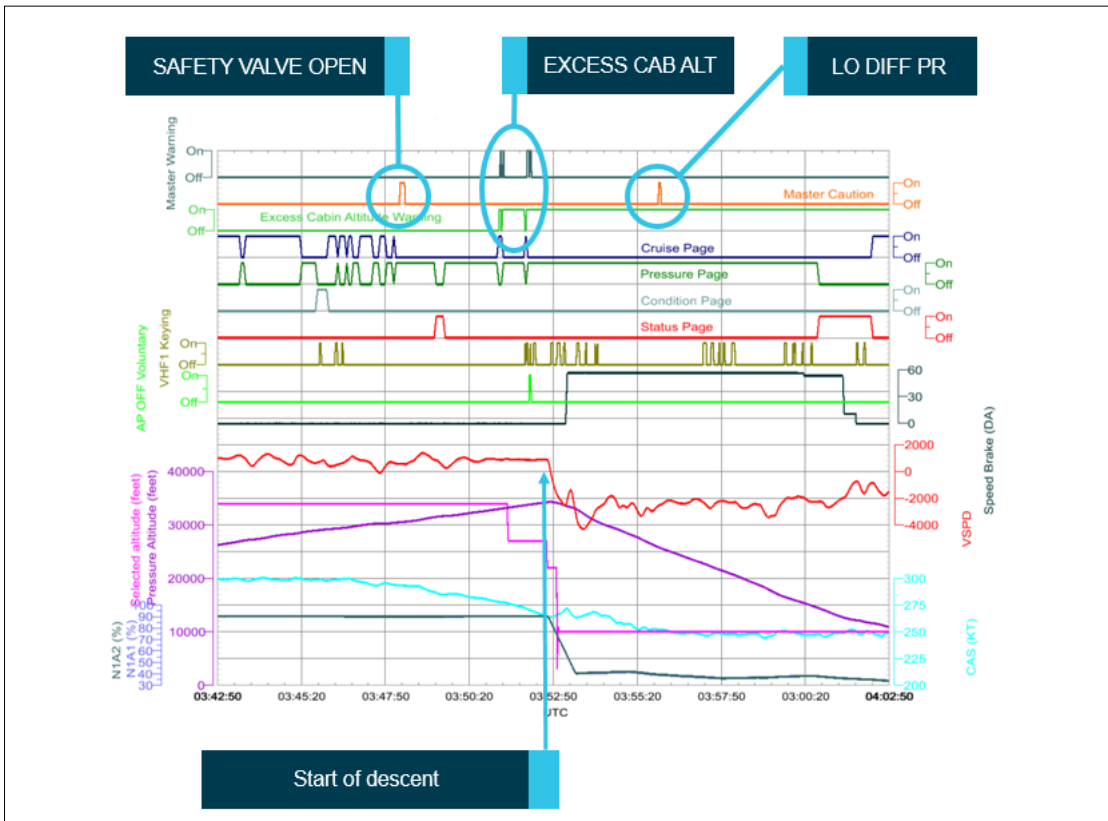
**Figure 1: Activation of alerts and start of emergency descent**

During the emergency descent there was an intermittent activation of the master caution for cabin low differential pressure (CAB PR LO DIFF PR). Figure 1 below depicts the flight data showing the activation of the alerts, and the descent from about FL 340 to 10,000 ft, which was at an average rate of about 2,300 ft/min (maximum of 4,300 ft/min). There were no reported injuries and the aircraft was not damaged. The post-flight maintenance tests identified a fault with the cabin pressure controller 1 (refer to *Aircraft information*).

Information from the flight data recorder depicting the activation of alerts and start of the emergency descent in UTC.<sup>7</sup>  
 Source: ATSB

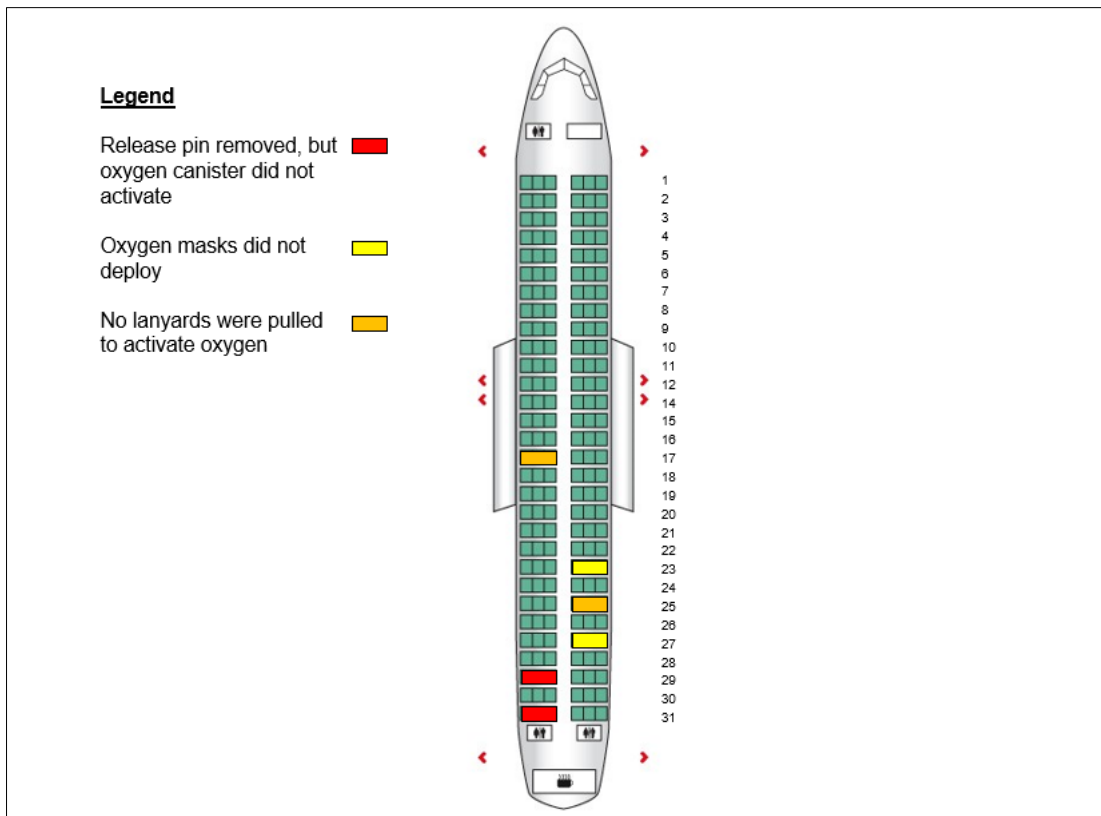
**Figure 5: Passenger oxygen units**

- two containers did not open at seats 23 FED and 27 FED (Figure 5)
- two canisters had the release pin removed, but did not activate to produce oxygen, at seats 29 CBA and 31 CBA
- two containers were found deployed, but the masks were not pulled to remove the release pin at seats 17 CBA and 25 FED
- all other passenger seat masks were deployed and their associated canister activated
- all cabin crew and toilet masks were deployed
- one portable oxygen unit appeared to have been removed from storage.

Depiction of the passenger oxygen units, as found by the ATSB after the incident aircraft landed.  
Source: ATSB

After the aircraft landed at Perth Airport, the ATSB inspected the passenger oxygen units and found two units had not deployed (23 FED and 27 FED) and two units had deployed and the release pin removed from the canister, but the firing pin had not activated (29 CBA and 31 CBA). The passenger survey results suggested that there were some additional units that were pulled-down manually by passengers.

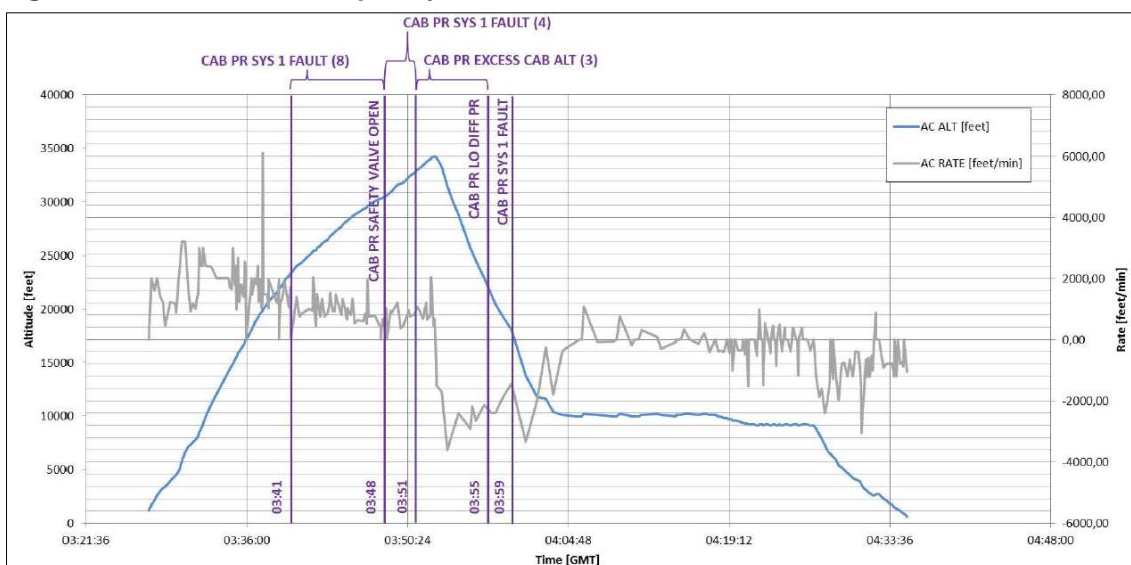
**Figure 6: Activation and frequency of alerts**

The manufacturer’s root cause analysis revealed a rare intermittent fault, in which the CPC 1 non-volatile memory remained in the operational state despite generating multiple fault messages (Figure 6).

The timings and frequency of activation of alerts of the cabin pressurisation system in UTC [GMT]. Blue line refers to Aircraft altitude, Grey line refers to Aircraft climb/descent rate.  
Source: Nord-Micro (courtesy Airbus)
