# Engine failure involving Airbus A330, 9M-XXD

445 km south-east of Alice Springs, South Australia, on 16 August 2016

**ATSB Transport Safety Report**

AO-2016-101

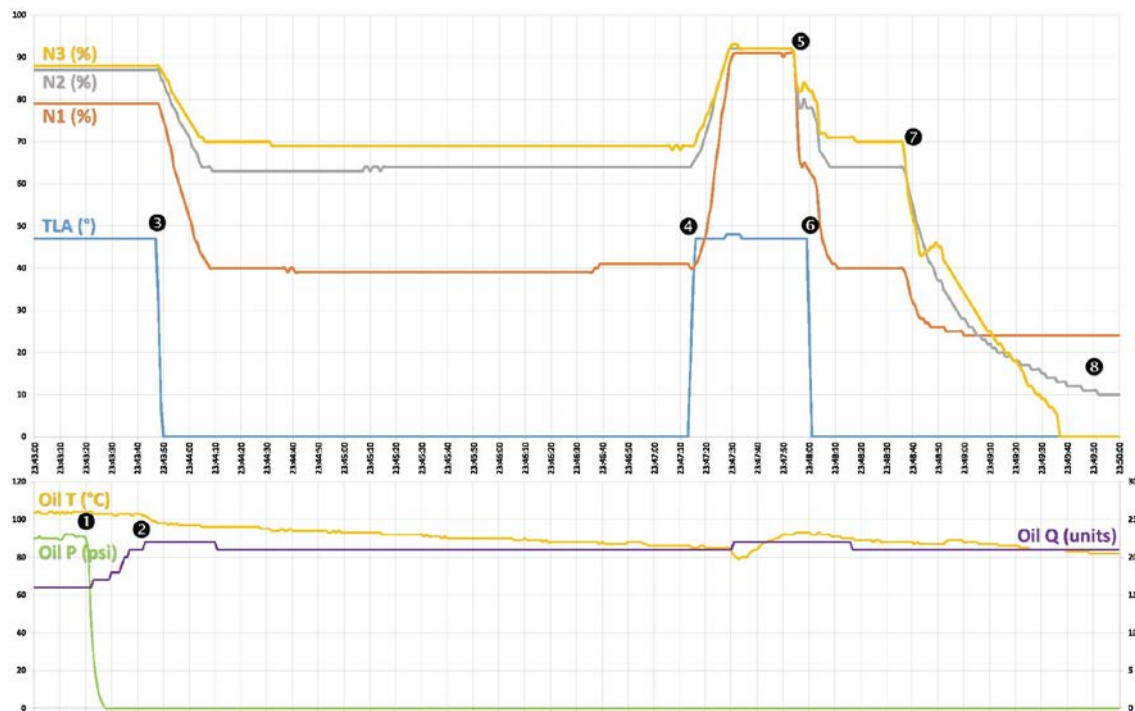
**Figure 2: Engine data recorded by the flight data recorder**

As the aircraft was in cruise at flight level<sup>7</sup> (FL) 380 and tracking towards Alice Springs, the engine 2 oil pressure pump failed as a result of the pump's drive shaft failing, resulting in a rapid and total loss of engine oil pressure. The shaft failure occurred at 2343:20, while the aircraft was 240 NM (445 km) south-east of Alice Springs. Over the subsequent 7 seconds, the aircraft's flight data recorder (FDR) recorded the engine 2 oil pressure drop from 90 to 0 psi (❶ and green line on Figure 2).

While no oil was being fed into the engine as a result of the oil pressure pump shaft failure, the air pressure in the bearing chambers would have forced the residual oil in the chambers down the scavenge lines and back to the tank. This resulted in the indicated oil quantity increasing by about one third (❷ and purple line on Figure 2).

At 2348:37, 35 seconds after the first engine stall, the engine stalled again and ran down further (⑦ on Figure 2). The second engine stall was also accompanied by a significant spike in the recorded engine vibration. The FADEC again responded by briefly cutting the fuel flow, however, this time the engine did not recover. The engine continued to run down, and failed. The ECAM detected the engine failure and at 2348:42, alerted the flight crew by:

The flight crew responded to the ENG 2 FAIL ECAM alert by commencing the displayed procedure. That procedure included a decision about whether the engine was damaged. The flight crew stated that they consulted the flight manuals and determined that the engine was not damaged. In accordance with the required procedure, the engine master switch was selected to off at 2348:50, shutting the engine down (⑨ on Figure 2).

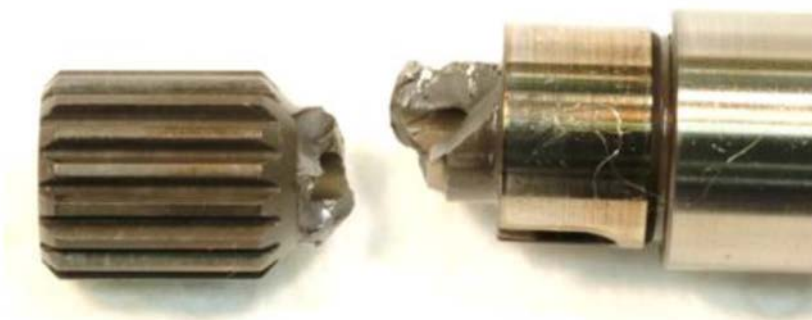
**Figure 7: Fractured oil pressure pump shaft**

- there were no obvious engine oil leaks
- oil tank contents were full
- the engine magnetic chip detectors and oil filters were clean
- the oil pressure pump drive shaft neck was fractured (Figure 7)
- the high pressure (HP) assembly was seized due to bearing stress
- damage to the HP assembly ball and roller bearings was consistent with engine operation without oil pressure.

On examination of the failed shaft, Rolls-Royce identified that the failure occurred at the shear neck,<sup>32</sup> but that the failure was not typical of any previous shear neck failures (Figure 8). Rolls-Royce found that the shaft fracture was the result of fatigue cracking that originated at multiple sites within the shaft bore. Those cracks grew over time, weakening the shaft, until the remaining material failed in overstress. The material and shaft dimensions reportedly complied with specifications. Rolls-Royce was not able to determine what generated the fatigue cracks in this pump shaft. Other than the fracture in the shaft, the pump was in a serviceable condition.

The Rolls-Royce investigation concluded that damage to the HP assembly bearings was consistent with engine operation without oil pressure. Rolls Royce also concluded that the surges were consistent with the expected behaviour of an engine with the identified damage to the HP bearings.

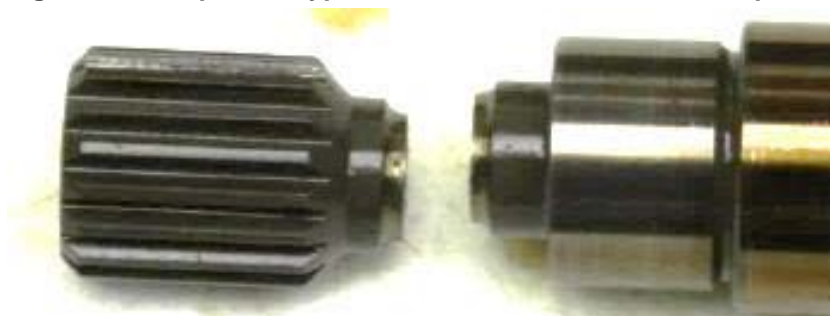
**Figure 8: Example of a typical shear neck fracture of an oil pressure pump shaft**

Note that the fracture surface is perpendicular to the shaft axis.  
Source: Rolls-Royce.

The oil pressure pump model is common to both the Trent 700 and the Trent 800 (fitted to Boeing 777 aircraft). Rolls-Royce reported that in an initial review of in-service experience, it identified two previously reported cases of pump failure. The first was on a Trent 800, with approximately 3,000 hours since overhaul, and the second was on a Trent 700, with 7,730 hours since new. In both cases, the failure was a result of pump bearing seizure, and the fracture was perpendicular to the axis of the shaft, consistent with that shown in Figure 8.
