Loss of power on take-off and forced landing involving Cessna 182, VH-DGF

Tooradin Airfield, Victoria | 6 January 2019

ATSB Transport Safety Report
Aviation Occurrence Investigation
AO-2019-002
Final – 31 January 2020

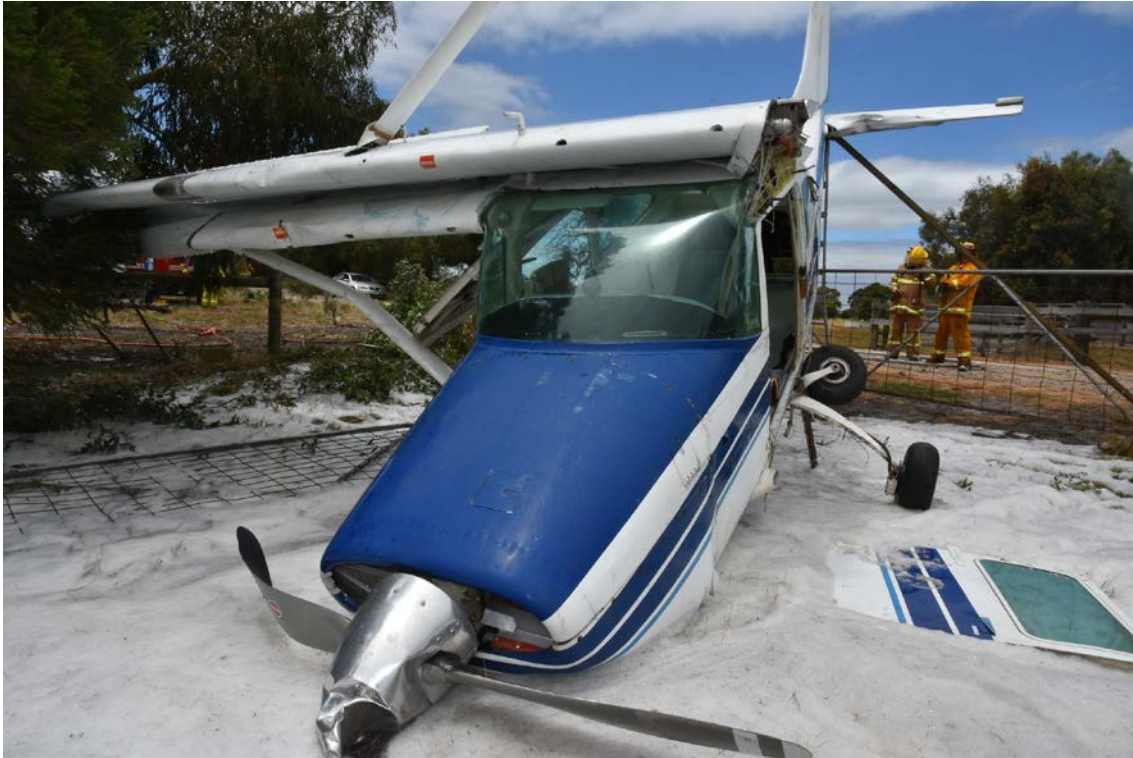
Figure 1: Accident site of Cessna 182, registered VH-DGF

The aircraft touched down in a relatively flat, open paddock. It initially bounced on the unprepared surface before settling on the ground and passing through two boundary fences. The pilot attempted to slow the aircraft and manoeuvre to avoid trees. As the aircraft passed through a gap in the trees, the left wing strut collided with a tree, which resulted in the left wing folding over on top of the right wing and fuel leaking from it onto the fuselage. The aircraft further collided with a third fence, crossed a private road, and collided with a fourth fence, which collapsed the nose landing gear (Figure 1).

The aircraft was substantially damaged and there were no injuries.

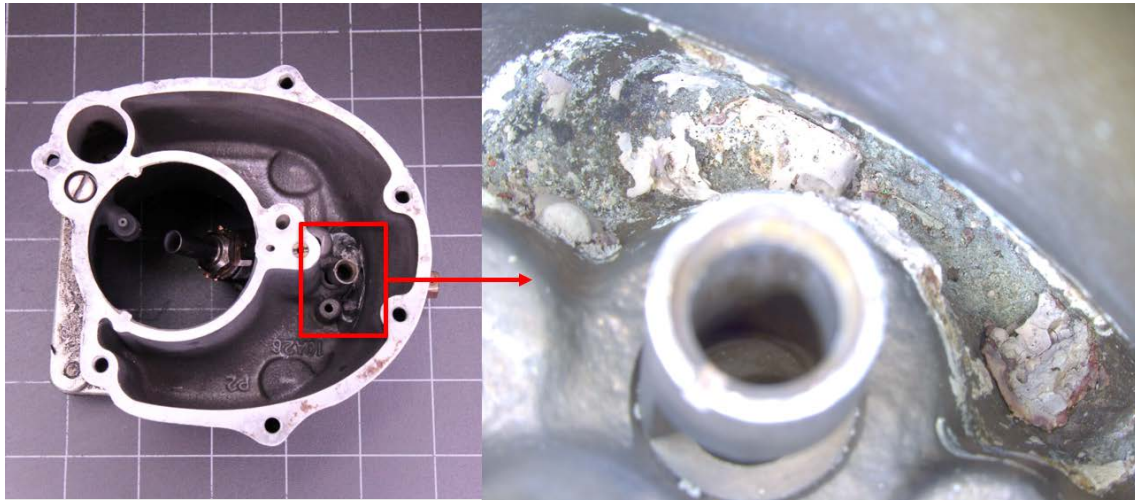
Figure 2: Material inside the carburettor bowl of VH-DGF

The carburettor and the recovered material were examined by the ATSB. Most of the recovered material had a white, chalky appearance and ranged in size up to 5 mm. Inside the carburettor bowl, a significant amount of the material had accumulated at the drain area, and a 'tide' line was visible on the sides of the drain area. The inside surface of the bowl exhibited pitting corrosion where the material had dislodged (Figure 2).

A small amount of similar white chalky material was also observed on a 'dip' in the carburettor bowl, slightly above the drain. Other than the areas described, the internal surfaces of the bowl appeared to be relatively clean and in good condition, although some other foreign material was observed in the bowl.

ATSB analysis of the debris found in the carburettor showed that it was primarily comprised of aluminium and oxygen. It was considered likely that the particles were aluminium oxide, a corrosion product from the aluminium carburettor bowl.

The carburettor fitted to VH-DGF contained aluminium oxide corrosion deposits. These were of sufficient size such that, when loosened, they probably blocked fuel flow within the carburettor, resulting in the aircraft engine suddenly losing power shortly after take-off.

As the carburettor bowl is on the 'downstream' side of the defences to prevent contamination, there are maintenance and storage processes to ensure its serviceability. The corrosion was probably able to form in the carburettor bowl during periods of inactivity. However, it was not possible to determine exactly when the corrosion started and propagated.

Corrosion was able to form within the carburettor that was not prevented or detected. This occurrence highlights the importance of following the maintenance program for the aircraft. Particularly in this case, this included draining and flushing the carburettor at its periodic inspection.
