Landing accident involving Van's RV-6A, VH-ANU

William Creek ALA, South Australia, on 28 July 2019

ATSB Transport Safety Report
Aviation Occurrence Investigation
AO-2019-037
Final – 12 February 2020

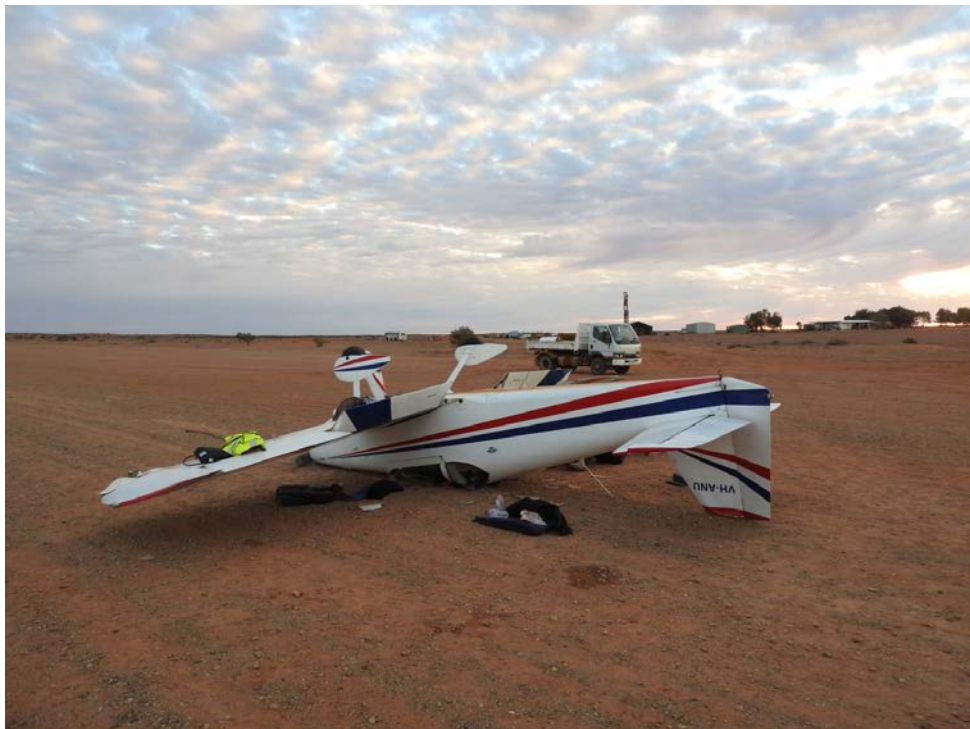
Figure 1: Accident site of VH-ANU

When the nose gear made contact with the runway surface for the second time, it bent under the aircraft. The propeller struck the runway and the aircraft skidded on its nose, then flipped over and came to rest inverted (Figure 1).

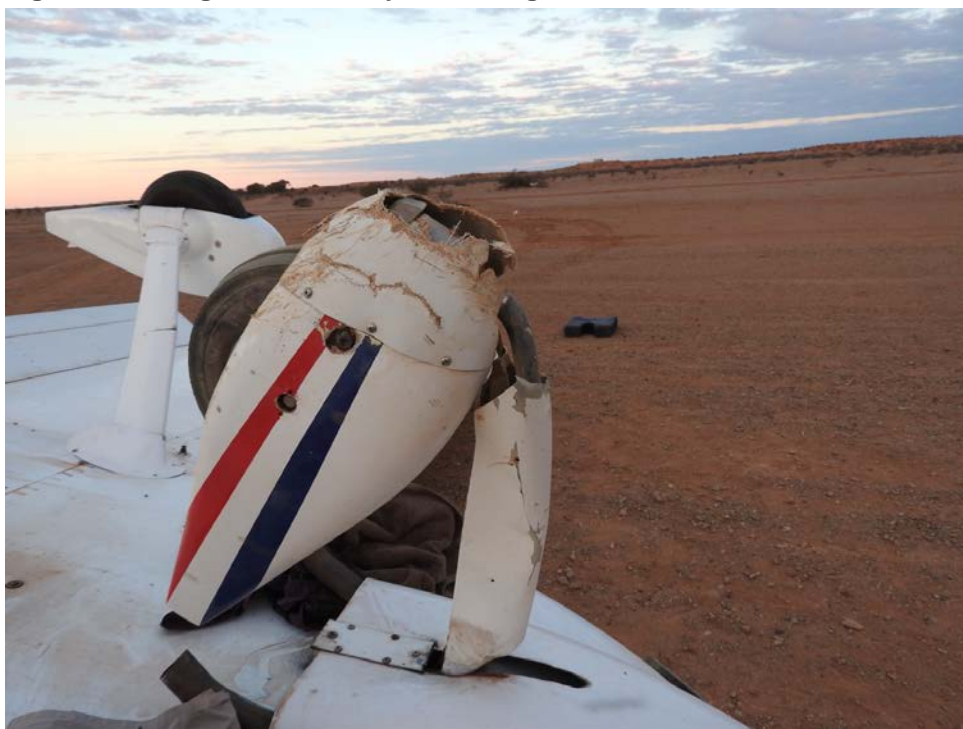
Figure 2: Damage sustained by the nose gear

During the accident sequence, no fractures were sustained by the nose gear strut or the fork. The principal deformation was the bending in the aft direction at the top of the strut, near the engine mount (Figure 2).

The ATSB reviewed the damage to the aircraft and found that the nose gear did not sustain a fracture through any of the major structural components (i.e. the nose gear strut or fork), but had deformed rearwards, under the aircraft. For this to have occurred, the ground clearance must have been sufficiently reduced so that the nose gear strut or fork made contact with the runway, imparting significant forces on the gear assembly and initiating the damage sequence.

The factors that affect the ground clearance during landing include the tyre pressure, engine weight, runway condition and dynamics of the landing. In this accident, the exact mechanism by which the gear made contact with the runway was not determined.

- During the landing sequence the nose gear fork or strut made contact with the runway surface and bent underneath the aircraft, causing it to become inverted.
