Collision with vessel involving Cessna 208, VH-ZWH

Berowra Waters, New South Wales on 29 June 2019

ATSB Transport Safety Report
Aviation Occurrence Investigation
AO-2019-030
Final – 26 February 2020

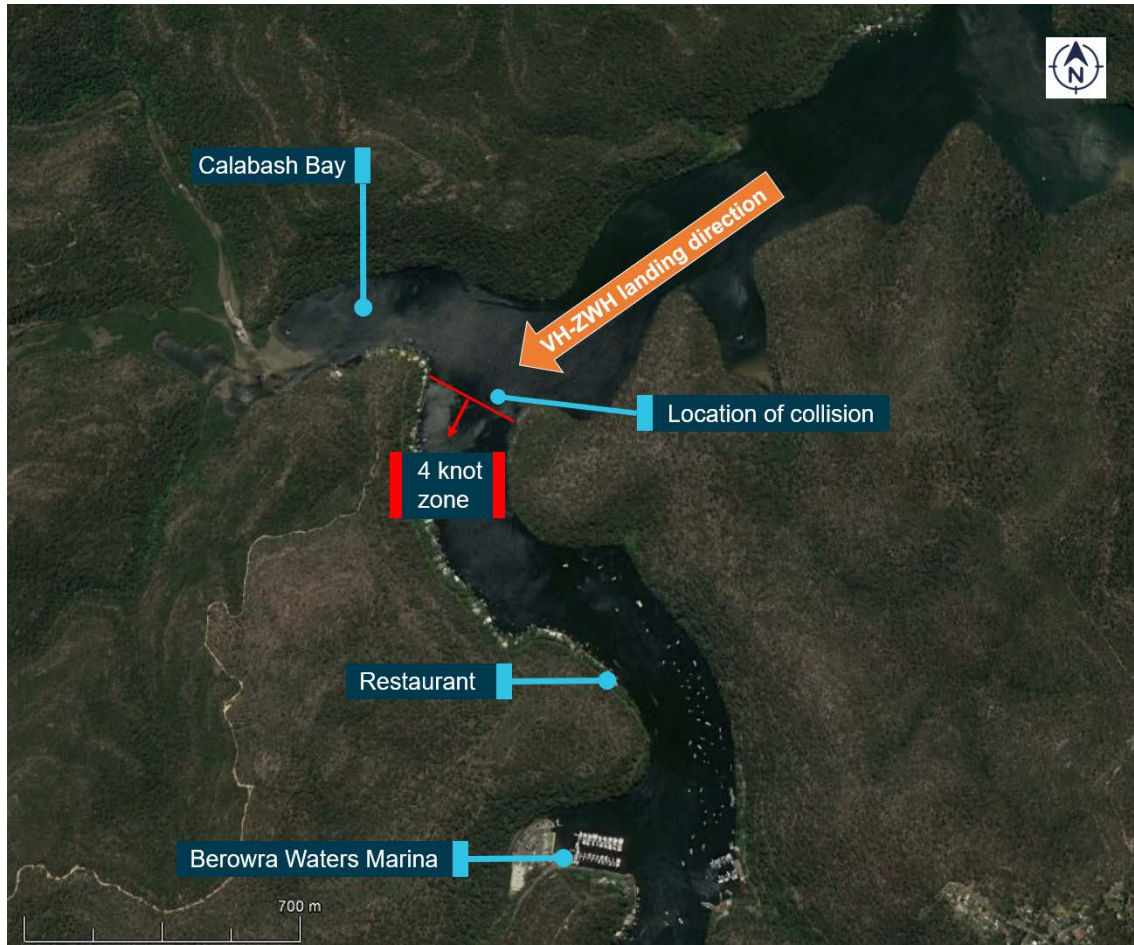
About 5 minutes after the boat had stopped, ZWH approached the landing area on Berowra Creek (located in Berowra Waters). The pilot assessed that the wind conditions were suitable for landing and positioned the aircraft to land on Berowra Creek in a south-westerly direction (Figure 1). After landing, because of the long distance to taxi to the restaurant, the pilot kept the aircraft's speed up, maintaining the aircraft 'on the step' (see *Seaplane positions*) for some time. At the same time, the pilot was also monitoring a large white boat that was heading south out of Calabash Bay, ensuring that it continued moving away from the aircraft and was not going to present a hazard. As the aircraft approached the 4-knot zone of the creek (Figure 1), the pilot reduced the speed and the aircraft moved from the step to the taxiing position.

Figure 1: Image of the Berowra Waters area showing the location of the collision, the landing direction of VH-ZWH and significant landmarks

- Company pilots where possible are to manoeuvre on the right hand side of the river to reduce the risk of a blind spot near the area of the incident.
- As standard operations, company pilots are to reduce the speed of the aircraft to an idle power taxi speed after landing, 100 m before the start of the 4-knot zone at Berowra.
- The company safety management system was updated to reflect additional post incident response requirements.
