Engine failure involving Airbus Helicopters AS355F-1, VH-SEV

Bankstown Airport, New South Wales on 12 March 2018

ATSB Transport Safety Report
Aviation Occurrence Investigation
AO-2018-021
Final – 12 March 2020

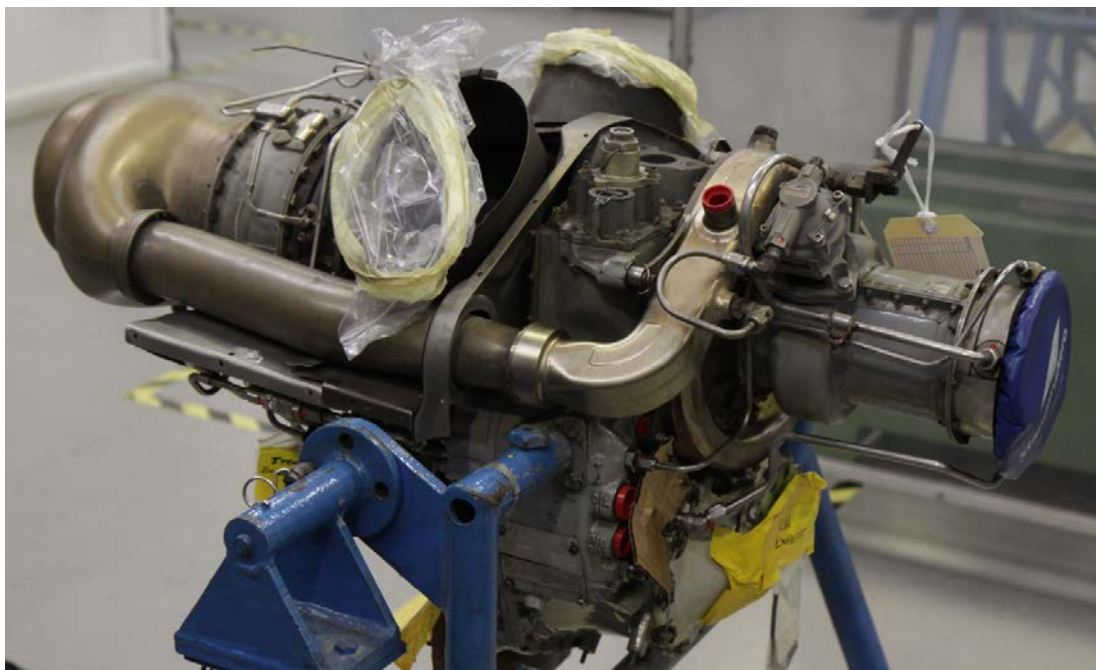
Figure 1: Right-hand engine from VH-SEV

The incident resulted in substantial damage to the right-hand engine and minor heat damage to the surrounding structure on the aircraft.

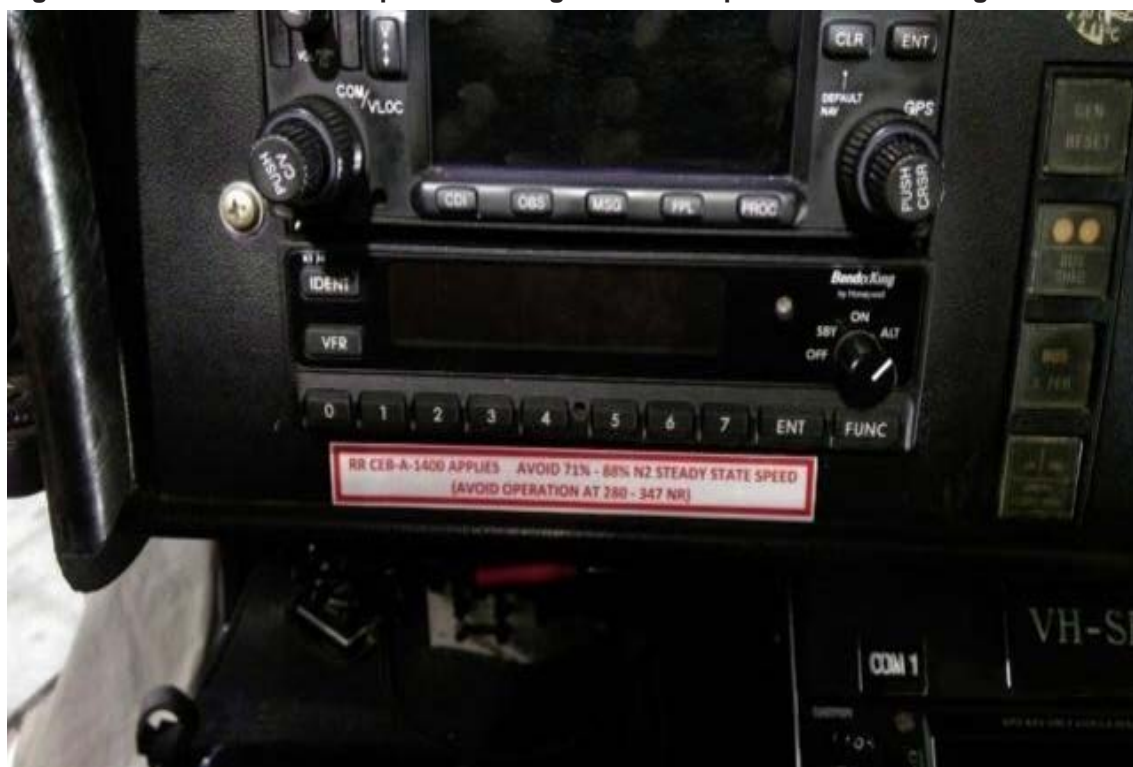
Figure 3: VH-SEV instrument panel showing decal with speed avoidance range

The 71-88 per cent N2 speed avoidance range observed by the pilot was a conservative range that encompassed the engine manufacturer's guidance (see the section titled *Aircraft safety alerts and operations manual*). The avoidance range was marked at the bottom of the instrument panel (Figure 3). The pilot's standard start-up and shut-down procedures were to transition between ground idle (approximately 63 per cent N2) and 100 per cent N2 in a continuous motion through the speed avoidance range. The pilot stated that there were no operational parameters that required operation in the avoidance range.

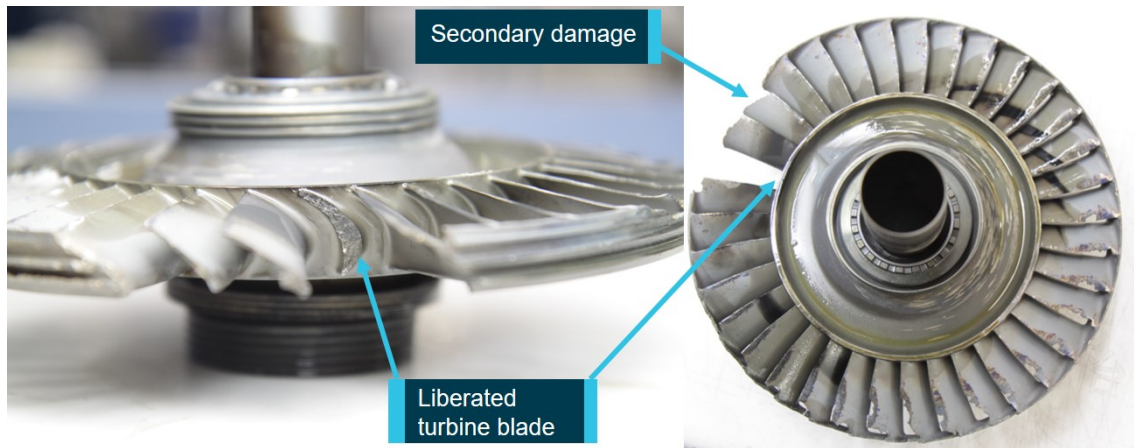
Figure 4: Third-stage turbine wheel removed from VH-SEV showing damage

- The damage was limited to the turbine section of the engine.
- One blade on the third-stage turbine wheel had liberated, resulting in substantial secondary damage to the wheel (Figure 4).
- Damage to the other engine components was consistent with secondary damage caused by rotor imbalance and impact damage from debris (Figure 5).⁷

In summary, a single third-stage turbine wheel blade failed due to fatigue cracking, resulting in secondary damage to the engine and total engine failure.

To reduce the risk of engine failure events, Rolls-Royce is re-designing the third-stage turbine wheel to improve the strength and durability of the component. The main feature of the new design is a larger fillet at the blade trailing edge, which will reduce the stress at the critical location, resulting in a more durable component with greater tolerance to fatigue cracking and operation at responsive wheel modes. The new design was expected to be released at the end of 2020.

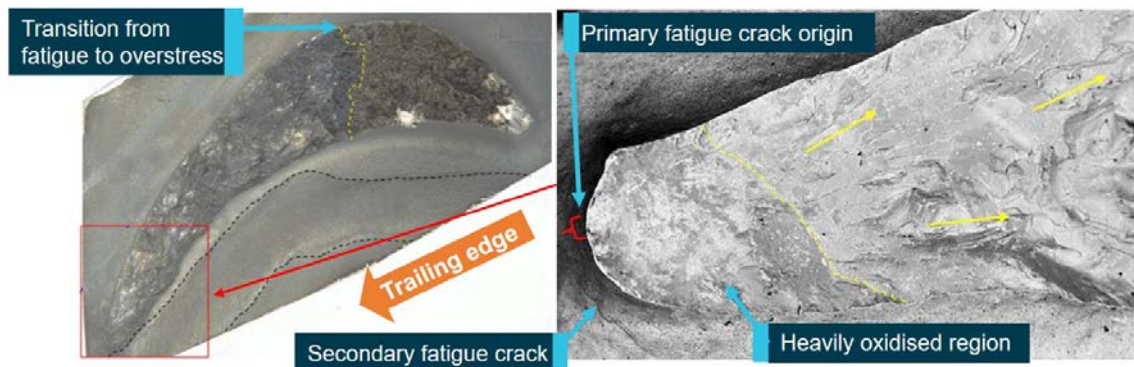
Figure 5: Fracture surface of liberated blade on third-stage turbine wheel

- One third-stage turbine wheel blade fractured and separated due to fatigue cracking. The fracture surface showed two distinct fatigue regions:
 - The initial portion of the crack was consistent with the crack-like indications in the trailing edge of the blades. It was 0.069 inches in length and characterised by oxidation across the fracture surface. The number of fatigue striations indicated that this portion of the crack was present at the time of the maintenance inspection. However, the exact size of the crack at the time of the inspection could not be determined.

- The crack then transitioned to a high cycle fatigue cracking mechanism, progressing towards the leading edge, before the blade liberated in overload (Figure 5).

One of the blades with crack-like indications was selected for further analysis. The blade was lab-fractured and the fracture surface compared to that of the liberated blade. The crack was measured to be 0.045 inches in length and the crack morphology was found to be consistent with the initial portion of the failed blade.

The primary fatigue crack on the liberated blade was no greater than 0.069 inches in length at the time of the inspection. Within 24 flight hours (22 flight cycles) the fatigue crack progressed to more than 50 per cent of the blade cross section. That is, it propagated to the critical crack length in under 0.5 per cent of the expected life of the wheel.

While it was not possible to verify the operation of the aircraft, based on examination of the fracture surfaces and expert opinion, the rapid fatigue crack progression in the third-stage wheel was probably caused by a momentary dwell in the speed avoidance range.

Since this occurrence, Rolls-Royce has also updated CEB 1400 (Revision 7) and the operations manual to simplify the speed avoidance range and more clearly articulate the possible consequence of dwelling. The operations manual now states:
