# Main landing gear wheel failure during taxi involving Boeing 737, VH-VUH

Brisbane Airport, Queensland, on 4 January 2017

**ATSB Transport Safety Report**  
Aviation Occurrence Investigation  
AO-2017-003  
Final – 30 March 2020

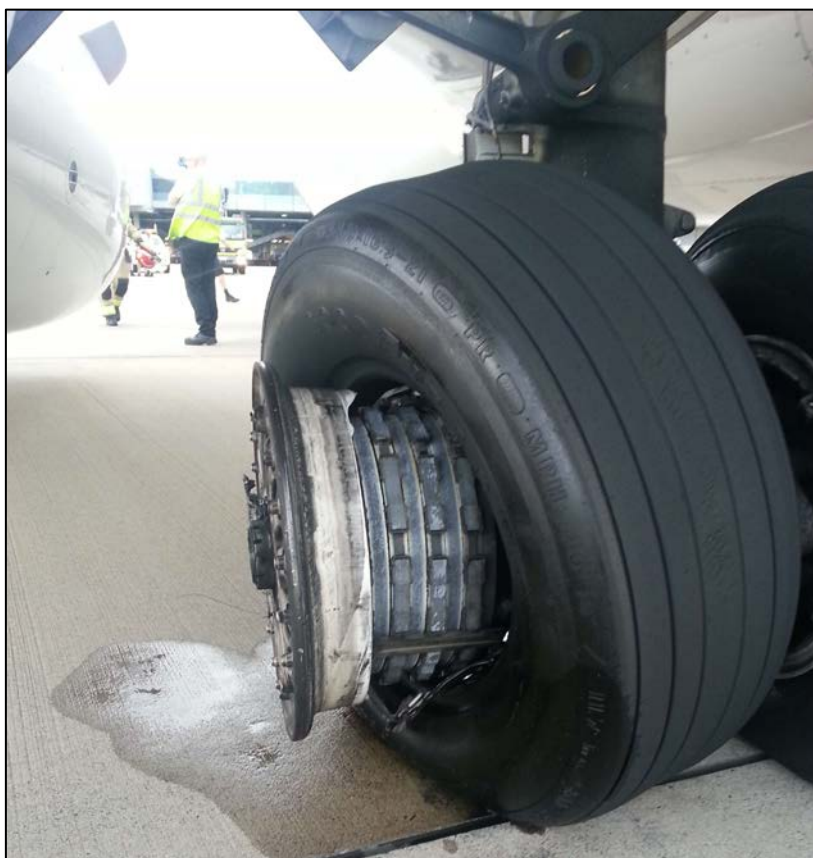
On 4 January 2017, a Boeing 737-8FE, registered VH-VUH (VUH) and operated by Virgin Australia Pty Ltd (Virgin), was scheduled to fly from Brisbane, Queensland to Melbourne, Victoria. Prior to take off, at approximately 1710 Eastern Standard Time,<sup>1</sup> VUH was holding on B3 taxiway when one of the main wheels experienced what was believed to be a burst tyre. The flight crew began to taxi the aircraft back to the gate. An attending engineer instructed the flight crew to stop the aircraft before reaching the gate, as they noticed the number one main wheel assembly (left-hand outboard wheel) had failed (Figure 1).

**Figure 1: Damage to the number one main wheel assembly on VUH**

An inspection at the maintenance facility found that the inner half of the wheel assembly had fractured (see the section titled *Wheel design*). The tie bolt assemblies that connected the two halves of the wheel were all present with mating faces intact, however some of the bolts were found to be loose.

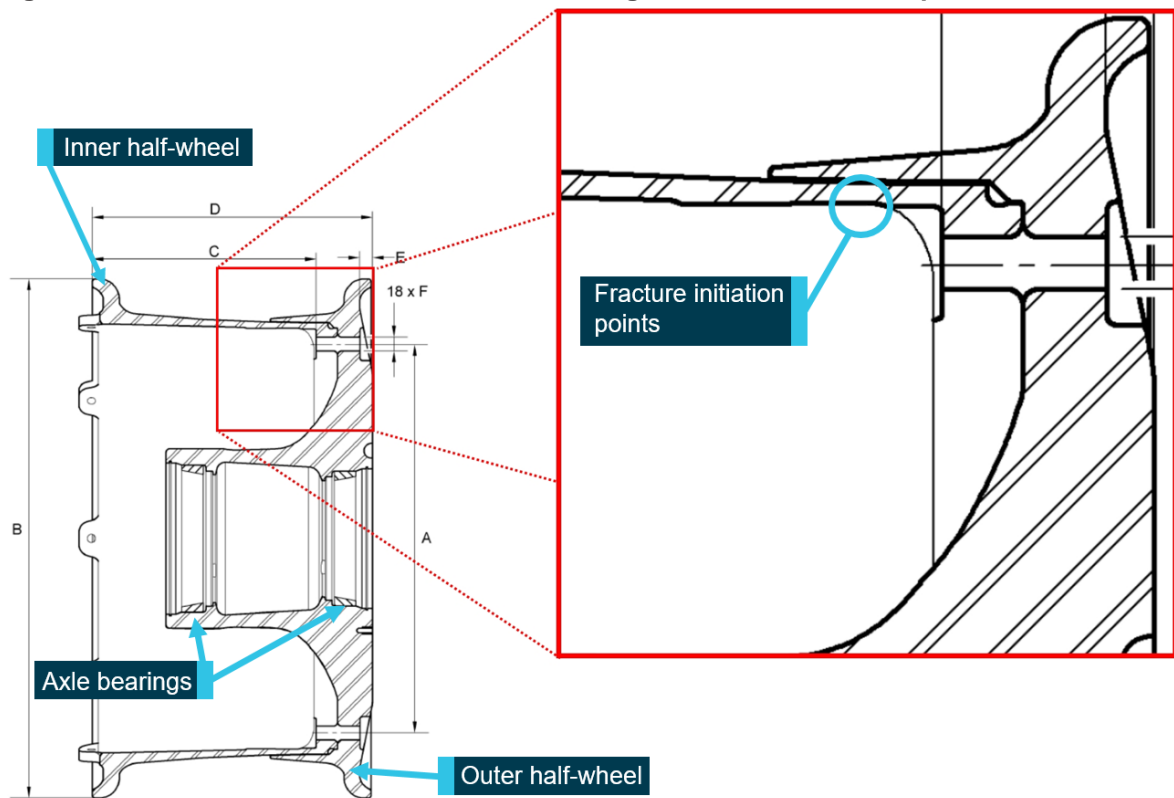
**Figure 2: Cross section of the main wheel showing the fracture initiation point**

The fracture location was coincident with a region of high stress during service. As seen in Figure 2, the cross section of the inner half-wheel reduced in thickness from left to right. The fracture occurred at the point where its cross section was thinnest, and near a change in geometry (tie bolt hole).

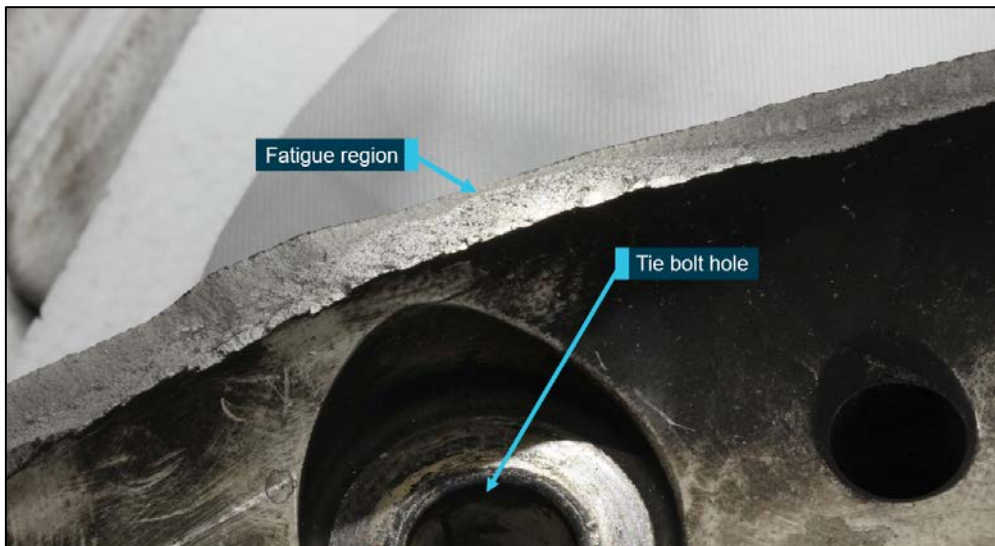
- Twelve of the 18 tie bolt assemblies could be twisted by hand.
- Several of the nuts had noticeably backed off the thread, with only three of the remaining six nuts above the minimum torque of 163 Nm.
- The breakaway torque<sup>3</sup> of each nut was tested, and four of the 18 nuts were below the acceptable value of 3.61 Nm.
- The tie bolt assemblies were visually inspected and found to be the correct part in every instance, with no evidence of damage.
- A region of the fracture surface near one of the tie bolt holes exhibited fatigue crack progression (beach) marks radiating away from several initiation points (Figures 3 and 4). The remainder of the fracture was consistent with shear overstress. There was no visual indication of material defect at the fatigue crack initiation sites.

**Figure 3: Outboard fracture surface on the inner half-wheel, with a fatigue region**

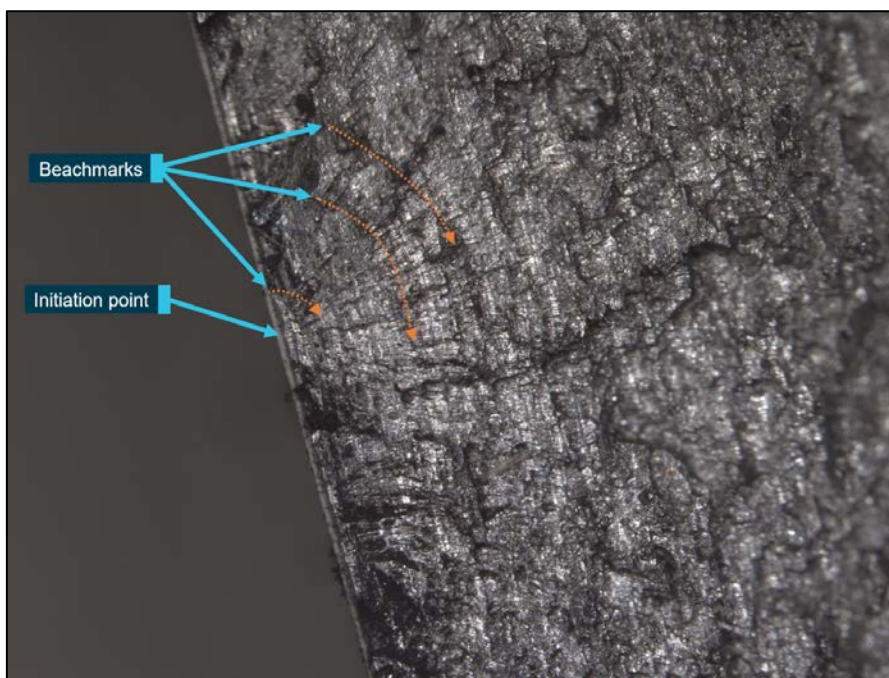
**Figure 4: Fracture morphology of one of the fatigue cracks through the fractured inner half-wheel**

The wheel manufacturer conducted a further examination of the failed main wheel, including a detailed analysis of the fracture morphology. They concluded that the wheel failed as a result of the observed fatigue cracks propagating into a mixed fatigue/ductile rupture mode. A small crack was also detected within the adjacent tie bolt hole, although this did not appear to have contributed to the wheel failure.
